# Leakage Investigation Survey

**Client: Blackburn**

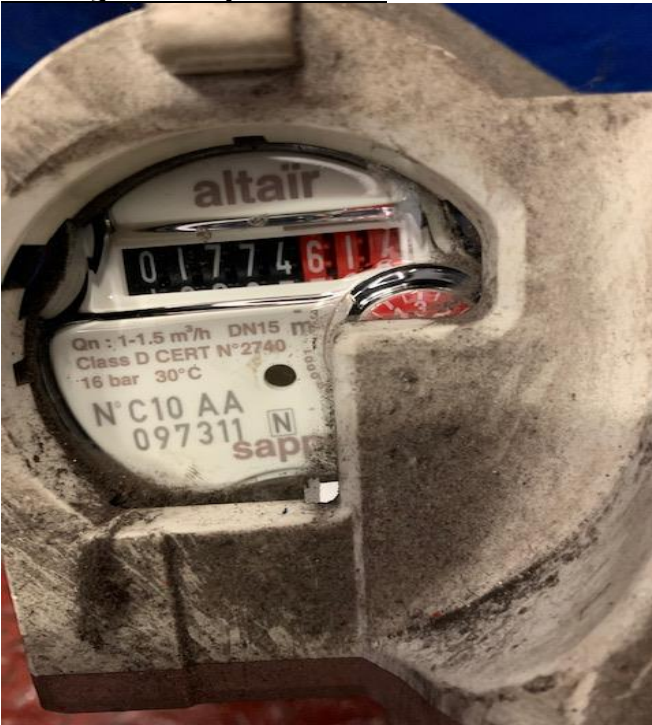
Pic 1

On arrival at site I checked the main revenue meter (pic 1) located internally behind tool chests, the meter had a constant flow rate of 12 litres per minute, which equates to = 17.28m<sup>3</sup> per day = 6,307m<sup>3</sup> per year = £19,300 per annum.

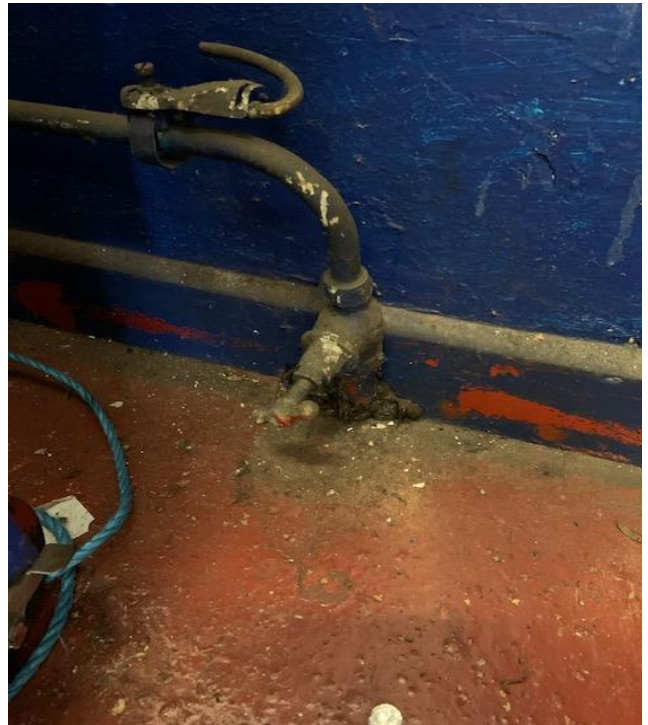
Pic 2

I first shut the internal stop tap (pic 2) and checked all end user areas and all were shut off confirming that the meter supplied the site.

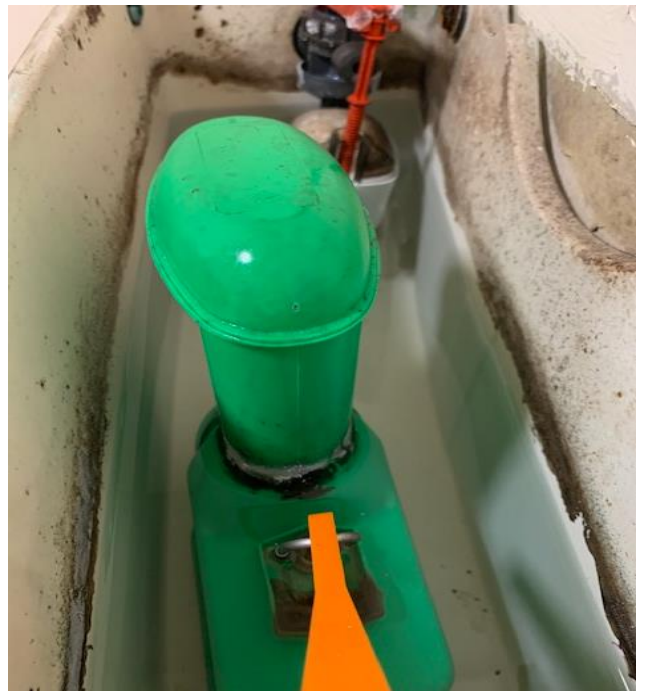
Pic 4

All WC's and sink taps were all in good order in the garage area, however in the public area there is a female WC (pic 4) which was in good order.

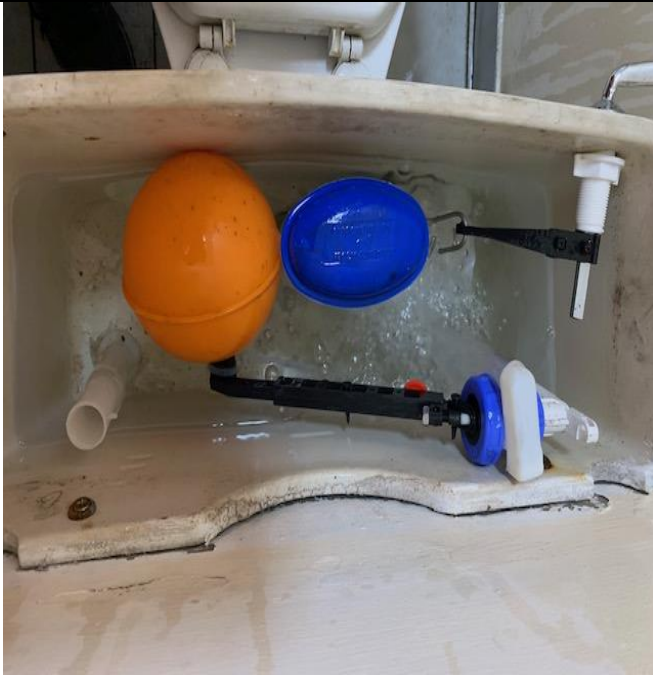
Pic 5

A male WC which was filling constantly and running through the integral overflow (pic 5) and direct into the WC bowl (pic 6).

On lifting the ball arm the water did stop but the cistern continued to drain into the bowl, with this happening I released the ball arm and let the cistern refill and again the water was going straight into the WC bowl thus confirming that the cisterns syphon mechanism wasn't working correctly.

I would think that the diaphragm inside the syphon is damaged and making the cistern continuously flush.

In all the cistern requires a new replacement syphon and a new replacement ball valve.

Replace syphon in WC cistern located in male public washroom

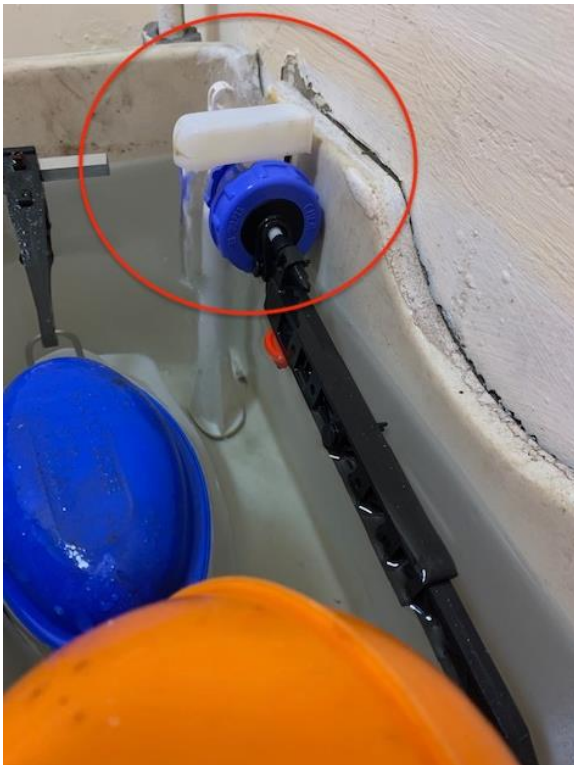
Pic 7

It was also noted that the ball valve is a left hand side bottom feed type, however the one that is installed is too tall for the cistern (pic 7) the cistern lid sits on top of the ball valve because of this and therefore needs replacing.

Replace left hand bottom feed ball valve with new shorter type (recommend a suspended type ball valve) see pic 4
