Report 12th January 2015

Client: Wiltshire SP2

Repair Activities

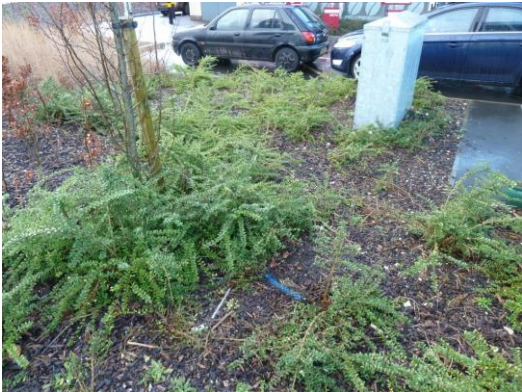
Traced pipework near Costa

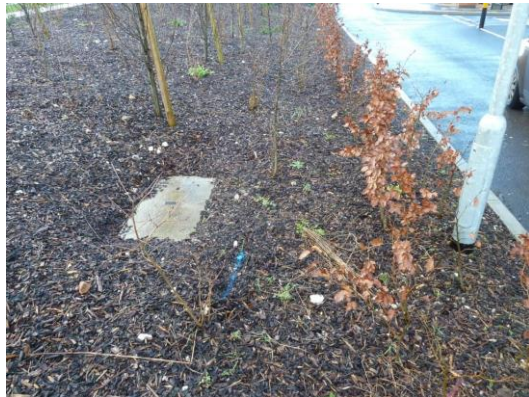
Traced pipework between Costa & McDonalds (adj. BT box)

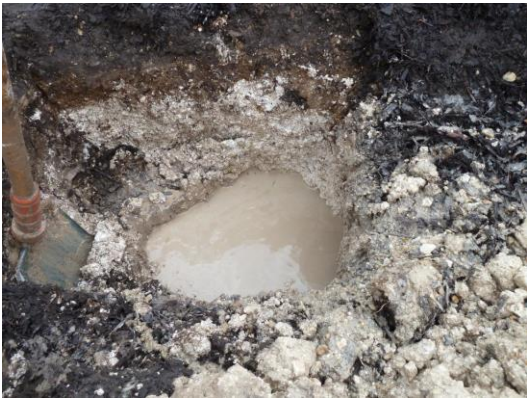
A second trial hole was then excavated at a suitable point mid-way along the length of the pipework, which found water approximately 300mm under the surface of the ground. Further digging showed clear water flowing from one side of the excavation, so the hole was extended another metre. The water was found to be draining away down a cut off piece of 50mm MDPE yellow gas pipe located just above the leaking connector (Philmac compression fitting).

Water found under surface of ground

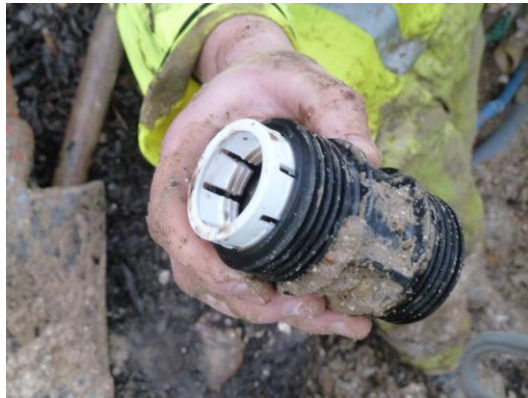
Once the excavation was cleared out, the water supply was isolated for the leaking connector to be inspected. The connector was very loose and pulled out easily. Upon closer inspection, the connector was found to have one gripper (white plastic ring with small 'teeth') inserted backwards. The pipe ends were also cut too short to provide sufficient length for the connector to grip onto.

Incorrectly inserted gripper ring

Recommendations: - The contractor who installed the water supply pipe is clearly at fault, the pipe end is cut too short, the gripper ring is incorrectly inserted and this has been leaking since day one.

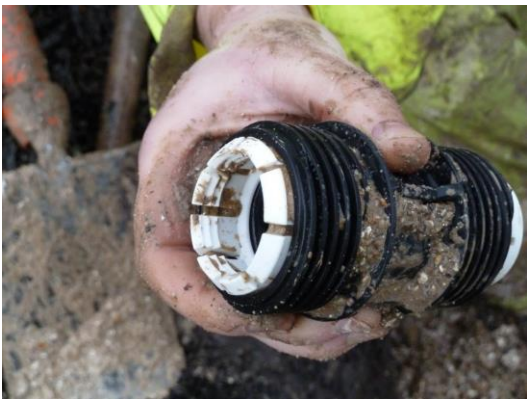
Correctly inserted gripper ring

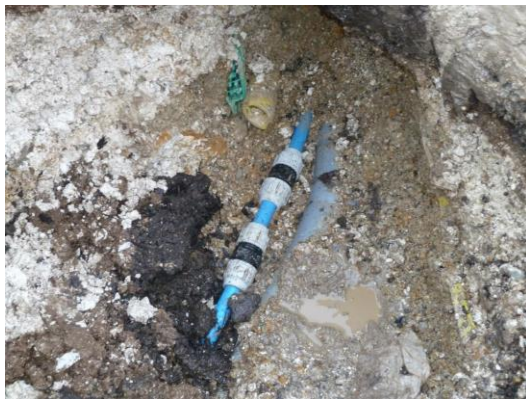
Completed repair

A small piece of 32mm MDPE and two new connectors installed to provide a repair. With the water back on, the pipework was again flushed through in the plant room and the meter checked, which was found stationary indicating no further leaks.

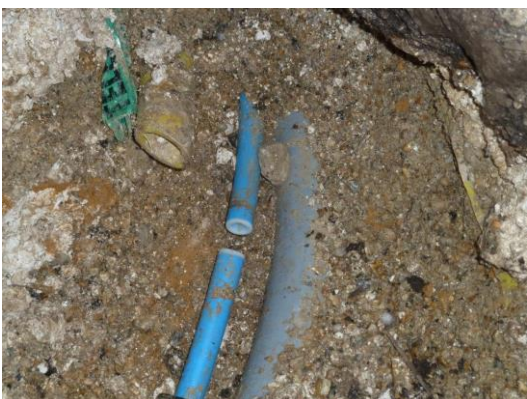
Pipe ends cut too short

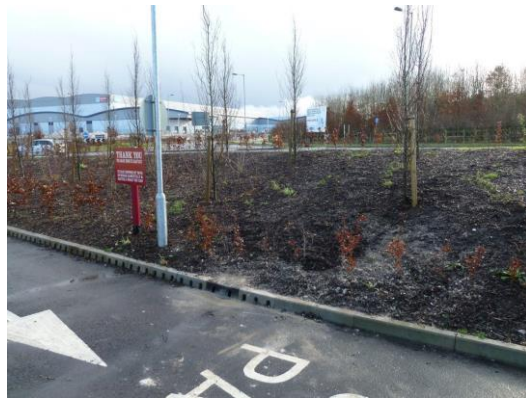
Area reinstated

The excavation was then backfilled and reinstated back to its original condition, and the meter read following the resolution of the water leak – reading 12950m³.

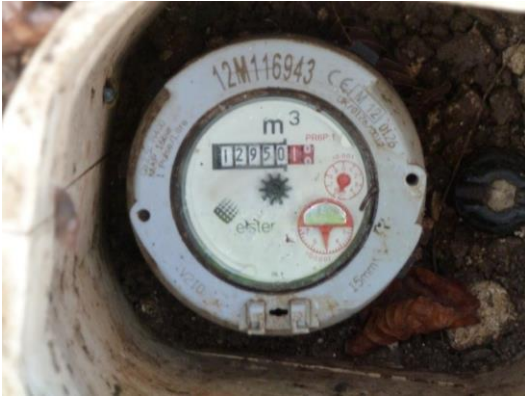
Water meter after repair
