Leak Detection Site Survey Report

30th January 2015

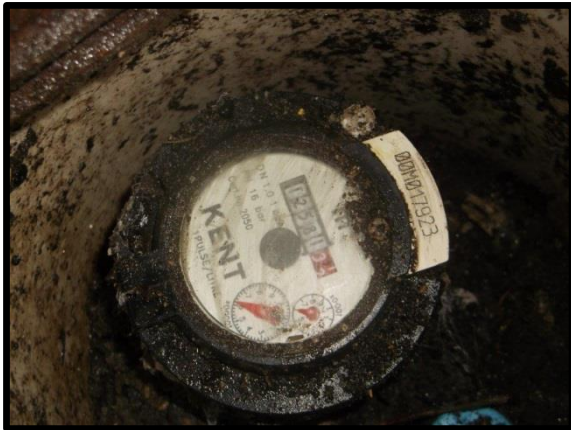
Picture 1 - Plymouth Water Meter

The meter was reading 12,581m³ with a **flow rate of approximately 0.3m³ per hour**, giving an **average daily usage of 7.2m³**. An average daily usage of 7.2m³ per day carries a **daily cost implication to Wolseley of £39.74** and an **annual cost implication of £14,506.56**.

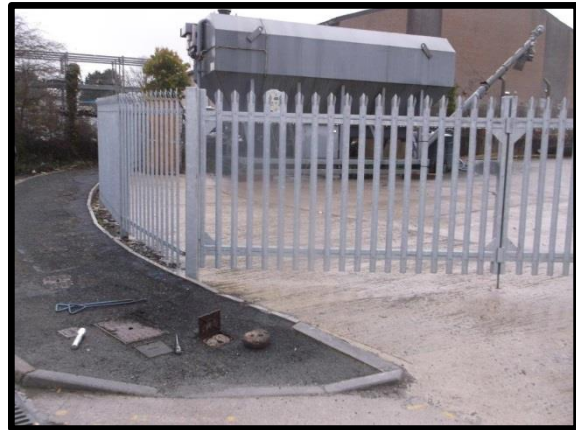
We arrived on site and began by locating the water meter which we found to be located about 0.5 miles drive from the Plymouth site on a separate road named, Huxley Close. It sits in the pavement near to the DVLA compound. The meter serial number was checked and correlates to the water bills we receive (00M017923). To ensure we had the correct water meter, we turned a kitchen tap on whilst observing the water meter. When the kitchen tap was turned on, the water meter increased in speed, we then turned the tap off and the water meter returned to a flow of 300 litres per hour.

Picture 2 – Plymouth Water Meter Location

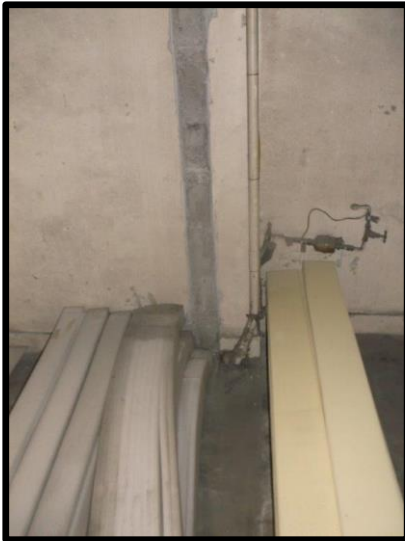
We looked around the building and found the rising main in the warehouse. There is no stop tap on the rising main where it comes out of the ground. The pipe rises up to high level and then it branches off in two directions. One branch goes left to a water storage tank and then back down to feed the toilets, kitchen etc. The branch to the right goes all around the warehouse to a hose tap then it crosses to the shop and there is a supply to the drinks machine. There was good noise on the rising main so we decided to isolate each branch and see if it would any difference to the leak noise and the flow rate through the water meter.

Picture 3 – Rising Main in the Warehouse

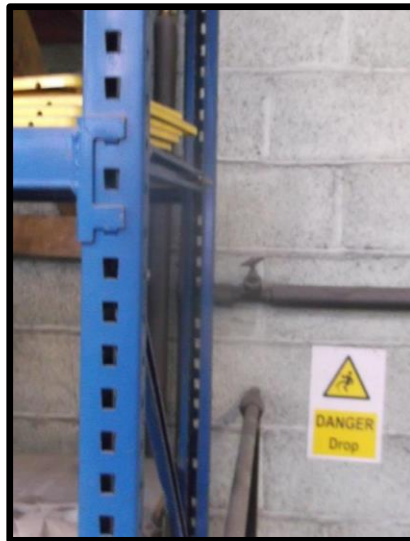
There was a stop tap to on the left hand branch at very high level, which was too hazardous to try and attempt to access however there was another stop tap on the branch by the water tanks. We closed this stop tap and found that the leak noise disappeared. We then went to the water meter and this had also stopped spinning indicating that the leakage/water loss was on the left hand branch within the main building.

Picture 4 - Stop tap on left branch used to isolate the left branch supply

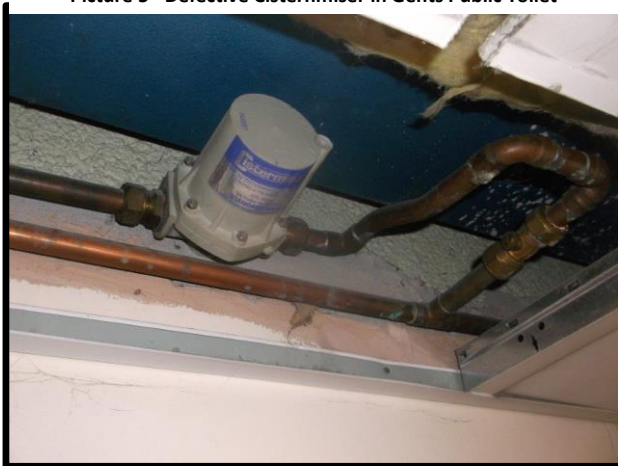
We lifted a ceiling tile above the urinal and we discovered a cisternmiser type urinal control which was running continuously. On the inlet side of the urinal control there is an isolation valve, so we shut this to stop the flow to the urinal cistern. We then went to the water meter again and found that the water meter was stationary.

Picture 5 - Defective Cisternmiser in Gents Public Toilet

There is a loss of 300 litres per hour at Burdens Plymouth which we found to be going into the building. Further investigations show that this entire loss is going into the Public Gents urinal.

Fit a new urinal control on the 15mm copper pipework in the public Gents toilet. There is a local isolation point by the urinal (the ball fix valve) and the control is mains fed, not tank fed.

Cost: £85 + VAT + Postage (Supply only)

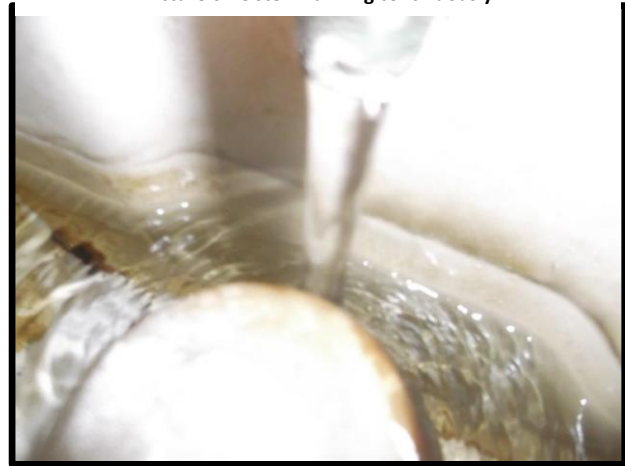
Picture 6 - Cistern running continuously
