Water Leakage Investigation Survey

13 May 2015
Winchester, Hampshire SO23

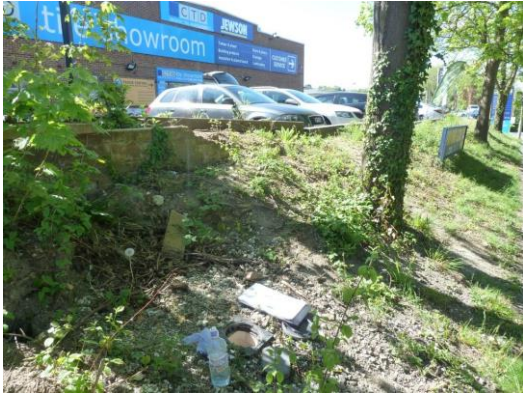
The water meter is located in the verge outside the premises.

Meter location in verge

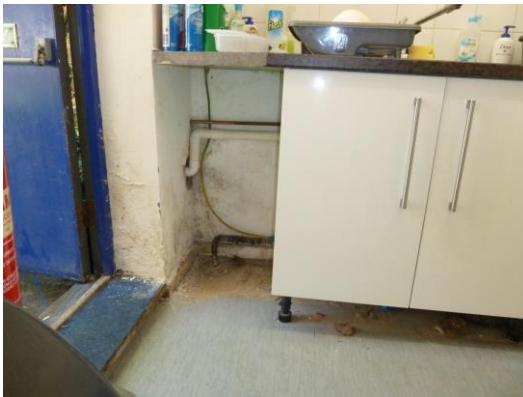
The rising main is 3/4" galvanised iron pipe, which rises in the kitchen area of Ceramic Tile Distributors at the side of the premises. The pipework was traced out from this point and found to run close to or just under a low rise retaining wall. From this point, 15mm copper pipe is surface clipped around the building to supply all points of water use.

Rising main in kitchen area of the Ceramic Tile Distributors

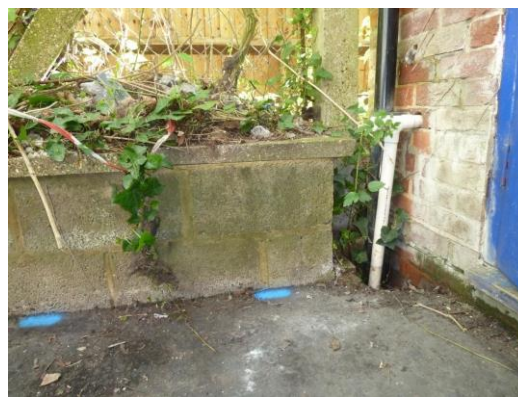
External line of pipework up to building

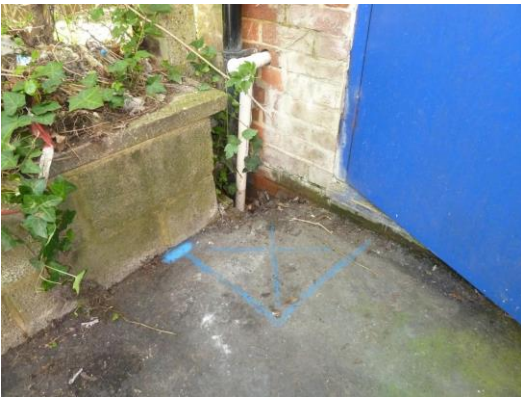
The anticipated route of the main was then acoustically sounded for leak noise. A small amount of leak noise could be heard along the edge of the retaining wall towards the rising main. Leak noise correlation was also carried out but the results were inconclusive. This was due to either a mixture of metallic and non-metallic pipe material or the proximity of the large volume of leak noise close to the rising main. Due to the volume of the audible leak noise within the building and lack of high area of leak noise externally, it is anticipated that the leak is either under the floor of the building, within the building wall structure (in the foundations) or just outside.

Location for trial hole to locate pipe and prove leak is under the building

1. Below ground leakage confirmed running at a rate of 22 litres/minute or 31.6m³/day;
2. The location of the leak is anticipated to be at or close to the point of entry into the building.

1. It is recommended that the leak is repaired as soon as practicable, starting with a trial hole just outside the building. If the leak is proved to be within the building, a new point of entry is recommended (using an Insuct or similar). With the pipework brought through the exterior wall, a new stop tap can be fitted under the kitchen worktop and connection made into the existing 15mm pipework.
2. It is also strongly recommended that regular meter readings are taken to monitor consumption going forward – ideally weekly if possible. This will prevent any future leaks being able to create high water bills.
