Water leak detection and Repair Report

4th March 2014

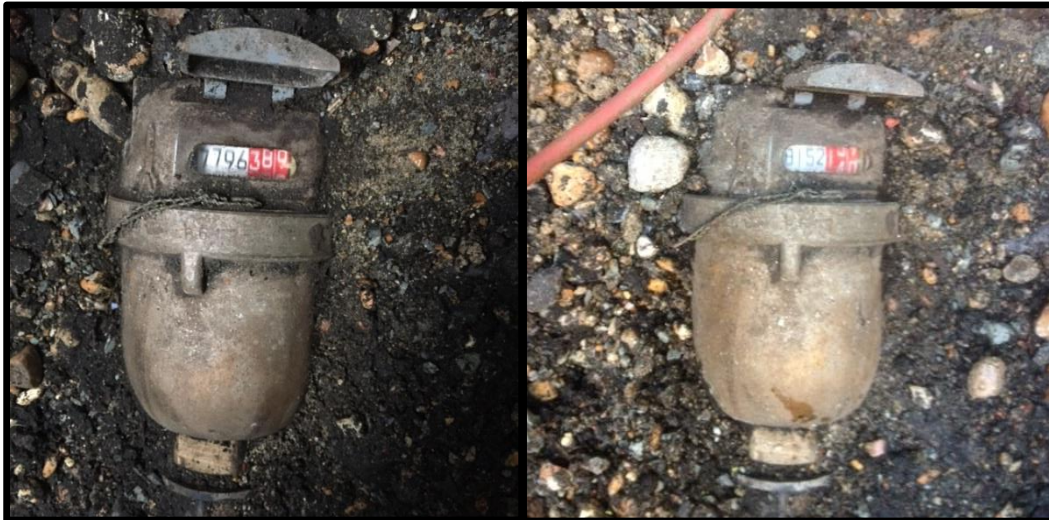
Our engineers began by excavating a trial hole at the entrance to the building to find the supply pipe. We located the supply & cut and capped the pipe which proved the leak was inside the building because as soon as this pipe was cut & capped, there was no movement on the water meter. This capping of the supply pipe eradicated the leakage on the section of supply running under the garage floor.

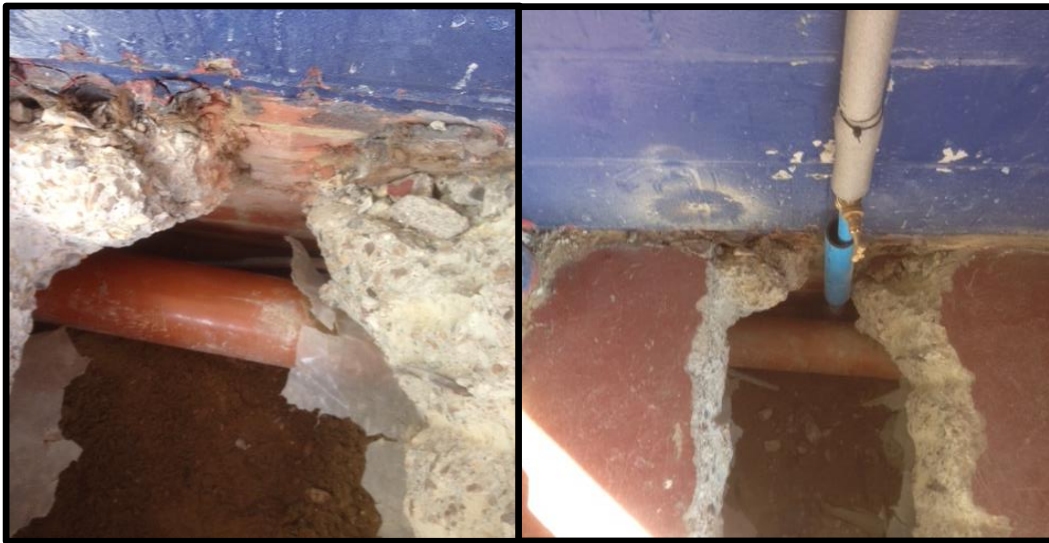
We continued our works and isolated the water supply. We removed the cap on the incoming external supply which allowed us to connect the new 15mm barrier pipe. We brought this up out of the floor up the wall and installed a new isolation valve. We continued to run this pipework up the wall, clipping in place as we installed.

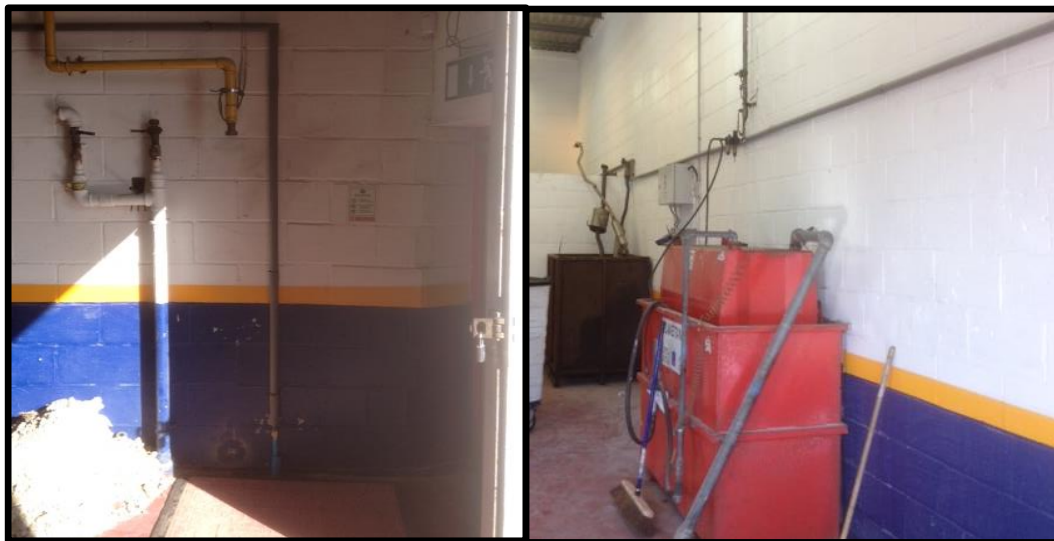
Once our engineers connected the new main, the supply was reinstated but as soon as the supply was reinstated, it was established that another leak had occurred on the section of supply between the water meter chamber and the new section of pipework. The **new leakage rate was measured at 16 litres per minute, equating to 0.96m³ per hour and 23.04m³ per day** carrying a **financial hit of £89.16 per day and £32,545.15 per annum.**

The pipework is aged worn copper which subsequently becomes very prone to bursts. When we detected for leakage noise on the new leak, we were unable to pick up any traces apart from the spinning meter. No leak noise could indicate that the supply tees off at some point between the meter and the new supply pipe.

In conclusion, the leakage that we originally attended site to repair has been completed & new pipework installed. There are no issues on this section of supply. However, when the supply has been turned back on, due to the deteriorated copper pipework, another leak has occurred between the meter box outside and the entrance to the building. This is leaking at a rate of 16 litres per minute and requires urgent attention.

To detect and eradicate this leak we need to excavate at the boundary in concrete and cut and cap the copper pipe to determine which side of the supply the leak is on. If the leak is in the footpath, then the detection and repair of this is the responsibility of the water company. If the leak is found to be from the boundary to the new supply pipe, this will need moling for approximately 15m in concrete to locate the leak and the 15m of pipe will be relayed to eradicate the leakage.

Attend site, excavate at the boundary, cut & cap the copper pipe & establish whose responsibility it is to repair. If site are responsible, mole for approx. 15m in concrete to locate leak. Once located, relay 15m of supply pipe to eradicate leak. All of the above is to be done within the same day.
