Leakage Investigation Survey

7-8 June 2015

Holiday Park, Northumberland

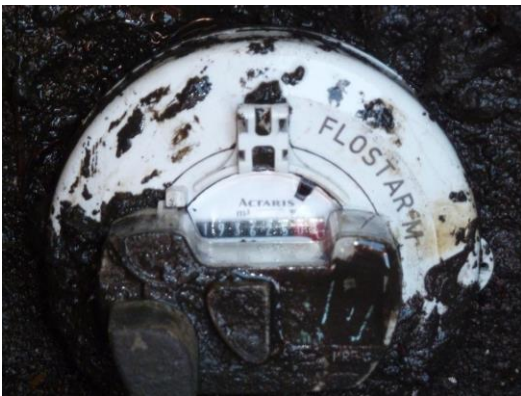
The main meter was read at 01:00 and confirmed to be recording water consumption at a rate of 28 litres per minute. This rate will also include a small amount of legitimate consumption as a number of residents were still awake around the park.

Meter reading 8 June

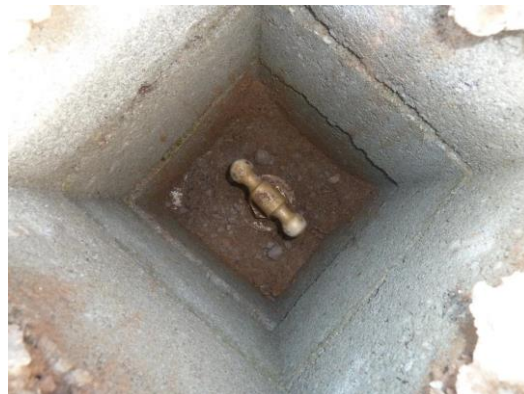
Stoptap in chamber

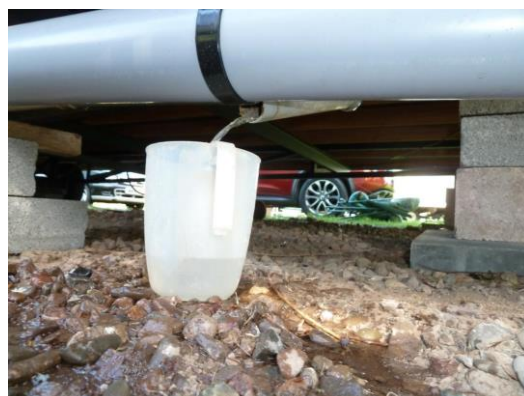
Quantifying volume of water left running – plot 52

1. Repair all identified leakage issues;
2. Further tracing and valve installation work will be required to track down the remaining leakage on the gravity fed half of the park. Additionally, the installation of further sub-meters at strategic locations around the park once the principle routes of pipework have been identified will be advantageous for the continued management of water at Riverside.

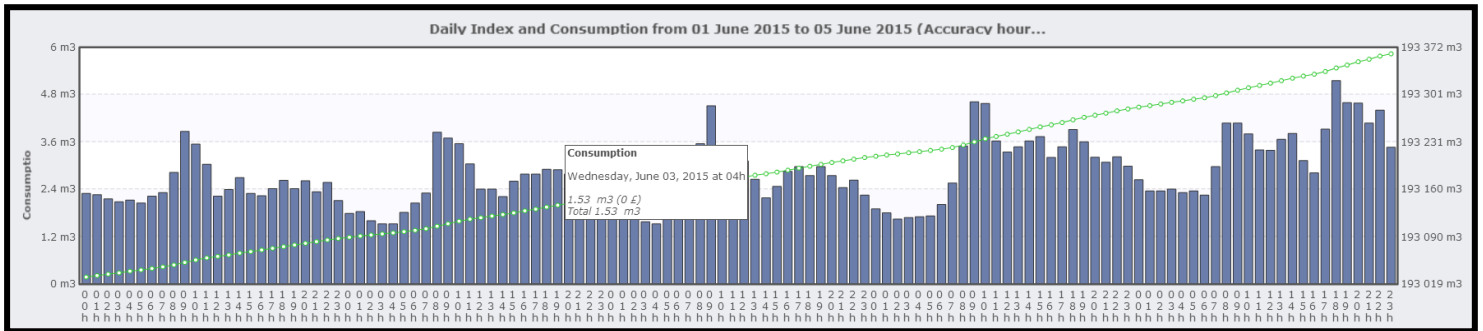
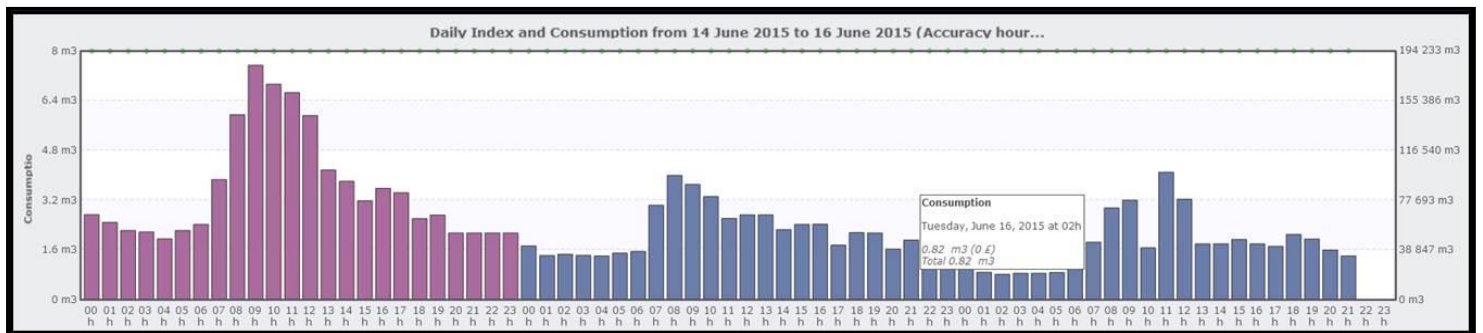
As we can see from the below data logger snapshot, the minimum flow rate has **now dropped from an average minimum flow rate of 1.53m³ per hour to a minimum flow rate of 0.82m³ per hour (820 litres per hour)**. The first data logger snapshot shows the flow rate before H₂O intervention and the bottom snapshot shows the flow rate after H₂O intervention and subsequent repair works carried out.

As a result of carrying out the repairs successfully, the Holiday Park are now **saving approx. 0.71m³ per hour (710 litres per hour) and approx. £37.65 per day on water costs.**

The customer completed the necessary repairs at the Holiday Park and as soon as this work was completed, we monitored the data logger to confirm that all the leakage found during our visit had been eradicated.
