# Lyons Holiday Parks - Robin Hood Water Leak Detection Site Survey Report

23<sup>rd</sup> July 2015

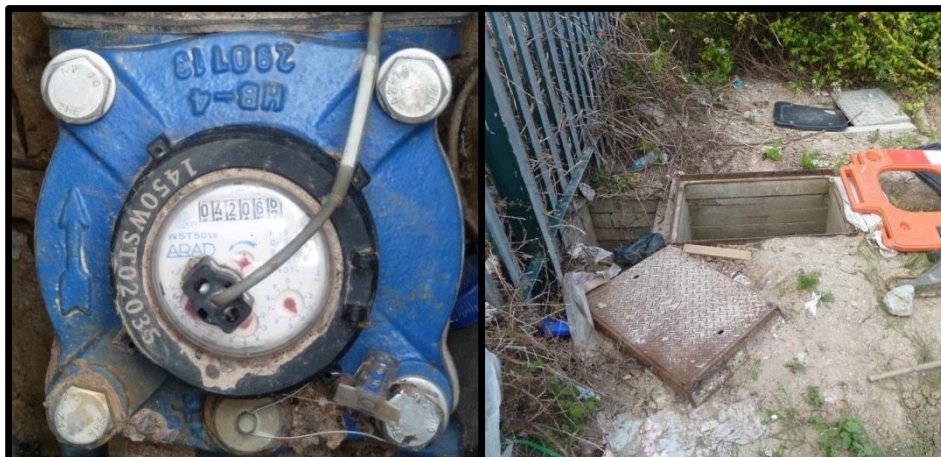
We established the water meter serving the site to be meter serial number 1450WST02035 and is located in a meter chamber in a fenced yard area on Sherwood Avenue. There is currently no lid on the water meter chamber.

Picture 1 – Water meter 1450WST02035

Picture 2 - Water meter chamber

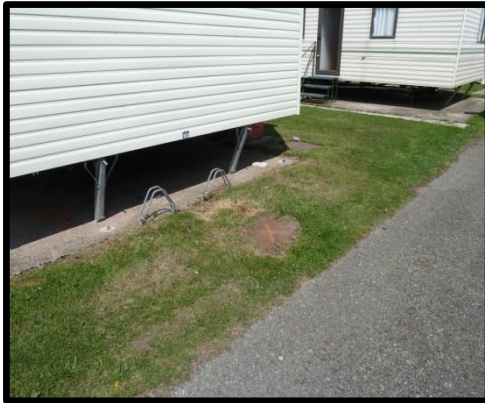
Picture 3 – Leak 1 location on stop tap at rear of plot HC8 (Valve under chamber lid)

Both leak locations were excavated during the survey so that the exact point of leakage could be confirmed, and also to enable a quick repair and an immediate water saving.

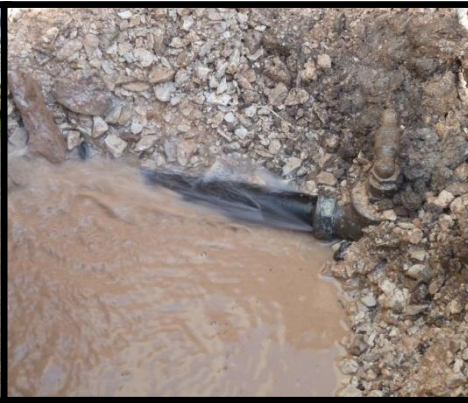
Picture 4 – Leak 1 uncovered found to be blown olive/compression nut on stop tap

In conclusion, we confirmed the leakage rate to be approximately **2.4m<sup>3</sup> per hour**, equating to approx. **57.6m<sup>3</sup> per day excess consumption** and a **daily unaccounted cost of £170.50** and **£62,232.50 per annum**. We identified and uncovered two significant leaks, one on a stop tap at the rear of plot HC8 and another on a split valve at the rear of plot RA3. Both of these leaks were repaired at the time of the survey.

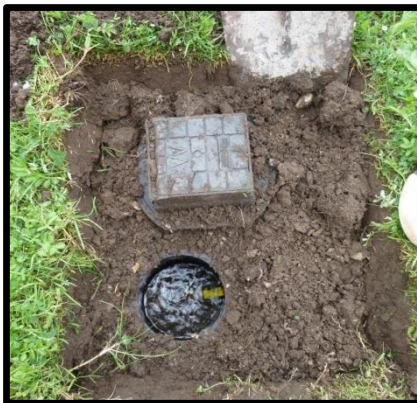
Picture 5 – Leak 2 location at rear of plot RA3 (Chamber lid was completely covered over with turf)

We also recommend that all surface covers (valve lids etc.) are clearly marked to prevent these being buried in the future. An example of good practise is shown below where valve covers have chamber lid surrounds installed:

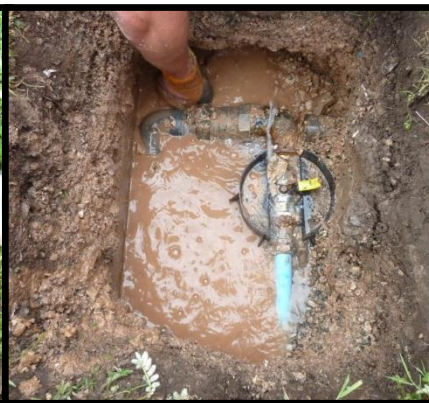
Picture 6 - Leak 2 excavated

A few trial holes had already been excavated on Rowan Avenue which helped to minimise time establishing routes of pipework in this area whilst pinpointing the leak in this location (Leak 2).

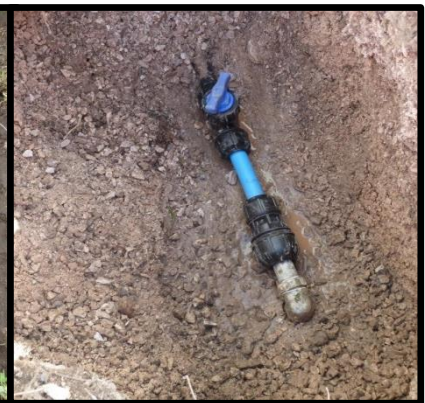
Picture 7 – Leak 2 repaired and stop tap replaced

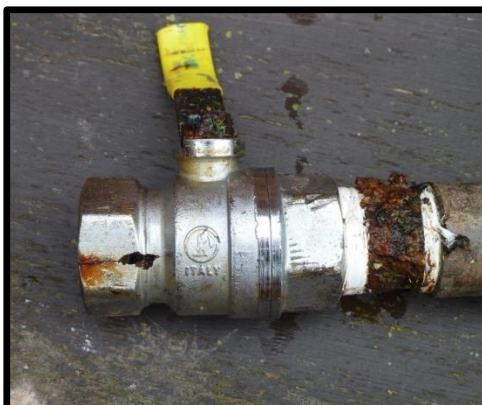
Picture 7 – Cause of Leak 2 was due to split in Valve

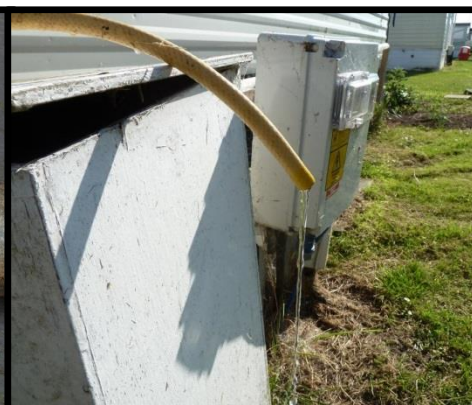
Picture 8 – Tap supply hosepipe left running on plot TP16

Other easily resolvable issues were also addressed during the survey, including a WC sink tap left running at plot SBW83 and a tap left running at plot TP16 supplying a hosepipe.
