Client

Electrical Technologies, Lincolnshire

Mains water meter information

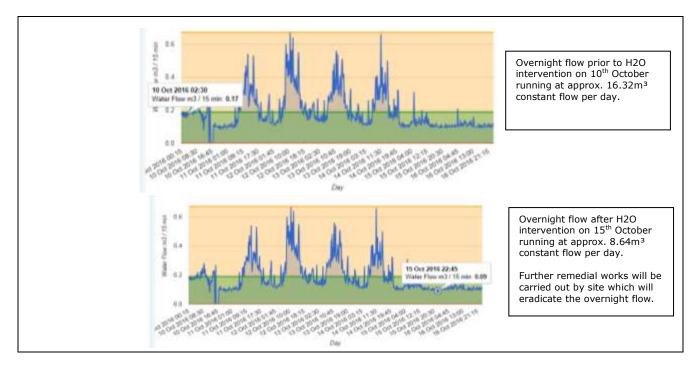
With all points of use checked in the central riser area of the main offices, this volume is likely to be leakage on the supply pipe to the central office riser. Acoustic sounding of the area around the old lift shaft and external connections identified potential leak noise.

Therefore, there is underground leakage running at a rate of approx. 6 litres per minute, 8.6m³ per day. This remaining underground leakage equates to £25.14 per day, £176 per week, £9176.10 per annum.

- 1. Lift wooden floor in old lift shaft and inspect incoming pipework for leakage. Also check to see if water is running in from outside. If the leak is not visible in the bottom of the lift shaft, it is recommended that an alternative means of supplying water to the central office area is considered as any excavation work will require removing a newly installed concrete ramp;
- 2. Inspect WC's periodically to check for correct operation;
- 3. Excavate area around valves in corner of contractors car park to expose meter/stoptap chamber supplying central office riser.
