**Tyre Store, Shropshire**

## Mains water meter information

## Leakage Activities

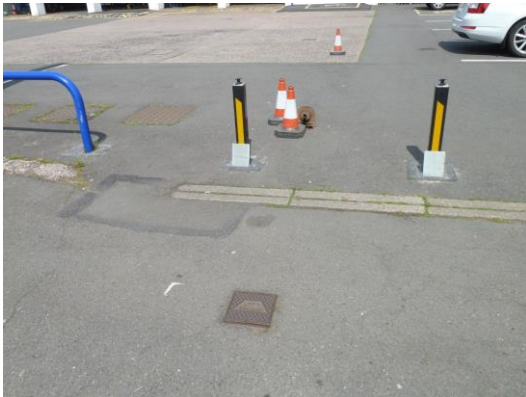
The water meter is located in the forecourt roughly in line with the front door of the premises. A further small chamber in the footpath contains a brass stoptap which isolates the water supply prior to the meter.

Stoptap and meter locations in forecourt

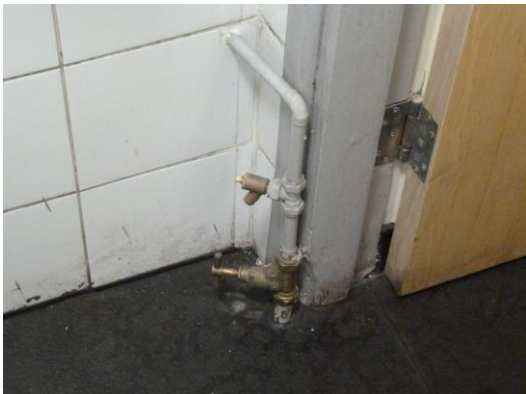
Rising main in staff WC

All points of water use were identified and checked for correct operation - all were found to be operating ok. The main incoming pipe (rising main) was located and the isolation valve closed (valve on rising main does not operate fully though) whilst the meter was checked to perform a leakage test.

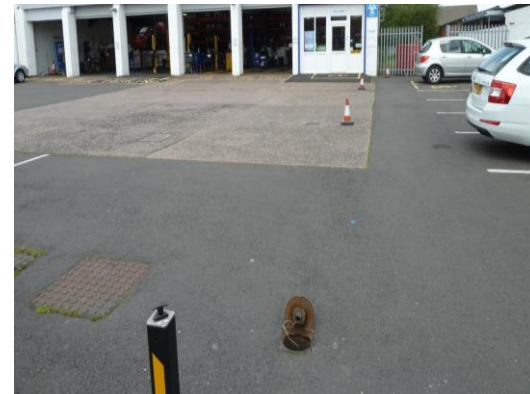
External line of pipework up to building (cones)

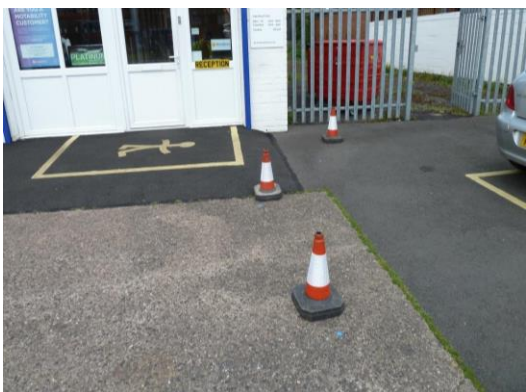
Line of main curving round building

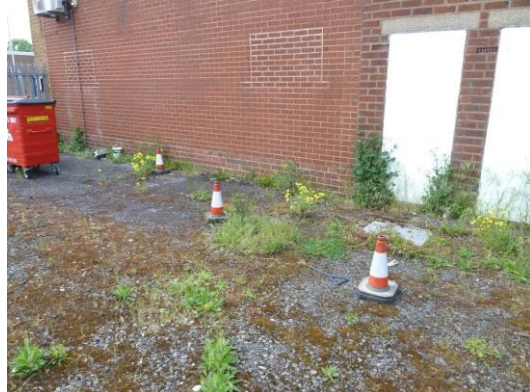
Traced line of pipework alongside building

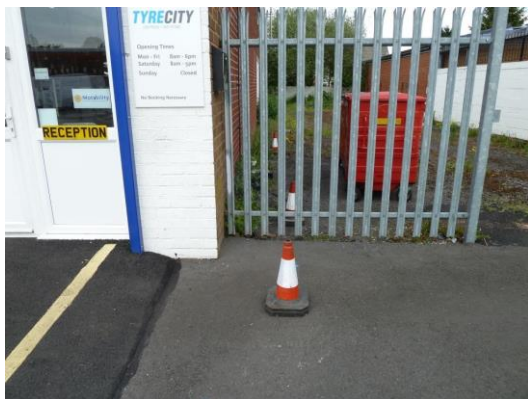
Audible leak noise could be heard on the rising main and at the water meter. Leak noise correlation was carried out which gave a clear leak position just in front of the high metal fence outside the front entrance to the premises. Although the whole area was acoustically sounded for any surface noise to confirm the correlation, none could be found. This may be due in part to the high amount of ambient noise being created by the constantly busy road running past the premises. The ground microphone was also used in this area but no noise could be identified.

Likely leak position just in front of the metal fence (no surface noise to confirm correlation however)

- 1. Below ground leakage confirmed running at a rate of 7 litres/minute or 10m<sup>3</sup>/day costing Tyre Store £19.50 per day and over one year, £7117.50;**
2. The location of the leak is anticipated to be just in front of the high metal security fence to the right of the entrance to the premises but this would potentially require several excavations in tarmac to pinpoint;
3. All water using fittings on the premises operating ok.

1. A full relay of the pipework would be most beneficial for the site. Given the age of the pipework, it is very likely that a repair will be carried out, the pressure reinstated and further leaks will develop on the pipework.

External pipework can be reconnected through the exterior wall of the staff WC via an Insuduct or Groundbreaker box into the 15mm copper pipework. Total distance to relay is approximately 35m.

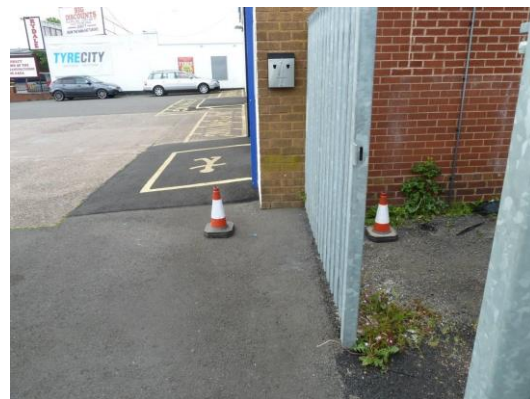
Excavate behind fence first (cone on RIGHT) to check leak isn't here before breaking into new tarmac in front of fence (cone on LEFT)

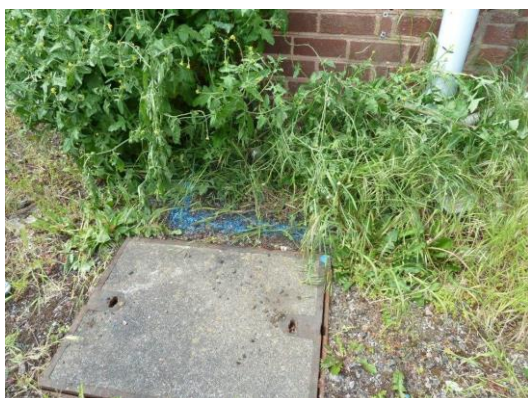
South Staffs area for investigation - IGNORE!  
Leak noise heard on building wall at this point believed to be originating from rising main

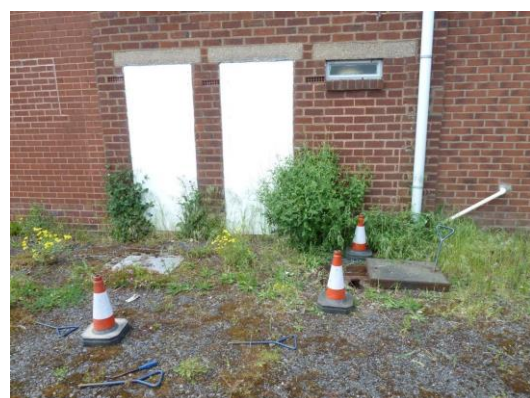
Line of main into building (cones marking route)
