Leakage Investigation Survey

17 November 2016

Leisure Park, County Durham

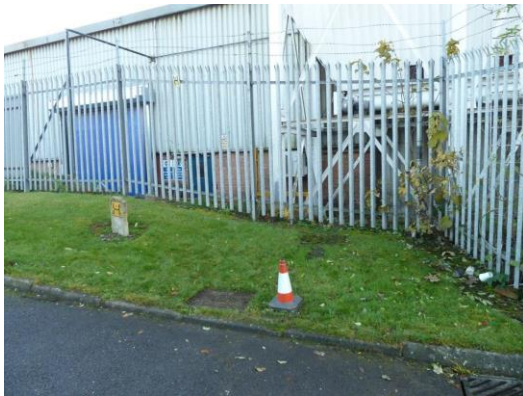
Meter location in grass verge

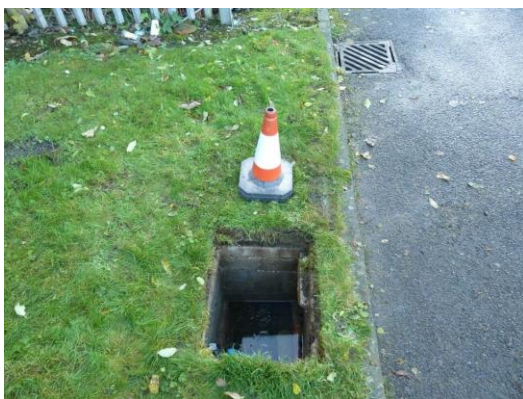
When checked, there was a high level of leak noise on the pipework in the meter chamber. With the valve behind the meter closed for a short period, the water level in the chamber was found to drop quite quickly. A chlorine residual test confirmed mains water immediately. The chamber was completely dewatered before opening the valve again. Water started filling the chamber within a few seconds.

Leak location behind water meter (traffic cone)

1. Leakage on the section of off-site pipework between the water meter and the main valve into the park confirmed to be 16.2 litres per minute or over 23m³/day equating to an excess cost of approx. £52.95 per day.

1. H2O to arrange with Water Company to attend site, identify, inspect and repair this leak.
2. Confirm reduced leakage volume (if any) once leak has been repaired.

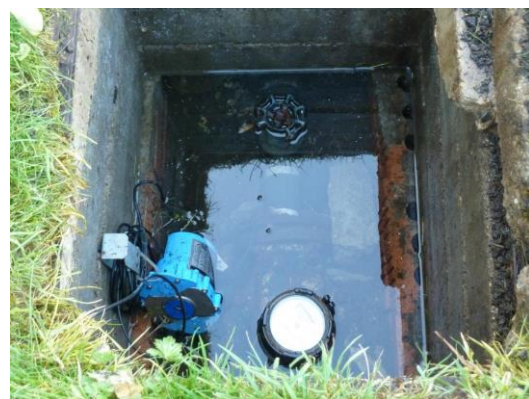
Water in chamber (level drops when gate valve closed)
