# Leakage Investigation Survey

08 December 2016

**Leisure Park, Northumberland**

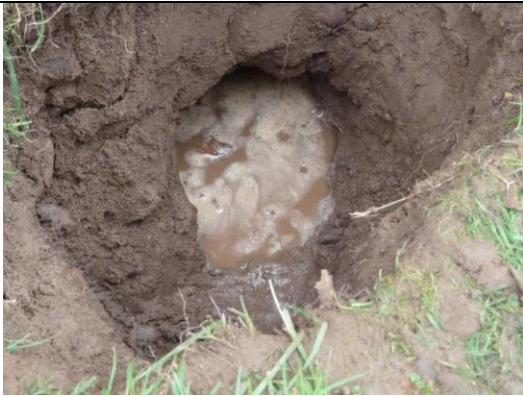
All plots in Morton Mews and River View were then acoustically sounded and visually inspected for leaks. A number of above ground issues were identified together with faint leak noise below ground on the **pipework to plot 35 Morton Mews**. A leak was confirmed on the supply pipe to this plot after using the tracing wire to identify the route of the 20mm MDPE pipework from the rising main, and the excavation of small a trial hole by park maintenance staff.

Trial excavation to pinpoint leak by 35 Morton Mews

1. Repair all identified leakage issues;
2. Continue to monitor flow logger for any further leakage issues that may arise;
3. Advise residents of the need to conserve water and protect pipework from frosts using lagging pipework rather than running taps continually.

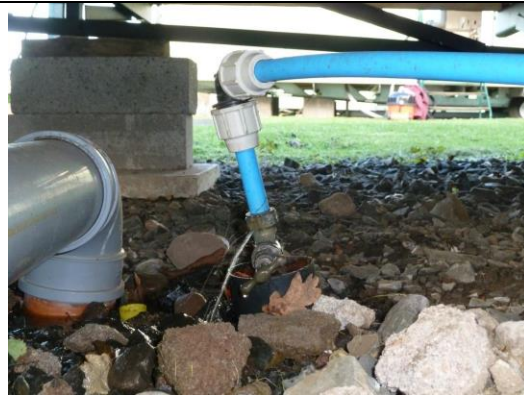
Leak on brass stoptap – plot 186 Bambi Court

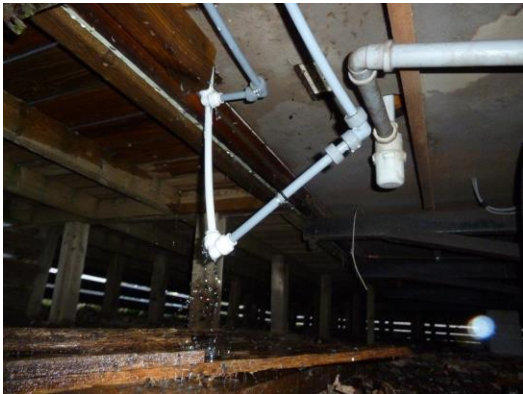
Leak coming from floor underneath mobile home

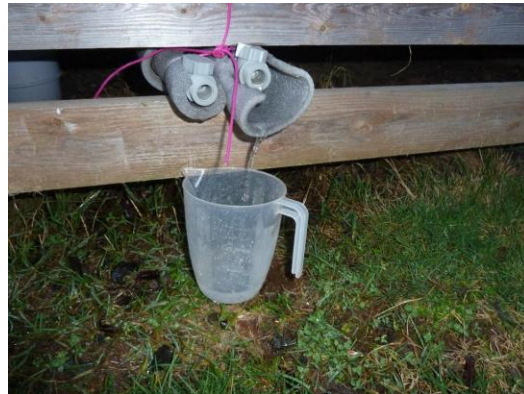
Measuring leak at plot 428 Wool Park

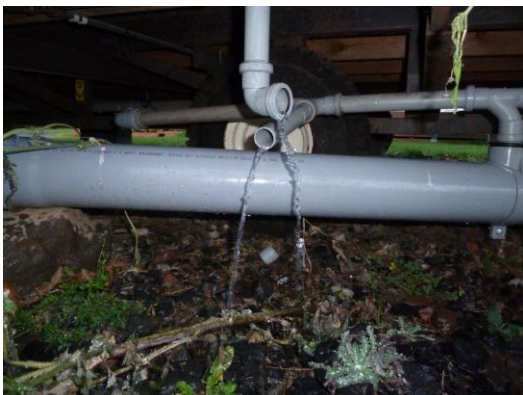
A reasonable volume of water was heard flowing down the drain at plot 445. The drainage pipework was separated for a short time to assess the volume of water running to waste.

2x taps left on inside plot 445 Wool Park for frost prevention?

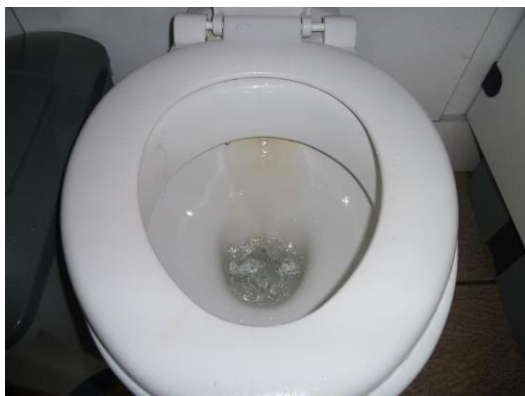
1. WC in ladies toilets (function room area) constantly running. Approximately 6 litres per minute - measured from main water meter in footpath. Maintenance aware of problem - new siphon assembly required; site advise this has now been repaired.  
**This is an immediate saving of 8.64m<sup>3</sup> per day & a financial saving of £19.09 per day & £6,969.46 per annum.**
2. Minor drip on WC in men's toilet in pool area.

Overflowing WC cistern in ladies toilets
