Leakage Investigation Survey

23 March 2017

Holiday Park, North Yorkshire

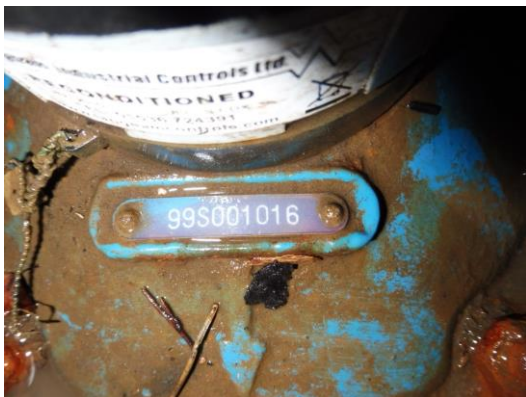
Second meter supplying Pine Ridge area

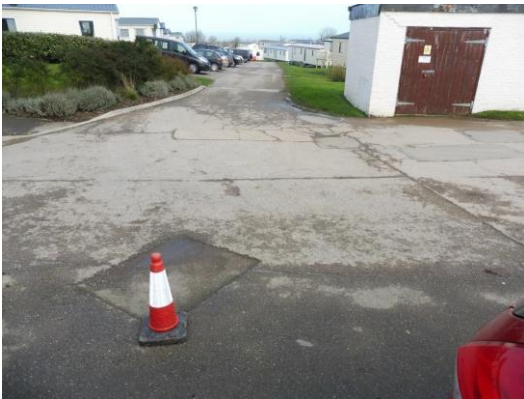
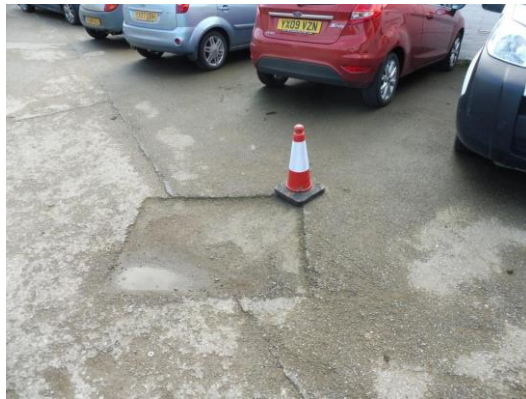
Leak 1 - location in staff parking area

Leak 1 - location marked by traffic cone

1. Excavate, locate and repair below ground leak identified in staff car park;
2. Excavate potential leak close to wall of staff canteen;
3. Repair all minor above ground leaks;
4. Check minimum night flow and confirm new leakage volume.

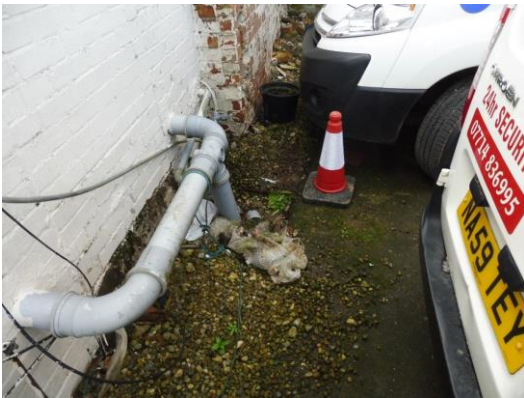
Leak to excavate by staff canteen – high leak noise

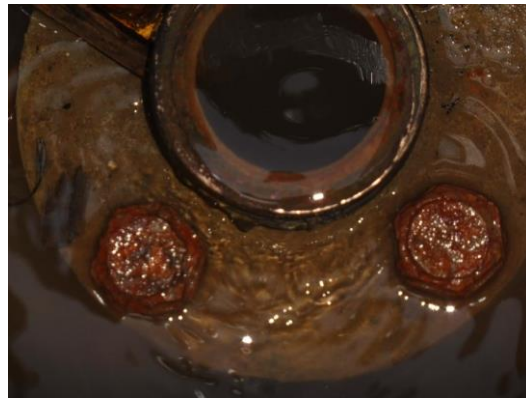
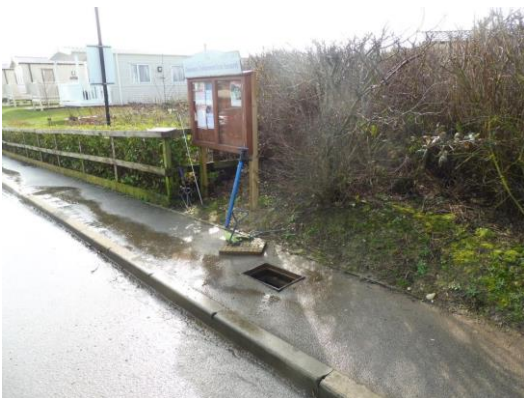
Leaking Fire Hydrant

Location of leaking Fire Hydrant

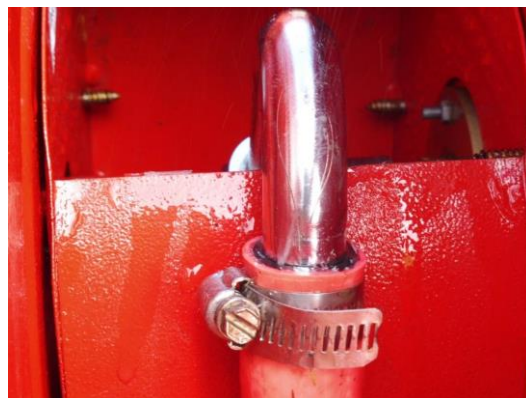
Leak on Fire Hose Reel – near plot 11 Bramp Heights

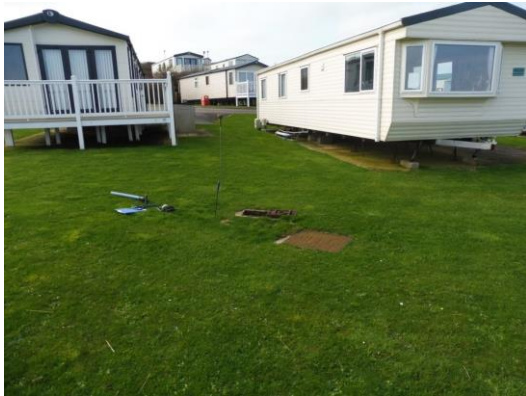
Location of leak on isolation valve between 5/6 Bramp Heights

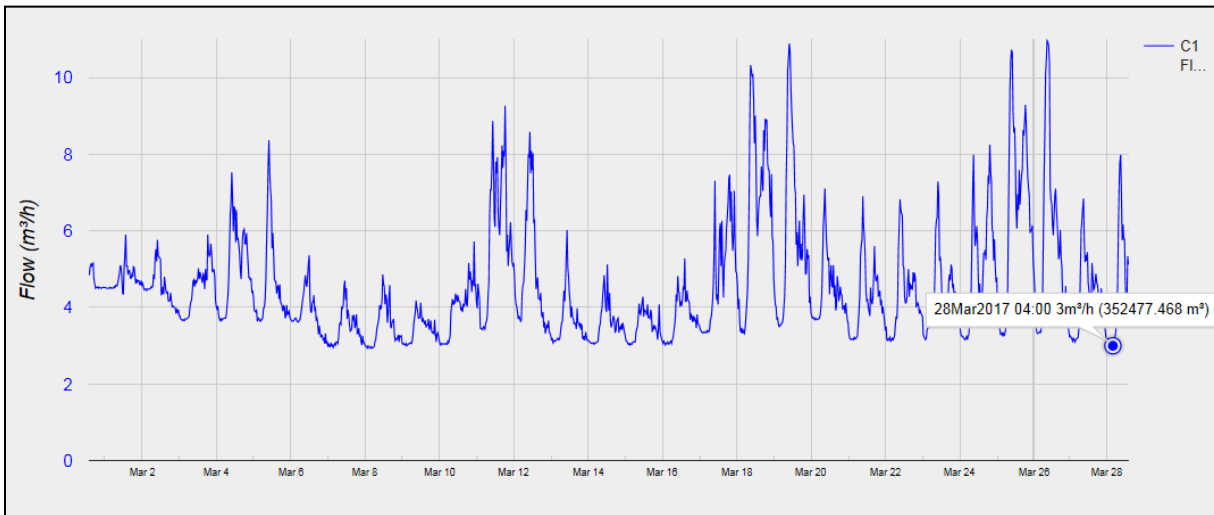
The above remote water data logger graph shows a constant flow of water running through the water meter and never dropping to zero. As mentioned above, this constant unaccounted flow equates to an **unaccounted cost of £8.55 per hour, £205.20 per day and over the course of one year an unaccounted cost of £74,898.**
