Leakage Detection April 2017 Survey Report

Hospital, North West England

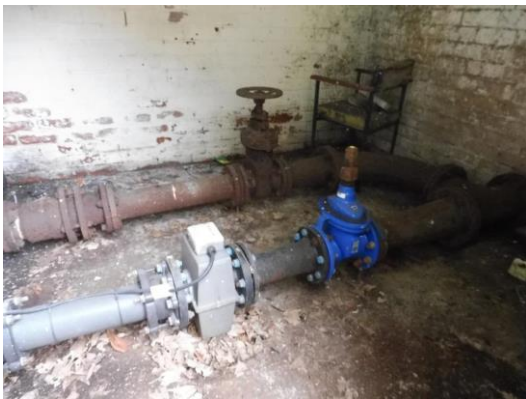
The water meter is located in a small room behind Lodge House off Main Road. The meter is non-mechanical with an outreader fitted to the wall (see below photographs). The average flow during the metering period is 26m³/hour which equates to a usage of 625m³/day.

Meter location in room off Main Road

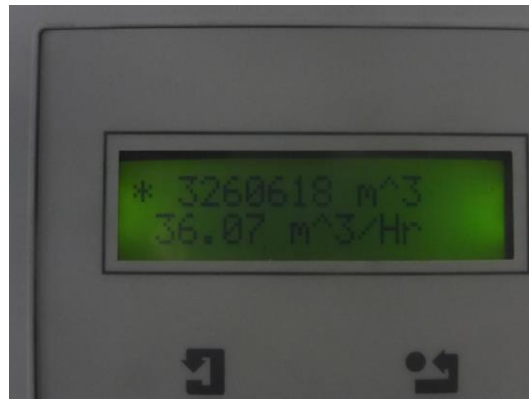
Meter reading

On arrival the main meter had to be repaired due to a faulty output from the meter which meant the meter was not recording data correctly. After repair, a reading was taken and a flow of 38.4m³/hour was noted.

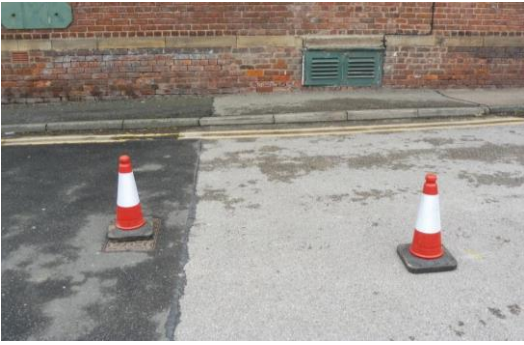
An **area of interest around a valve was noted outside on the road by the health clinic on a 180 MDPE main**. The main is close to a ducted service walkway. This area has been correlated and acoustically sounded with a ground microphone to further investigate the area.

A good correlation was achieved which suggests a leak position close to the isolation valve.

Additionally, **a drain situated around 15m away has a large continual flow of clear water running through it**. The next drainage chamber upstream has little flow through it.

Valve (L/H cone) and service duct (R/H cone). Likely excavation point is between the two, taking care to avoid disturbing the service duct beneath

It is recommended that the area identified outside the Health Clinic should be shut in prior to carrying out any repair to confirm the leakage volume. These options and all relevant valves required for the shut have been discussed at length and in detail with the site contact on how to proceed with carrying out these works.

Once confirmed, the leak position should be excavated taking care to avoid the service duct below the surface.

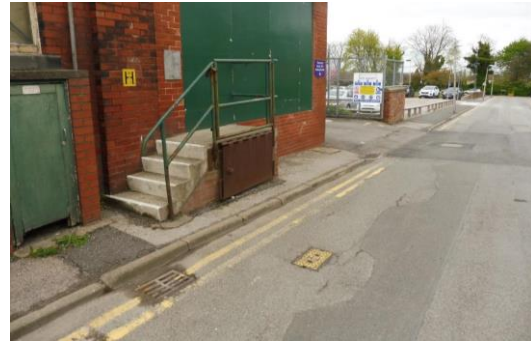
Three further leaks were also found on site. Two overflows were found to be leaking and also a fire hydrant which could not be fully shut off. Photographs of these leak locations are below.

Hydrant leak on Barn Drive near Motor Road

The three small leaks were confirmed and should be repaired as soon as possible, although this is **not the main cause** of the increase in water consumption at the Hospital.

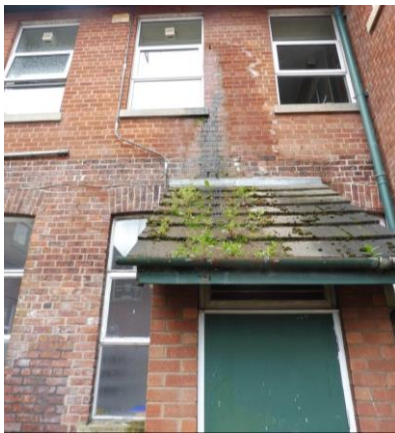
Overflow leaking rear of Health Clinic

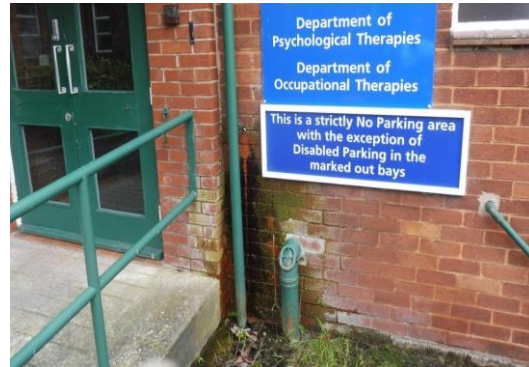
Overflow leaking from the Silver Centre
