Leakage Investigation Survey

23 March 2017

Holiday Park, North Yorkshire

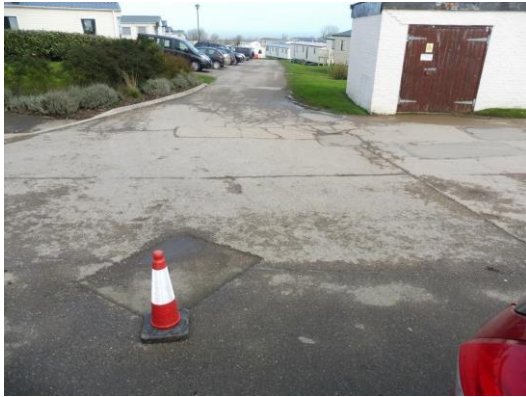
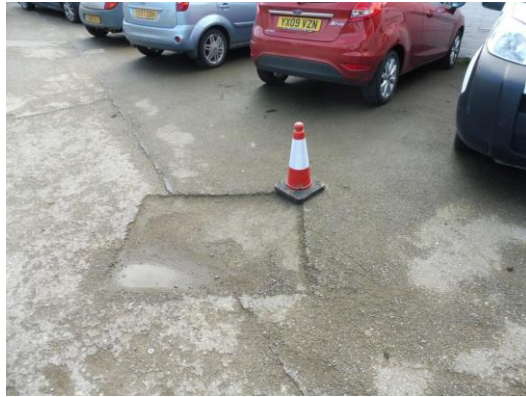
Leak 1 - location in staff parking area

Leak 1 - location marked by traffic cone

1. Excavate, locate and repair below ground leak identified in staff car park;
2. Excavate potential leak close to wall of staff canteen;
3. Repair all minor above ground leaks;
4. Check minimum night flow and confirm new leakage volume.

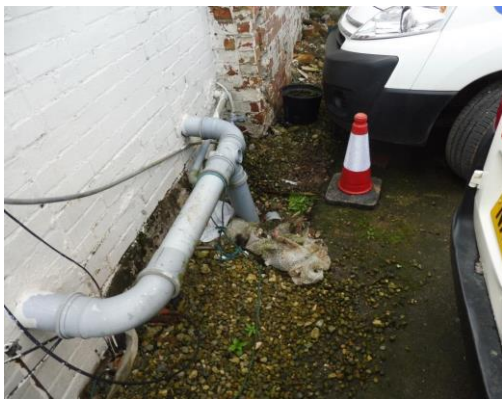
Leak to excavate by staff canteen – high leak noise

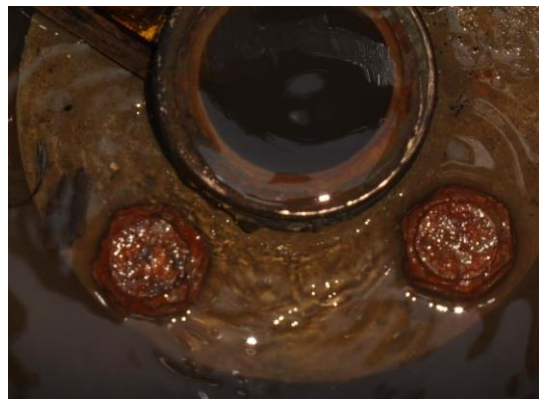
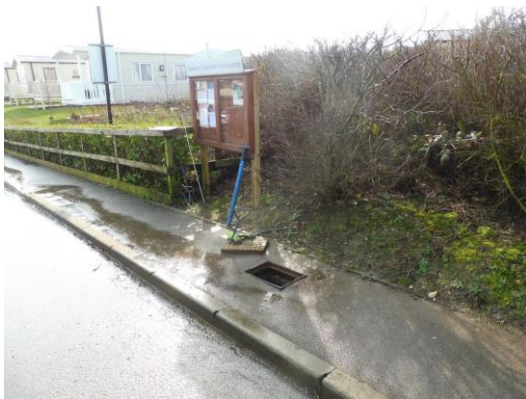
Leaking Fire Hydrant

Location of leaking Fire Hydrant

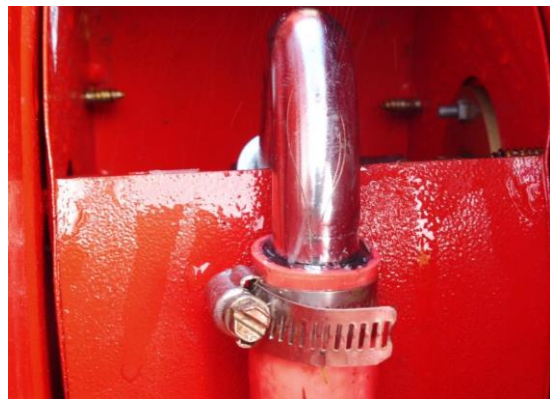
Leak on Fire Hose Reel – near plot 11 Brampton Hedge

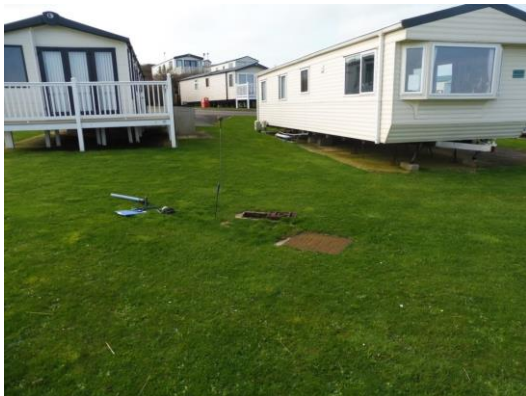
Location of leak on isolation valve between 5/6 Brampton Hedge

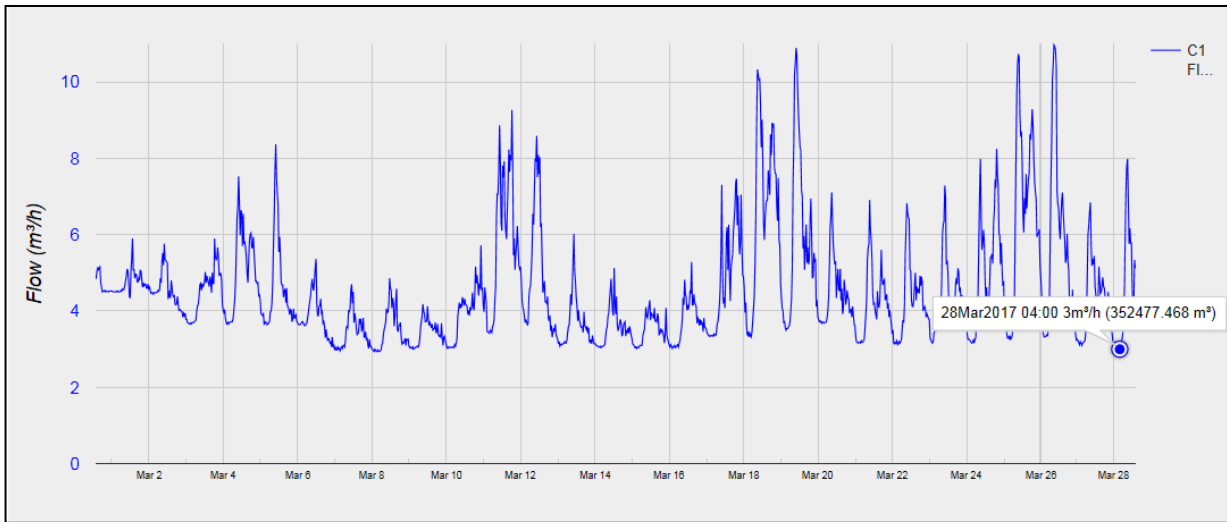
The above remote water data logger graph shows a constant flow of water running through the water meter and never dropping to zero. As mentioned above, this constant unaccounted flow equates to an **unaccounted cost of £8.55 per hour, £205.20 per day and over the course of one year an unaccounted cost of £74,898.**
