Leakage Investigation Survey

Client: Car dealership, Glasgow

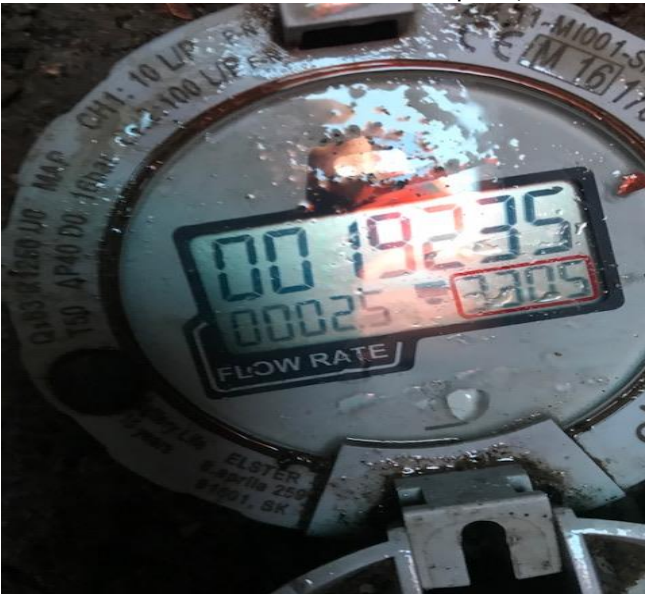
Pic 1

The water meter is located in footpath, LHS of entrance road

A reading of the revenue meter was taken (pic 1) which had a flow rate of 2.5m³ Pper hour, on inspection of some of the internal meters it was evident that in the valeting plant room there was a sub meter (pic 3,4&5) that had a costant flow. On timing this flow rate for a while it was noted that it had a constant flow rate of 40 litres per minutes which equates to 2.4m³ per hour and 57.6m³ per day at a cost of £129 per day, this supply was then isolated.

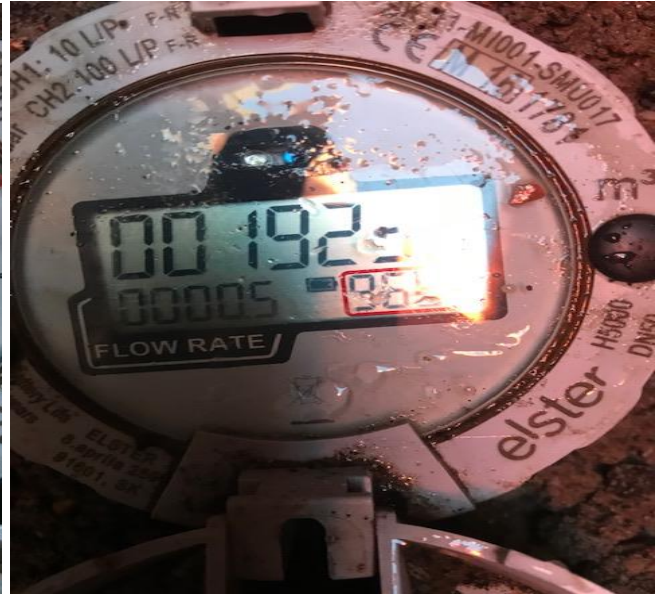
Pic 2

The revenue meter was then checked and the flow rate had reduced to 0.5m³ PH (pic 2), this flow rate was confirmed by the tanks filling for the vehicle jet wash area in valeting and also the use of the jet wash.

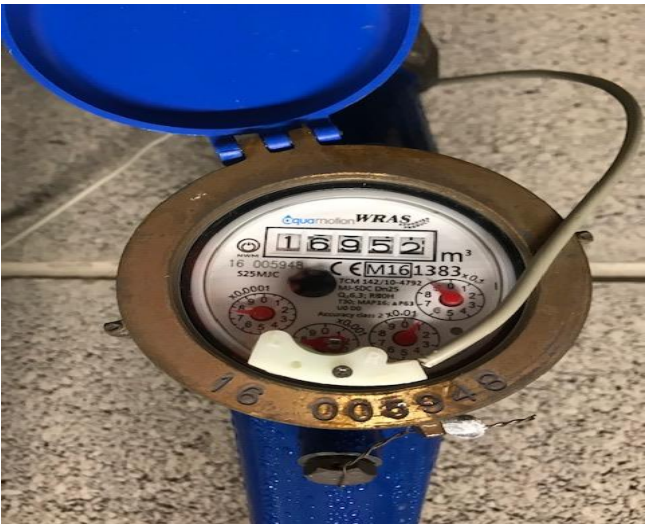
Pic 3

The sub meter in the valeting plant room (pic 3) was then put back in commission, our engineer made an enquiry to the valeting manager who pointed out that the meter measured water used on the main pitch areas around the show room.

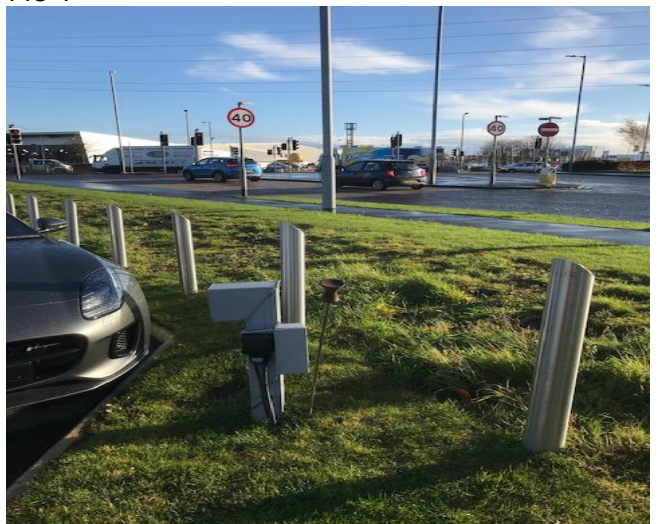
Pic 6

Using aquaphones on the standpipes, leak noise could be heard almost straight away, on one of the standpipes, also subsidence was apparent. On checking out the standpipe a substantial leak noise could be heard, on probing of the grassed area clear water was being drawn up confirming a leak below ground at this location (pic 6,7&8).

Substantial leak located on pitch standpipe

Excavate and repair. – Client to advise of this is being carried out by the builder.
Re-claim water and waste water costs due to poor workmanship - £33,000.
