Client: Caravan Park

Mains water meter information

<p>To attend site to carry out water leak detection due to the fact the water company had been in touch with the client to say there was leakage at site and this needed to be rectified.</p>

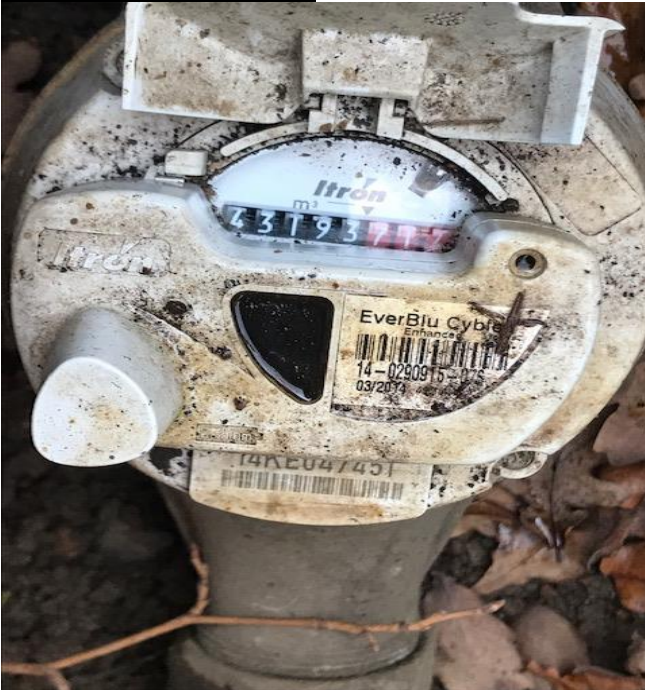
Pic 1

Whilst I was on site I too shut all isolation points (pic 5) and checked the meter (pic 1), which

had a constant flow rate of 9.5 litres per minute.

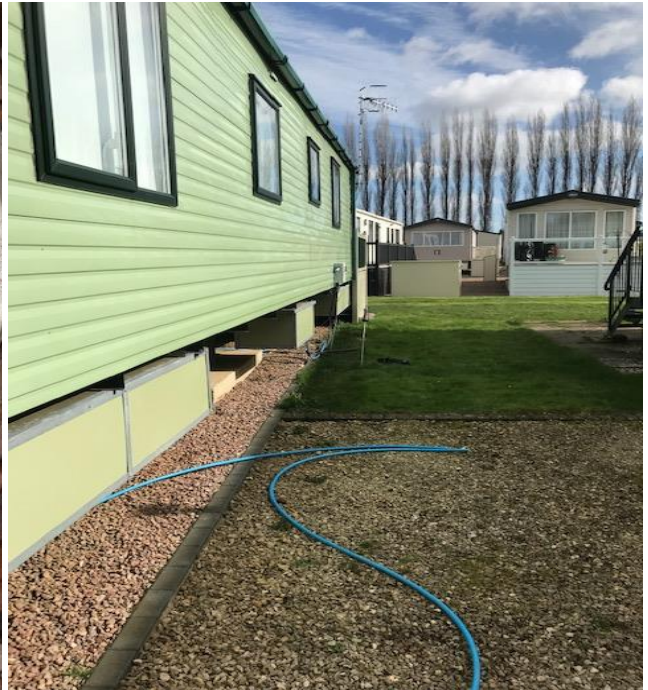
Pic 2

These homes were checked along with the section between the barrier and the meter, noise was picked up on two homes (pic 2&3). Further investigation showed that water was constantly flowing in a sewer chamber (pic 4) at the side of one of the homes that had the leak noise. Further checks were carried out using electronic ground probe and the leak pinpointed under one of the homes.

Excavate and carry out repairs to leaking pipe work, this is being undertaken by the site themselves.

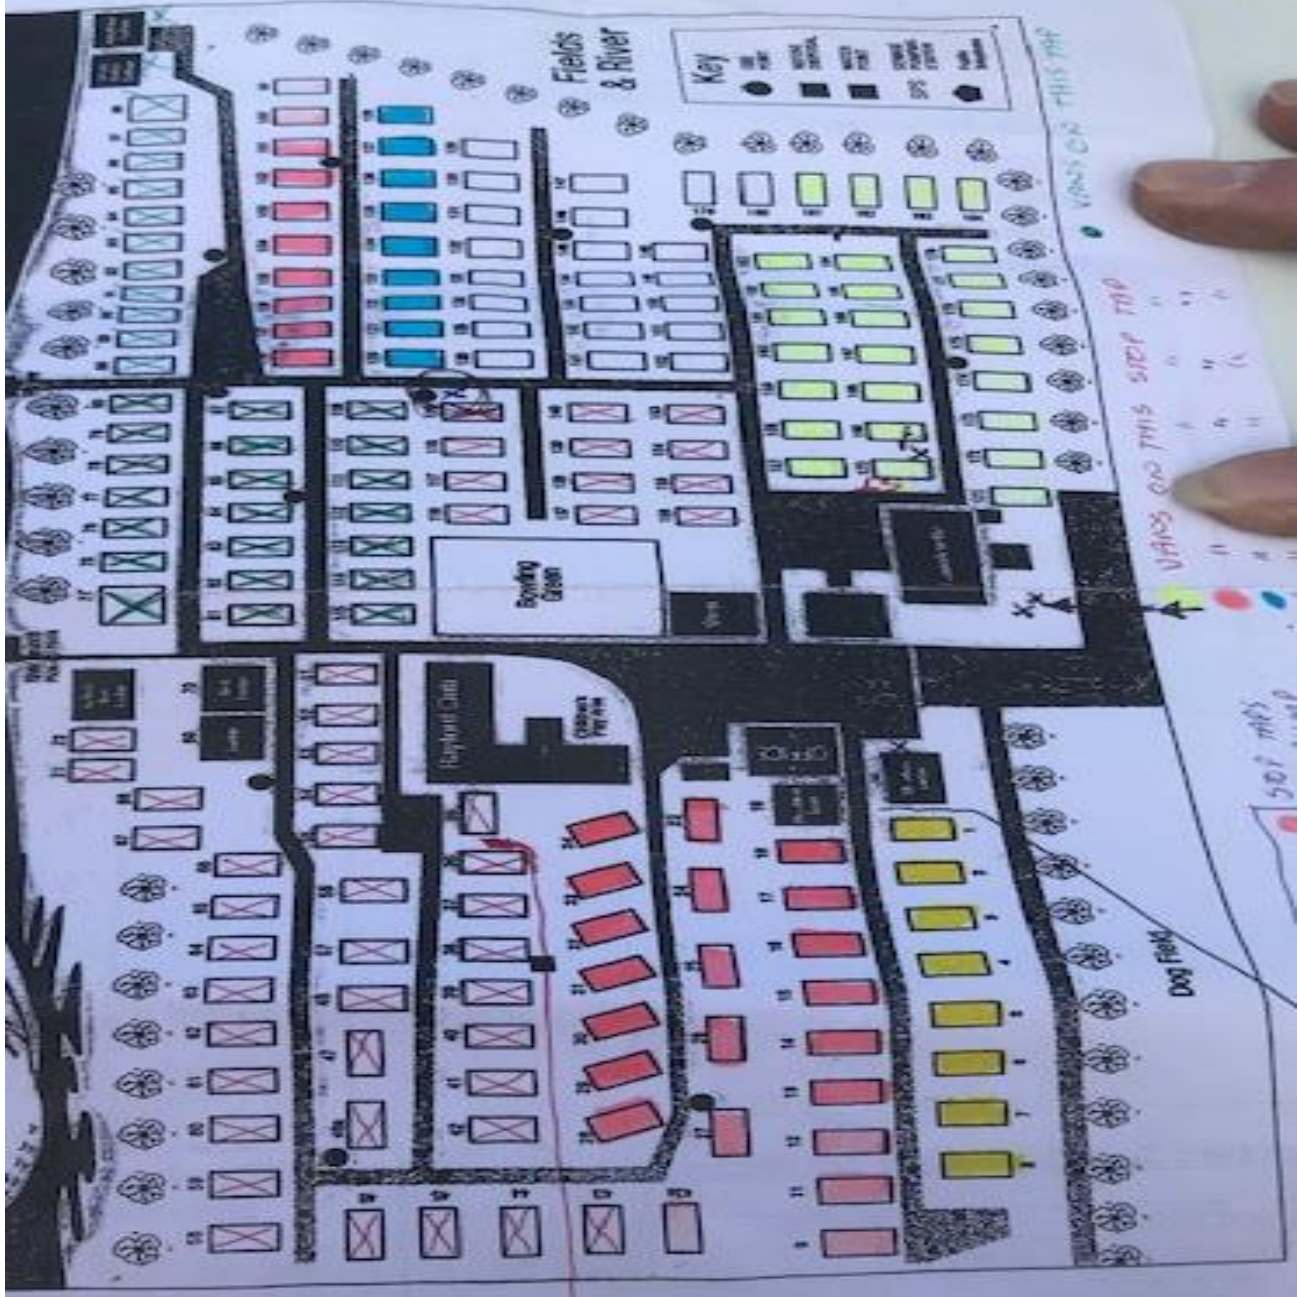
Pic 5

It was pointed out that several isolation tests had been carried out around the park by park maintenance trying to locate the problem pointed out by the Water Company, on every section (pic 5) that was shut down the meter was checked and still had a substantial flow rate.

Looking at the site layout (pic 5) it looked like there was a leak between the meter and the traffic barrier to the park, on investigation there was approx. 30 homes that were still live with water.

Install additional isolation point to remaining section of 30 homes, also being undertaken by the site.
