# Leakage Investigation Survey

**Client: Caravan Park, Stratford on Avon**

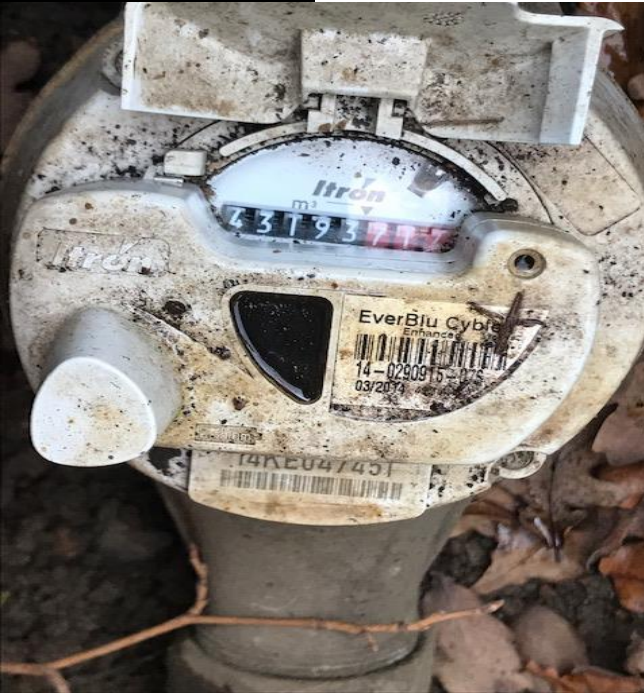
Pic 1

Whilst I was on site I too shut all isolation points (pic 5) and checked the meter (pic 1), which

had a constant flow rate of 9.5 litres per minute.  
Looking at the site layout (pic 5) it looked like there was a leak between the meter and the traffic barrier to the park, on investigation there was approx. 30 homes that were still live with water.

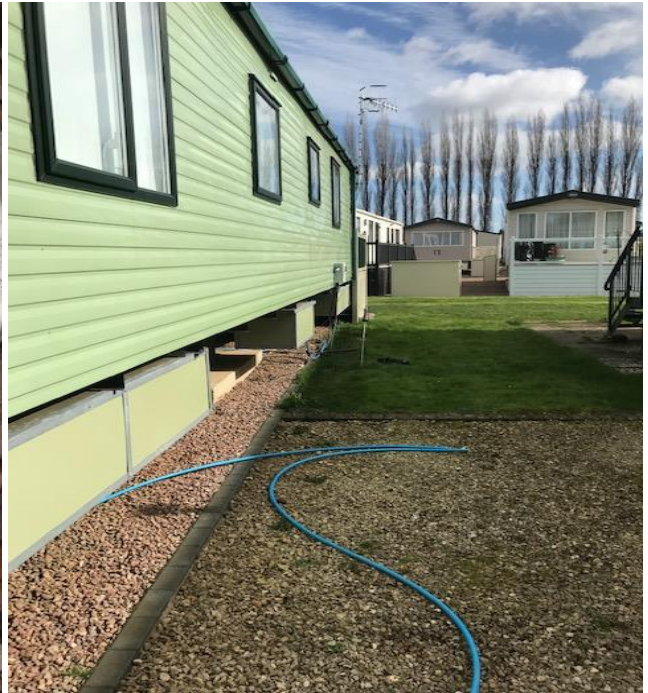
Pic 2

These homes were checked along with the section between the barrier and the meter, noise was picked up on two homes (pic 2&3). Further investigation showed that water was constantly flowing in a sewer chamber (pic 4) at the side of one of the homes that had the leak noise. Further checks were carried out using electronic ground probe and the leak pinpointed under one of the homes.

Excavate and carry out repairs to leaking pipe work, this is being undertaken by the site themselves.

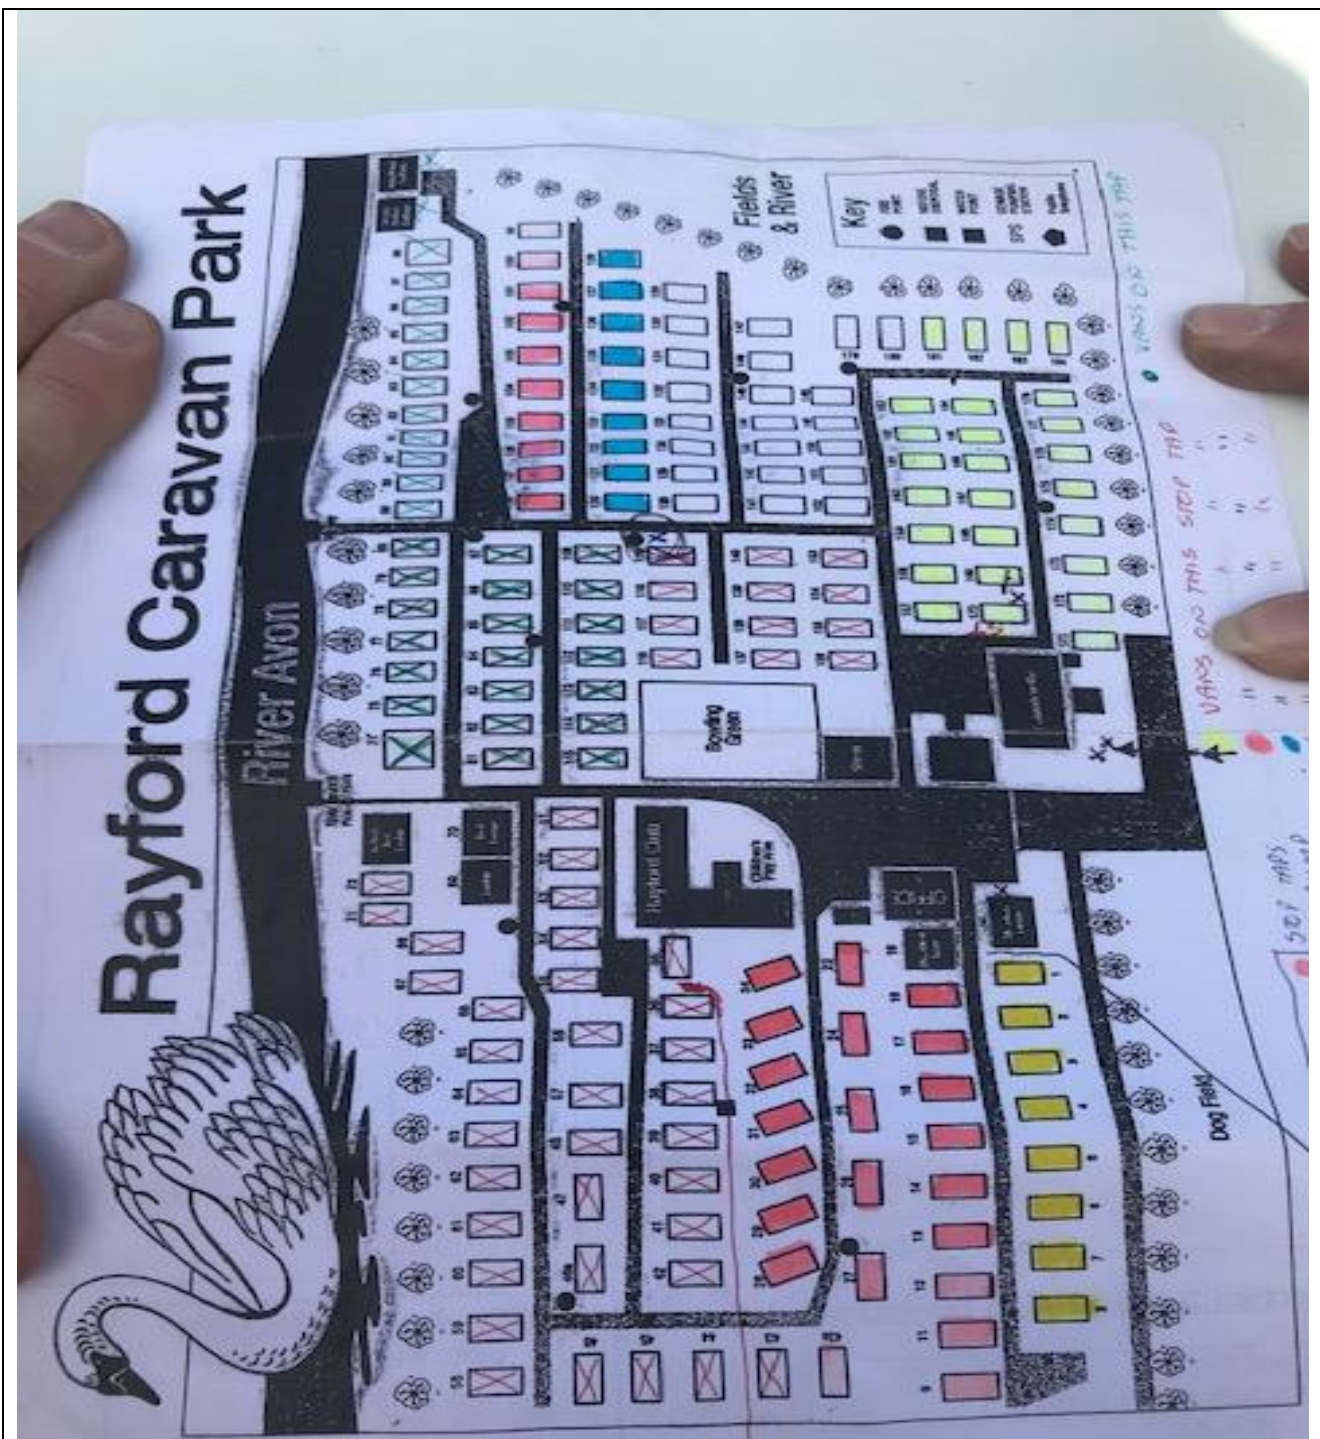
Pic 5

It was pointed out that several isolation tests had been carried out around the park by park maintenance trying to locate the problem pointed out by the Water Company, on every section (pic 5) that was shut down the meter was checked and still had a substantial flow rate.

Install additional isolation point to remaining section of 30 homes, also being undertaken by the site.
