Leakage Investigation Survey

Client: Holiday Park, Northumberland

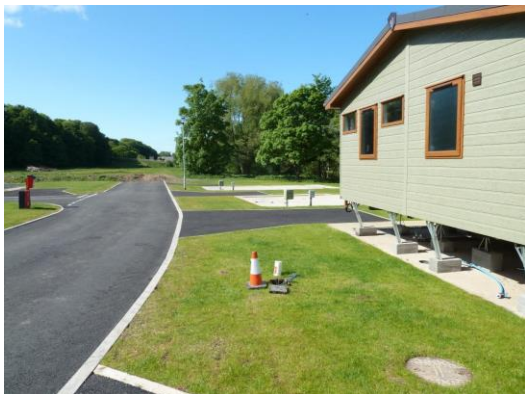
A check of the new area recently developed (Woodside) indicated a significant leak on the stoptap off the 125PE main across the field. Audible leak noise could be heard in the valve chamber itself, which increased in volume when the base of the chamber was cleared of concrete lumps to identify the connections of the stoptap itself.

Leaking stoptap supplying new Woodside development

1. Repair all identified leakage issues;
2. Further tracing and valve installation work will be required to track down the remaining leakage on the gravity fed half of the park. Additionally, the installation of further sub-meters at strategic locations around the park once the principle routes of pipework have been identified will be advantageous for the continued management of water at Riverside.

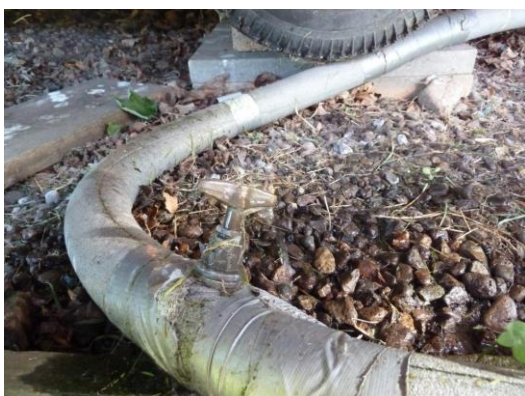
Leak on stoptap – plot 69 Morpeth Mews
