## Leakage Investigation Survey

**Client: Leisure Park, Kent**

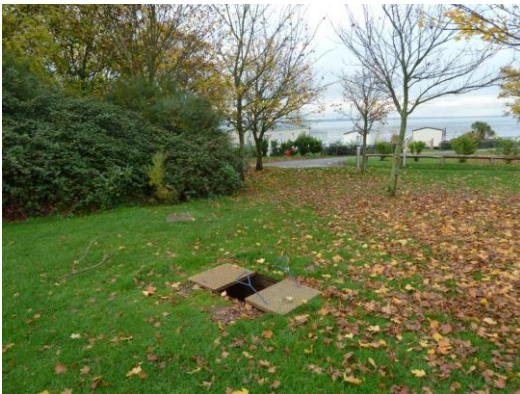
Meter location in field on left after security

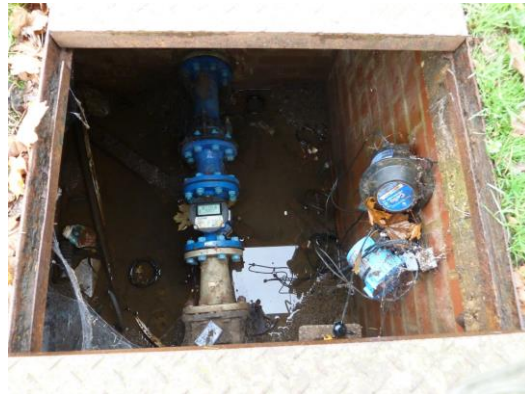
Meter chamber and water flow data logger

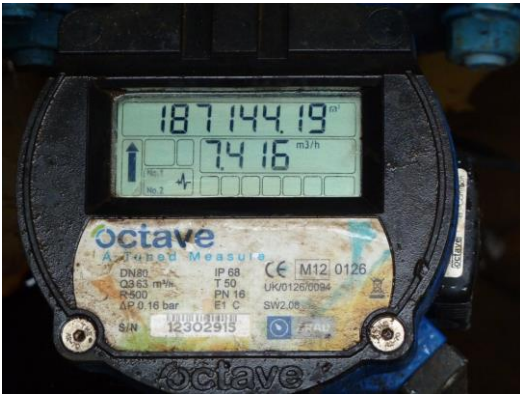
Water meter

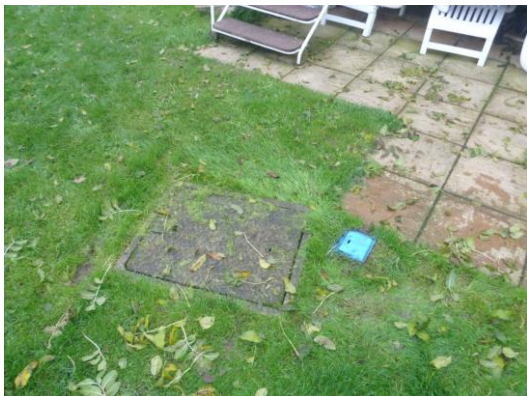
Leak	Location	Description	Volume (Estimated)		Pinpointed?	% of leakage
			L/min	m <sup>3</sup> /day		
1	15 Sidings	Stoptap	16	23.0	Yes	25%
2	Rear of 31 Thames Bank	63mm tee?	32	46.1	Yes	50%
3	Fire Hydrant by Beacon Close	Valve passing	3	4.3	Yes	4%
4	Rear of Launderette	25mm pipe?	4	5.8	No	6%
5	Hose Reel by 24 Hillside	32mm pipe?	3	4.3	No	4%
6	50 Beacon Close	25mm pipe?	3	4.3	No	4%
	All above ground leaks	various	4	5.8	Yes	6%
<b>Total</b>	[Taken from current nightline of 3.9m <sup>3</sup> /hour]		<b>65</b>	<b>93.6</b>		<b>100%</b>

Leak location 1 – leaking stoptap by 15 Sidings

1. Excavate, locate and repair all below ground leaks identified;
2. Repair all minor above ground leaks;
3. Once all repairs are complete advise H2O and we will check minimum night flow via the water flow data logger (AMR) and confirm new leakage volume. We will then assess viability and costs of further work to identify any remaining leakage but the **initial leaks found must be repaired** before we can move onto this stage.

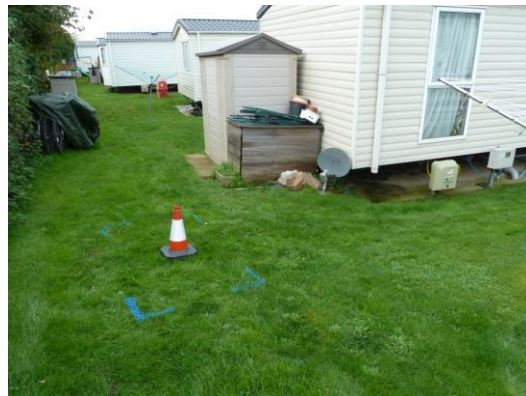
Leak location 2 – leak rear of 31 Thames Bank

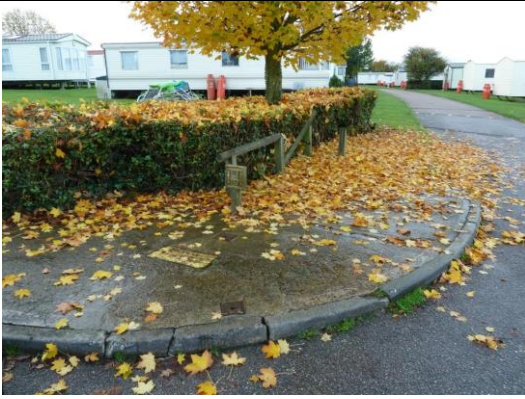
Leak location 3 – Fire Hydrant valve passing

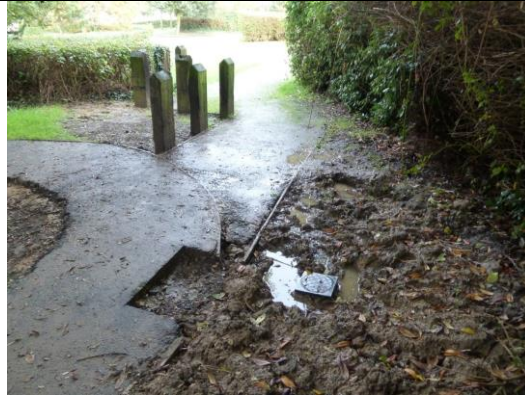
Leak location 4 – leak on pipework by new atlas box

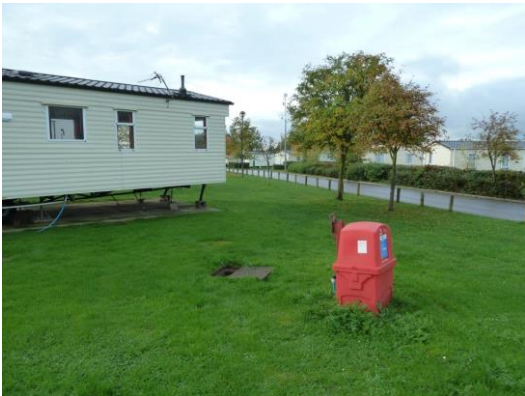
Leak location 5 – leak on below ground pipe  
[Unable to pinpoint without tracing pipework out]

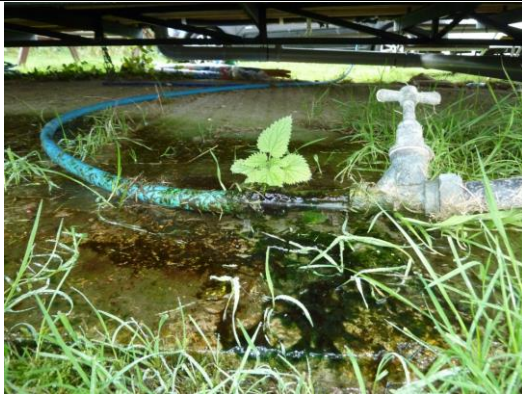
Park Area	Plot	Fault
Meadowside	42	Leak on stoptap
Hillside Drive	77	Drain cock open
	158	Leak on stoptap
Thames Side	2	Leak on stoptap
	17	Leak on stoptap
Thames Bank	6	Drip on bib tap, front of plot
Thames View	48	Drip on stoptap
Beacon Rise	25	Leak on stoptap
Central Park	12 (rear of)	Leak on Fire Point pipework
Yanlet Drive	24	Drip on stoptap

Leak on stop tap - 42 Meadowside

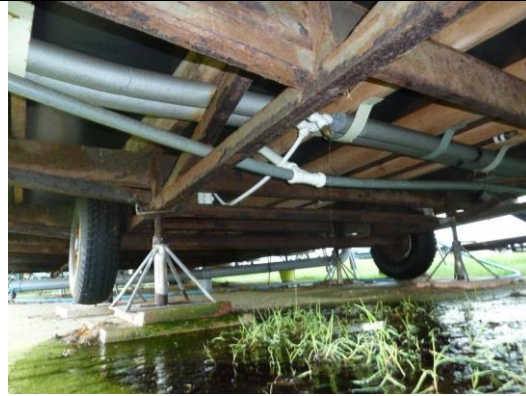
Leak on drain cock – 77 Hillside Drive
