Leakage Investigation Survey

Client: Caravan Park, Stratford on Avon

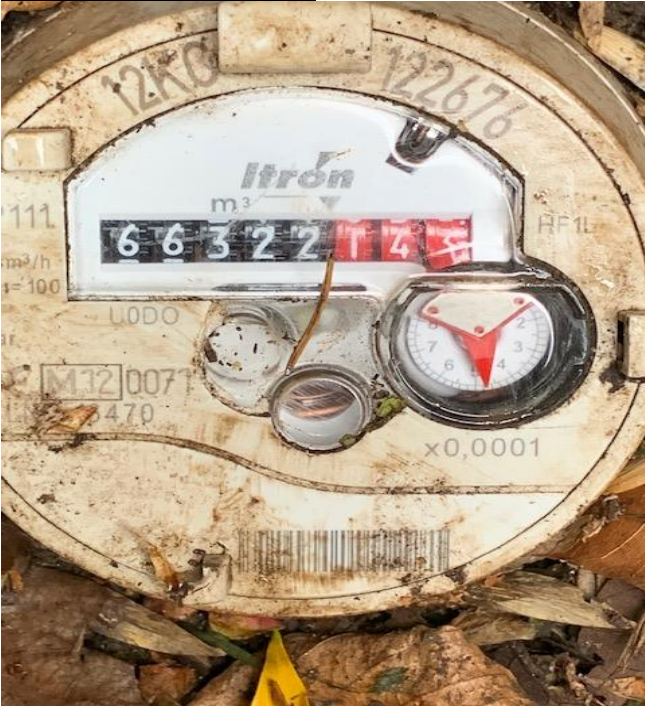
Pic 1

On arriving at site a meter reading (pic 1) was taken and a flow rate estimated based on three separate reads over one minute each, the flow rate was approx. 2.5m³ per hour some 1700 litres per hour more than what the local water company were saying at 03.00am.

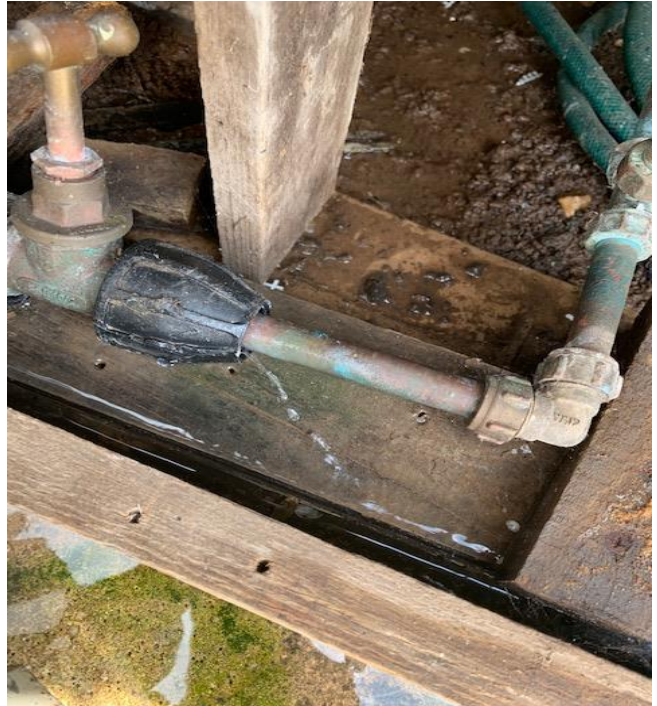
Pic 2

A small leak was found at unit 212 (pic 2) and was isolated by site staff.

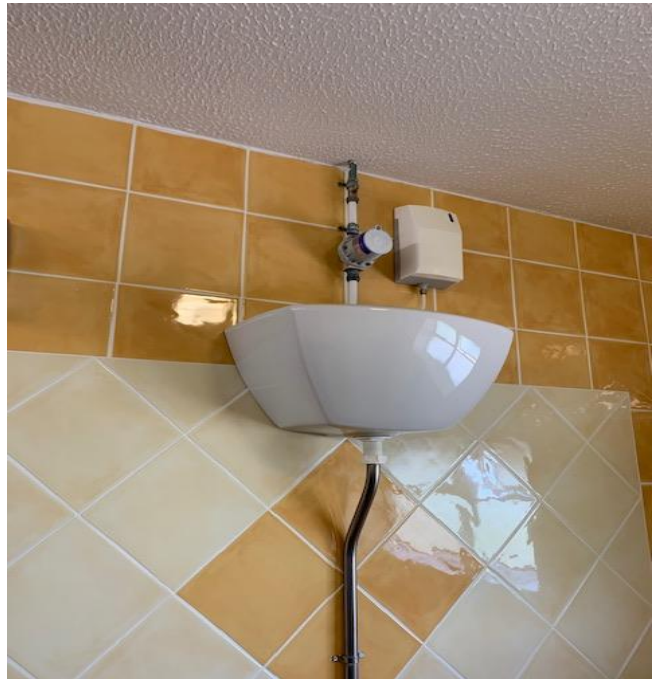
Pic 4

The main toilet block and laundry were then checked only to find three separate urinal cisterns (pic 4,5 & 6) where the inline timed controls had failed.

The estimated losses at all three urinal cisterns were approx. 5 litres per minute = 300 litres per hour.

It is recommended that all urinals have new PIR controls installed at the earliest opportunity, just the failed urinals are costing a small fortune in losses.

Install PIR urinal controls to all urinal cisterns ASAP to prevent out of occupancy flushing

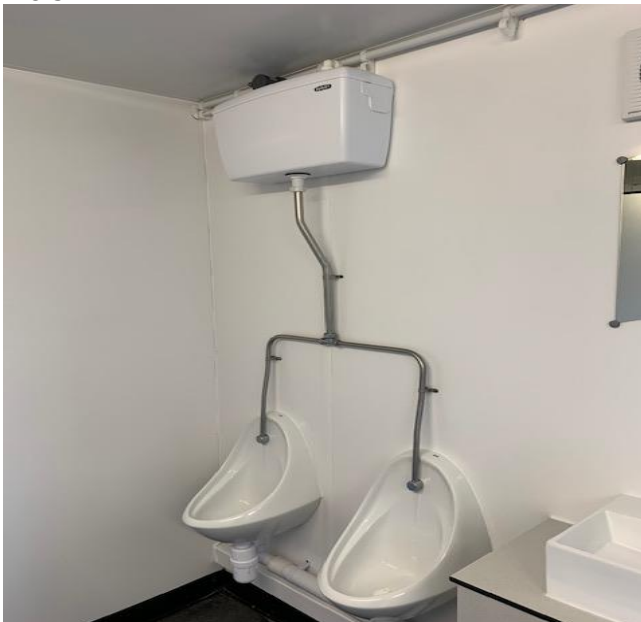
Pic 7

The toilets adjacent to the rally fields (pic 7) were then checked and the urinals were filling flushing constantly with approx. losses of 3 litres per minute = 180 litres per hour.

The combined losses of all urinals on the site was in excess of 480 litres per hour.
