Leakage Investigation Survey

Client: Car Dealership, Glasgow G52

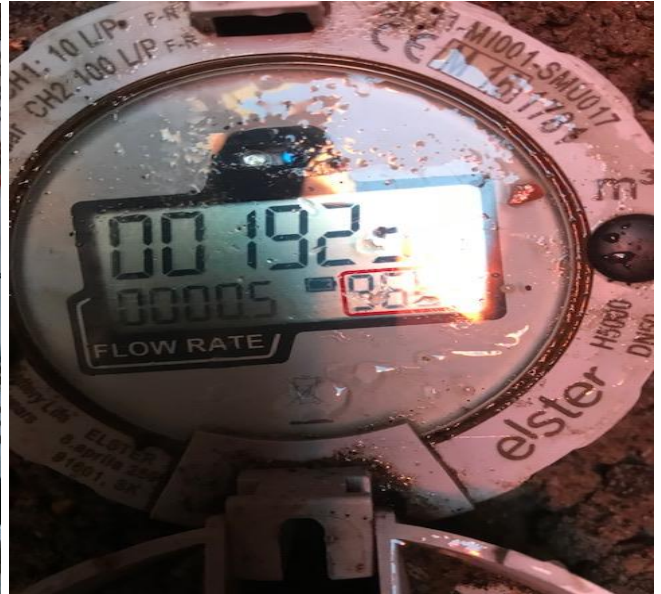
Pic 2

The revenue meter was then checked and the flow rate had reduced to 0.5m³ PH (pic 2), this flow rate was confirmed by the tanks filling for the vehicle jet wash area in valeting and also the use of the jet wash.

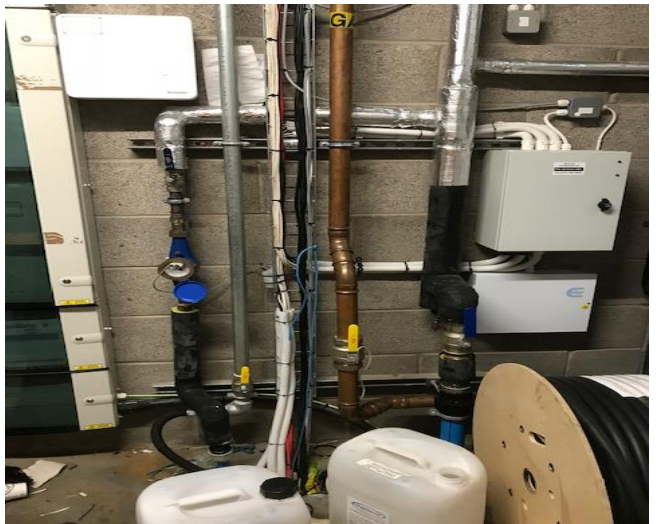
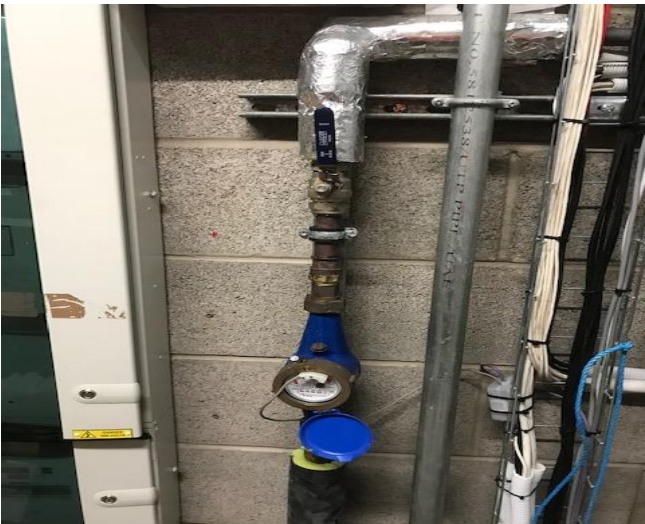
A reading of the revenue meter was taken (pic 1) which had a flow rate of 2.5m³ Pper hour, on inspection of some of the internal meters it was evident that in the valeting plant room there was a sub meter (pic 3,4&5) that had a costant flow. On timing this flow rate for a while it was noted that it had a constant flow rate of 40 litres per minutes which equates to 2.4m³ PH, this supply was then isolated.

The sub meter in the valeting plant room (pic 3) was then put back in commission, our engineer made an enquiry to the valeting manager who pointed out that the meter measured water used on the main pitch areas around the show room.

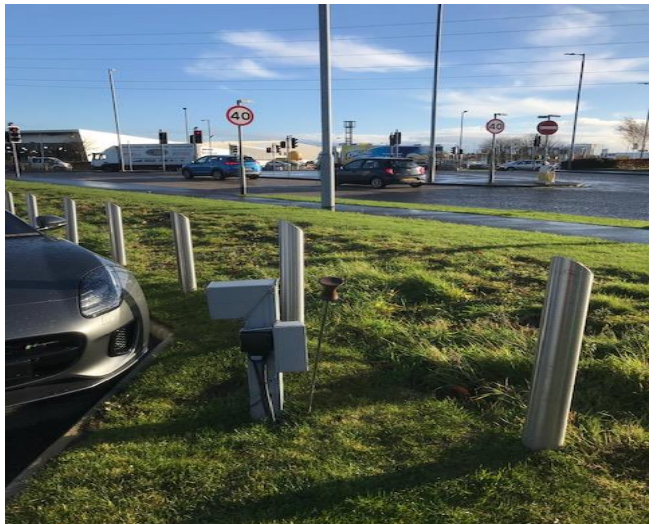
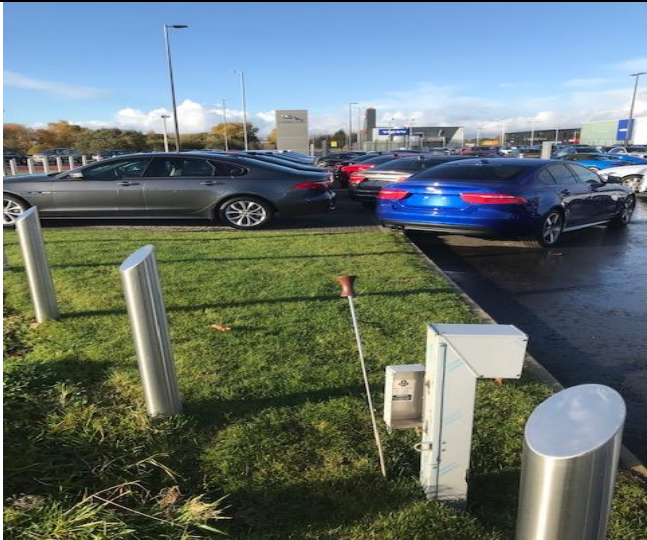
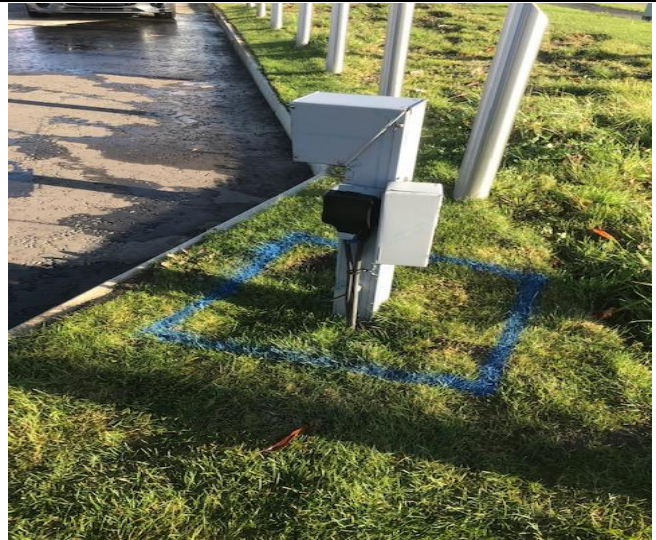
Once sounding began on the standpipes, leak noise could be heard almost straight away, on one of the standpipes, also subsidence was apparent. On checking out the standpipe a substantial leak noise could be heard, on probing of the grassed area clear water was being drawn up confirming a leak below ground at this location (pic 6,7&8).

The site is less that one year old so it maybe a warranty issue with the builder, this to be confirmed with site before action is taken.

Substantial leak located on pitch standpipe

Excavate and repair – Client to advise if this is being carried out by the builder.
