Leakage Investigation Survey

23 March 2017

Client Case Study

Holiday Park, North Yorkshire

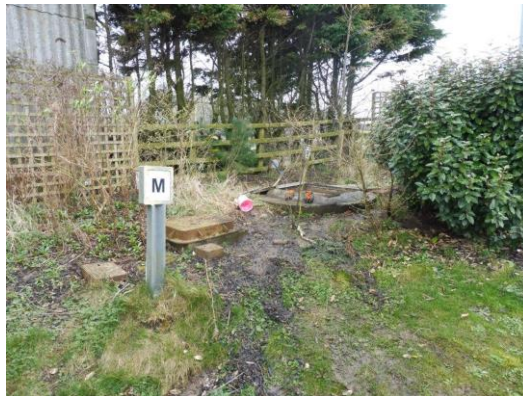
Main meter location

Size (mm)	15-28		32-50		75-100	✓	125-200		Above 200mm	
Meter Serial Number	08XI123456									
Readings (1)	351807.120				Time:	14:48 22 March 2017				
Readings (2)					Time:					
Location	Meter located in large chamber behind caravan 37 Lakeside. Accessed with two large lifting keys.

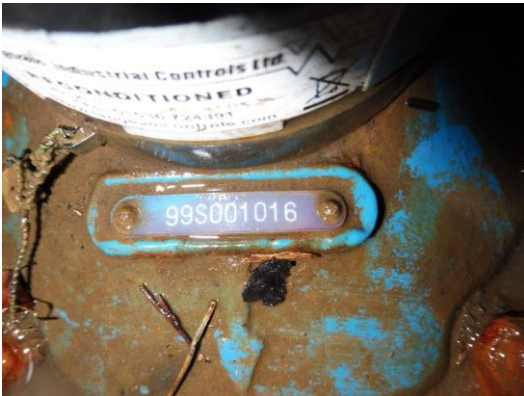
Second meter supplying Pine Ridge area

The main meter supplies most of the park with water. The only area not supplied by this meter is Pine Ridge (approximately 130 plots) which is supplied by meter 99S001016.

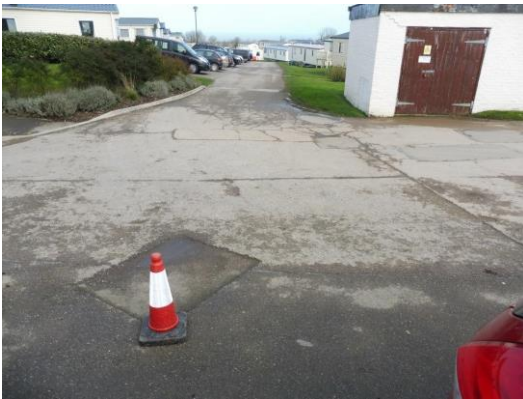
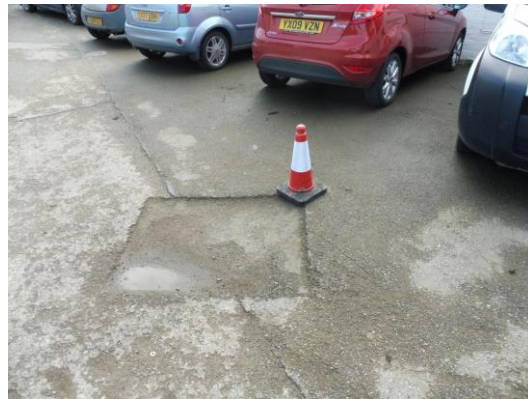
Leak 1 - location in staff parking area

Leak 1 - location marked by traffic cone

1. Excavate, locate and repair below ground leak identified in staff car park;
2. Excavate potential leak close to wall of staff canteen;
3. Repair all minor above ground leaks;
4. Check minimum night flow and confirm new leakage volume.

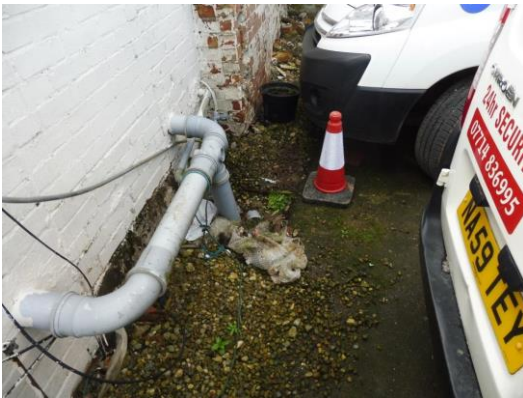
Leak to excavate by staff canteen – high leak noise

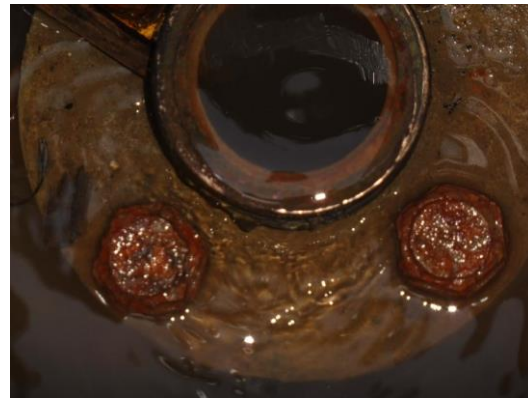
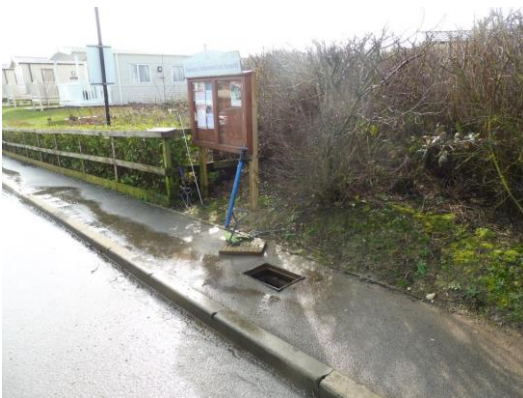
Leaking Fire Hydrant

Location of leaking Fire Hydrant

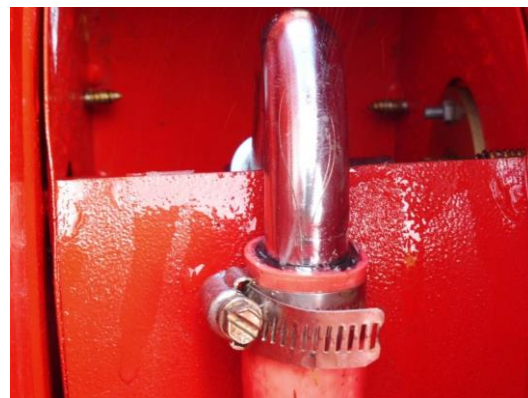
Leak on Fire Hose Reel – near plot 11 Brampton Heights

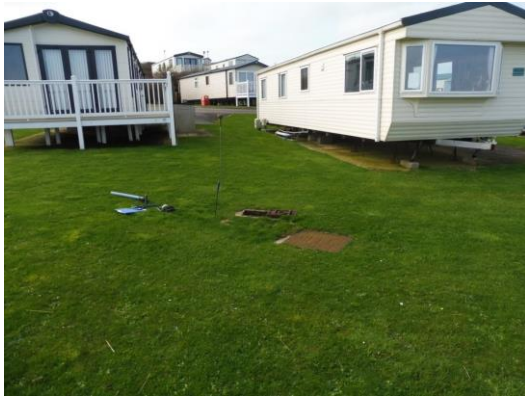
Location of leak on isolation valve between 5/6 Brampton Heights

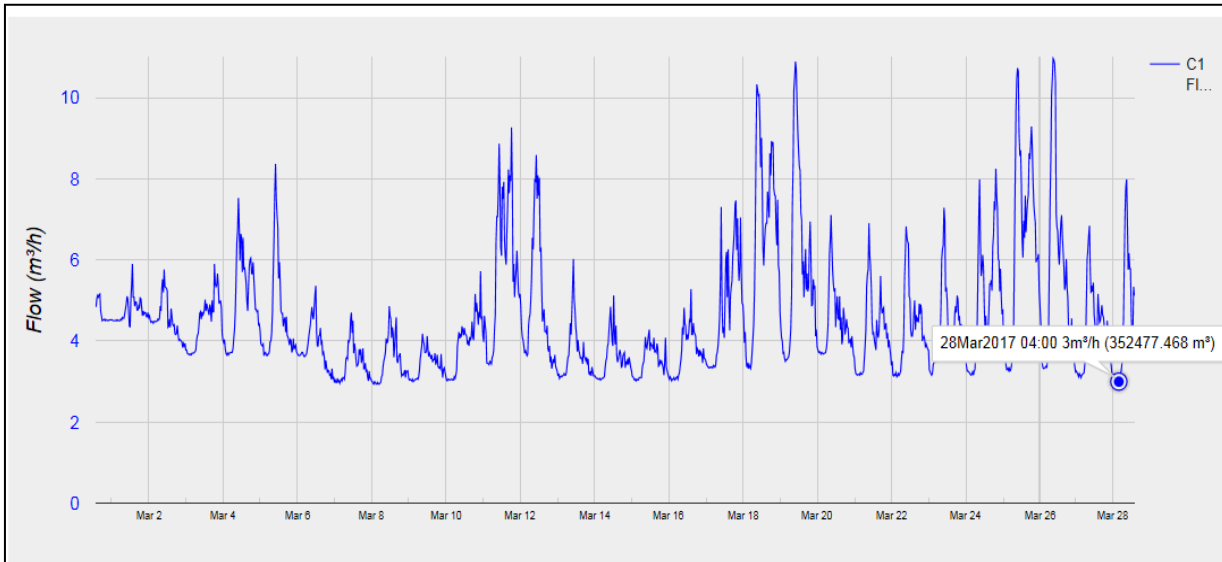
The above remote water data logger graph shows a constant flow of water running through the water meter and never dropping to zero. As mentioned above, this constant unaccounted flow equates to an **unaccounted cost of £8.55 per hour, £205.20 per day and over the course of one year an unaccounted cost of £74,898.**
