Leakage Investigation Survey

Client: Business Park, Bradford

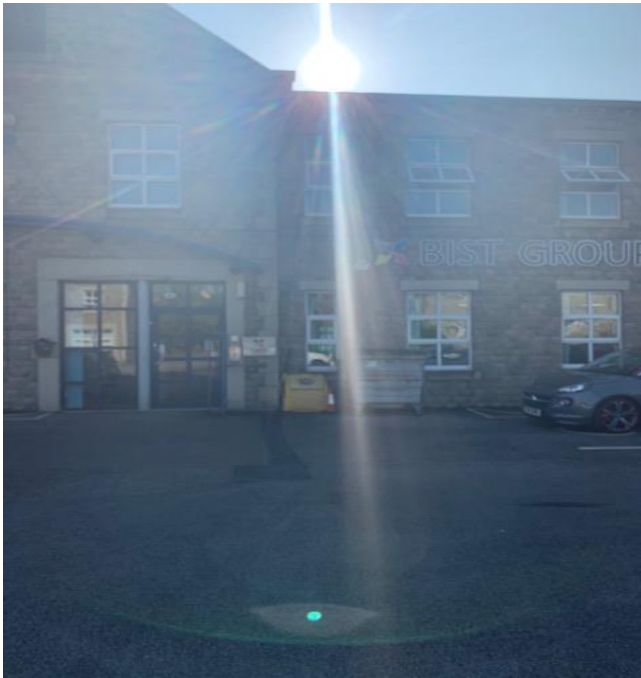
Pic 1

I met with client on site and she told me about the high bills etc and confirmed which meters she suspected supplied the buildings (pic 1) concerned, on checking meter 13MU0**** (pic 2) and shutting the internal stop tap confirmed that this supplied the buildings to front and rear right hand side, the meter was stationary confirming no leak externally.

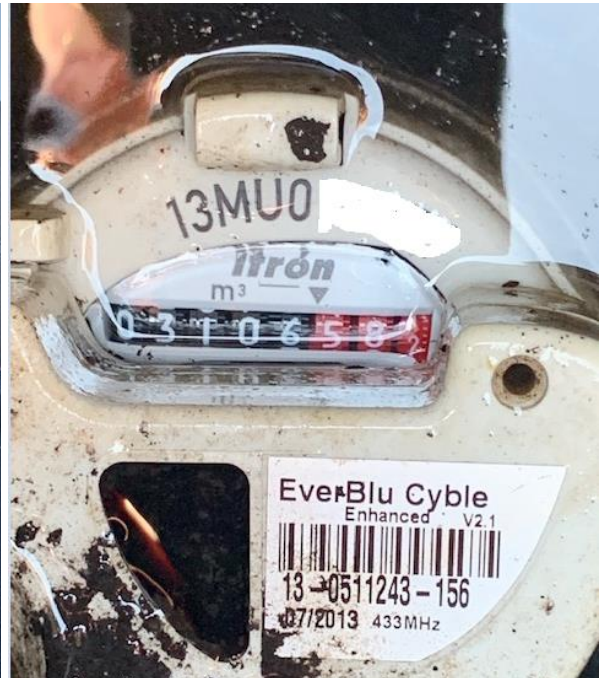
Pic 2

On restoring the supply the meter was rechecked and still no movement confirming no internal issues.

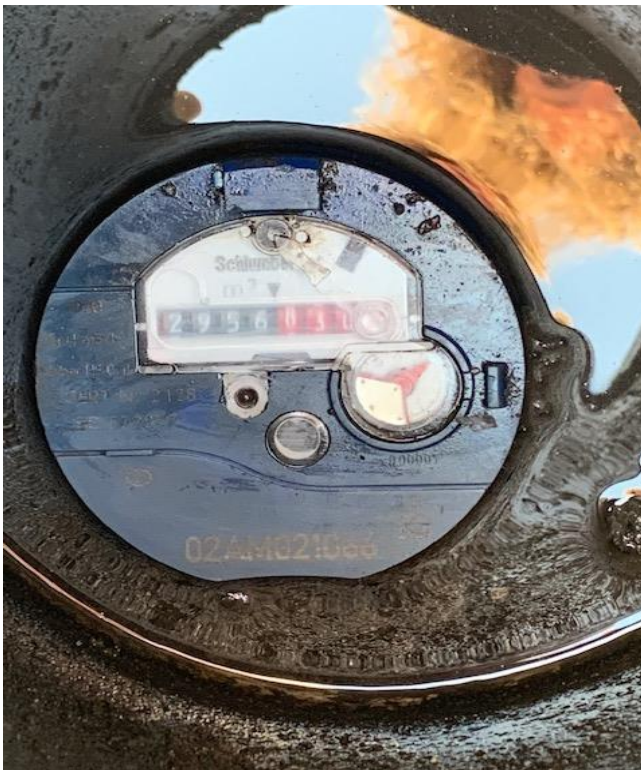
Pic 3

On checking the second meter 02AM012345 (pic 3) it was noted that the meter was constantly flowing at 2 litres per minute = 2.8m³ per day at a cost of £8.68 per day or £3,169 per year. The internal stop tap was shut and confirmed that it isolated the supply to the left hand side building, the meter was then rechecked and zero flow was noted.

This confirms that there was internal issues but no leak on the supply pipe.

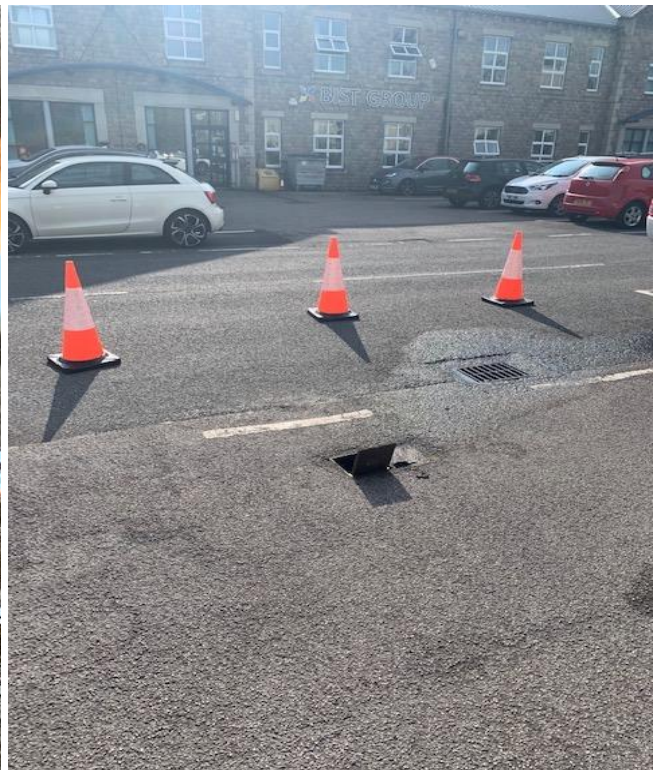
Pic 4

Size (mm)	15-28	✓	32-50		75-100		125-200		Above 200mm	
Serial number	02AM012345									
Readings (1)	2956.830				Time:	08.54 01/08/2019				
Readings (2)	2956.842				Time:	09.00 01/08/2019				
Location	Meter located in hard standing opp side of road in line with front doors (pic 4)

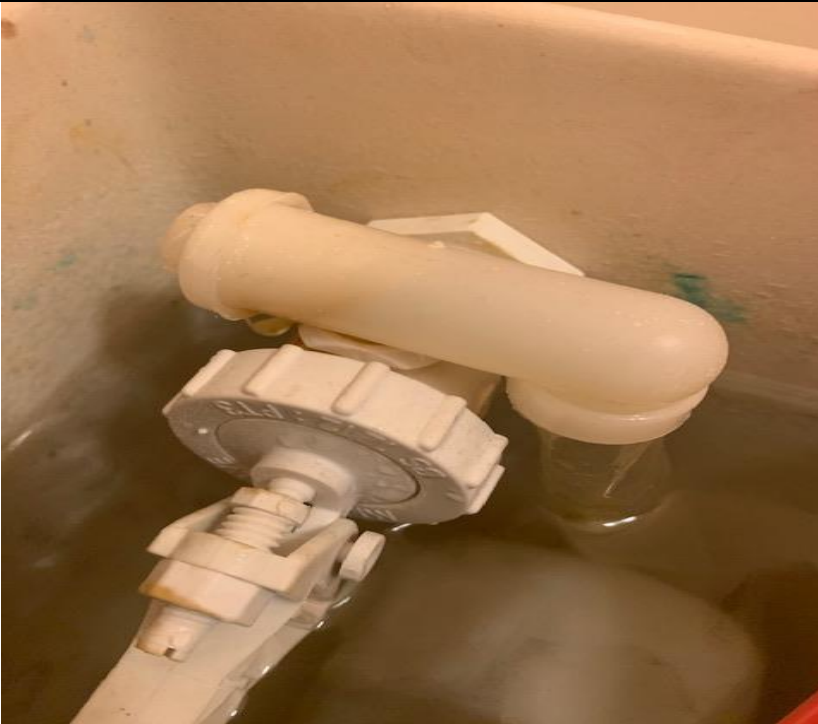
Pic 5

On further investigations, a WC was found to have a faulty ball valve (pic 5) and was overflowing through the integral overflow straight into the WC pan, this was reported to the tenant on site by the client.

Failed ball valves located in buildings, no leak on supply pipe

Replace faulty WC flushing device and install an external WC overflow pipe so if faults occur in the future the water loss will be visible not concealed by pouring into the WC pan.
