Leakage Investigation Survey

Client: Dudley Street, Walsall

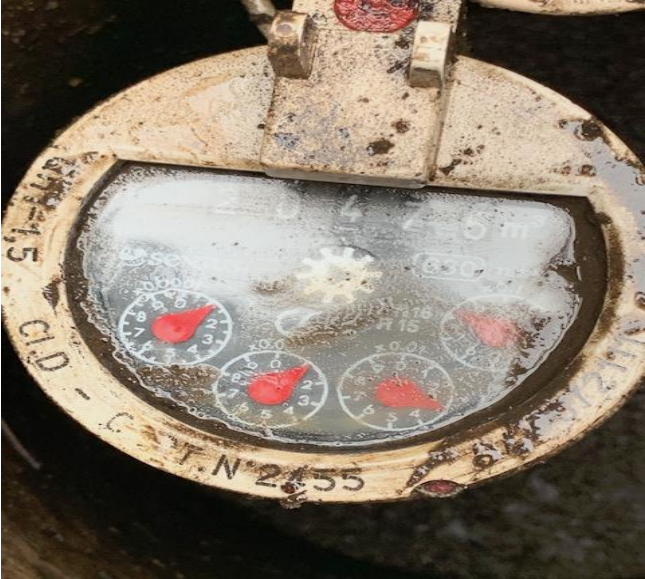
Pic 1

I first went to the main revenue meter (pic 1) to check location and flow rate.

The flow rate was approx. 2.5 litres per minute of continuous flow = 3.6m³ per day.

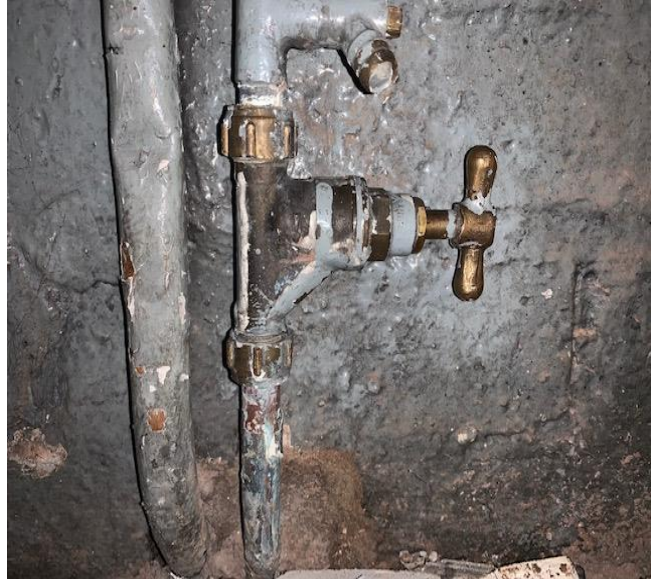
Pic 2

Access to a stop tap (pic 2) at the washroom in the garage area was operated but found to be inoperable so an isolation test could not be carried out to the washroom as a whole.

David has requested a quotation for the supply and installation of a PIR urinal control and also the repair or replacement of the garage washroom stop tap that was inoperable.

Renew ½" stop tap in garage washroom.

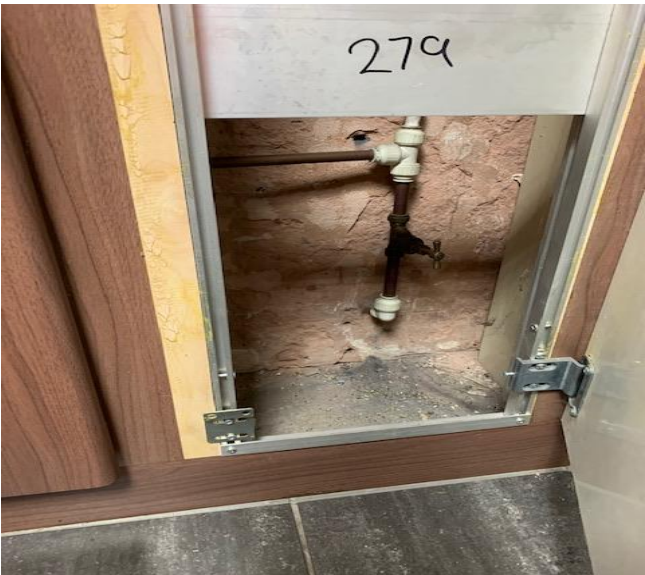
Pic 3

We first closed the stop tap in the public washroom area (pic 3) and then rechecked the meter which still had a flow rate of 2.5 litres per minute.

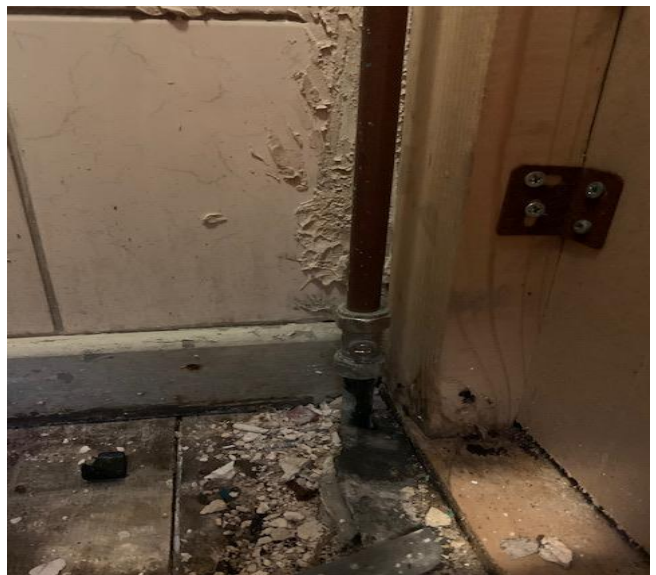
Pic 4

We then closed the isolation valved at the urinals (pic 4) in the main garage area, again the meter was checked and was found to have zero flow rate, indicating that the urinals were the reason for the continuous flow rate.

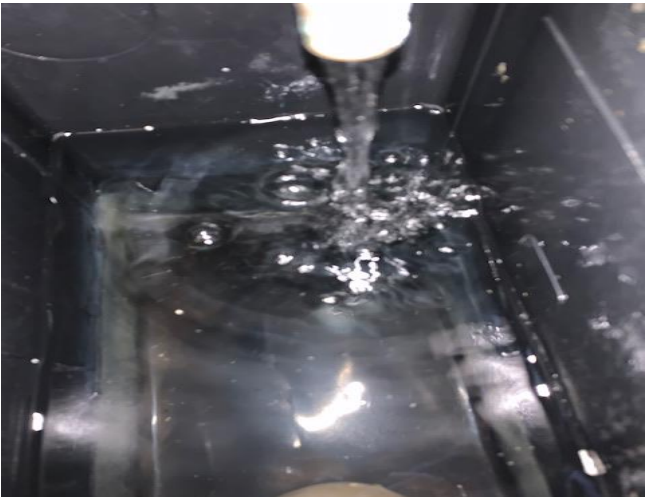
Pic 5

Pipe-work to the urinals (pic 7) were checked to identify if it supplied anything other than the urinals, it was confirmed that the pipe-work only supplied the urinals and also concluded that the continuous filling of the urinals (pic 5) was the cause of the continuous flow rate at the meter.

The urinals and the stop taps were all re opened and supply fully restored, the flow to the urinals was reduced but not stopped, the main reason for this is that the site manager had pointed out that crystallising of the urinal outlets was a major problem so regular flushing was essential.

No underground leak on supply, no water leak was found and the leak noise was continual uage through the flushing urinals uncontrolled.

Water wastage through the uncontrolled urinal volume is **1,314m3 per year or 289,000 gallons at a cost of £2,667 per year.**

Install urinal control

Savings when urinal control installed and stop tap replaced £2,667 with a **payback of 1 month.**
