Leakage Investigation Survey

Client: Newbury, RG14

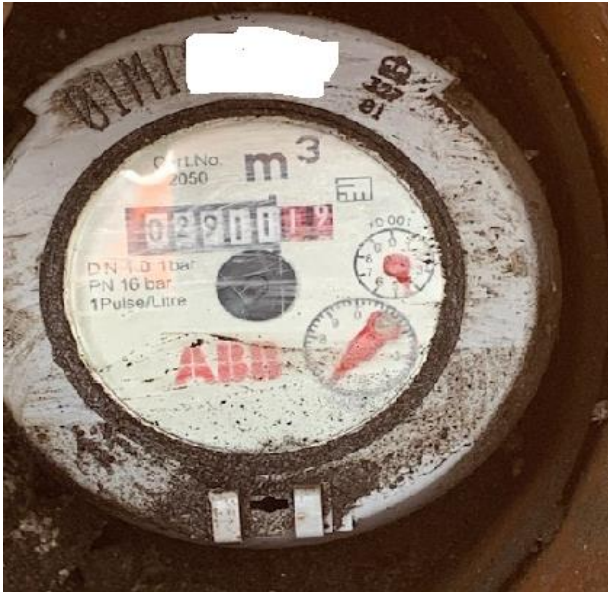
Pic 1

On arriving at site, it was evident where the area of possible leakage was as there was a large wet patch in the yard opp the main entrance doors, on checking the main meter (pic 1) which had a constant flow rate. I shut of the internal stop tap (pic 2)at the POE and re checked the meter, it still had a constant flow rate confirming a leak on the supply pipe. The flow rate was timed over a one minute period and the flow rate was recorded at 6LPM. This equates to 360LPM per hour, ADU 8.64 = Cost **£7,504.40** per annum.

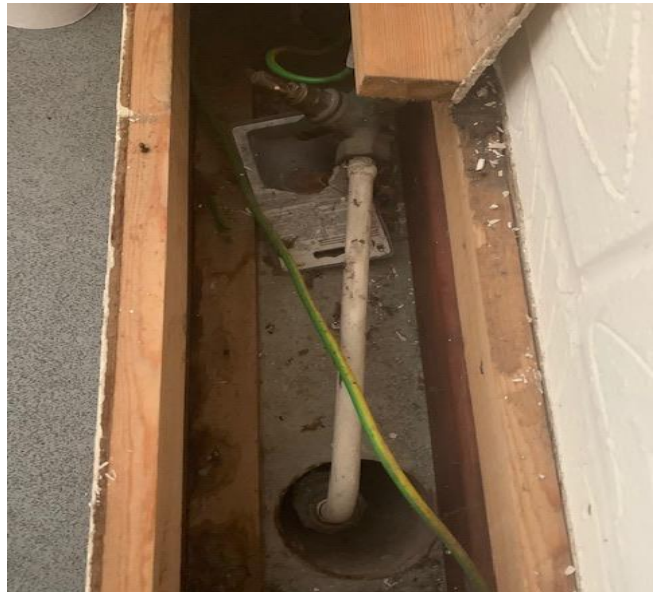
Pic 2

The internal stop tap (pic 2)was re opened and a surface sounding exercise was carried out around where the wet patch was in the yard, it was very difficult to pinpoint the leak due to a very busy road outside the site and road traffic noise was very high. After a long waiting game sounding in between the traffic gaps, a leak noise was located and marked with a blue cross.

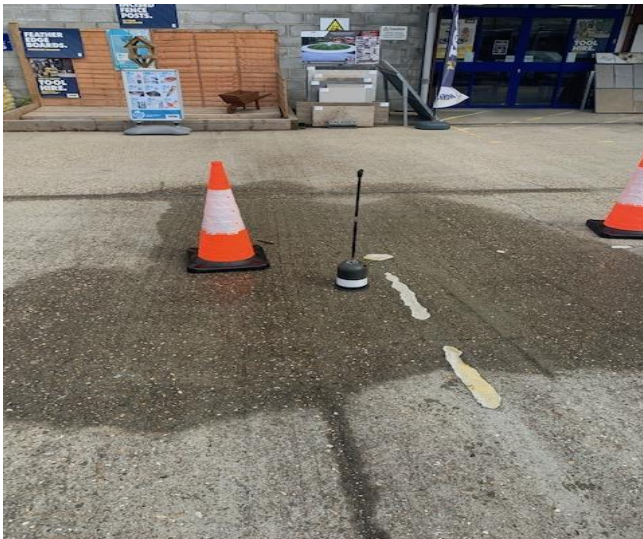
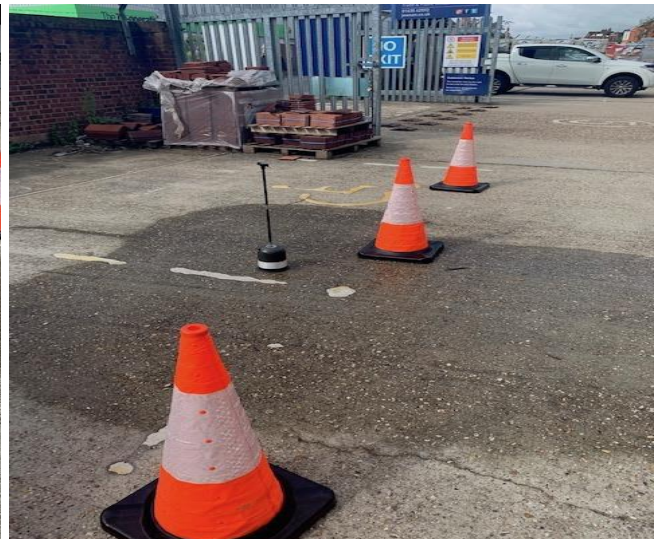
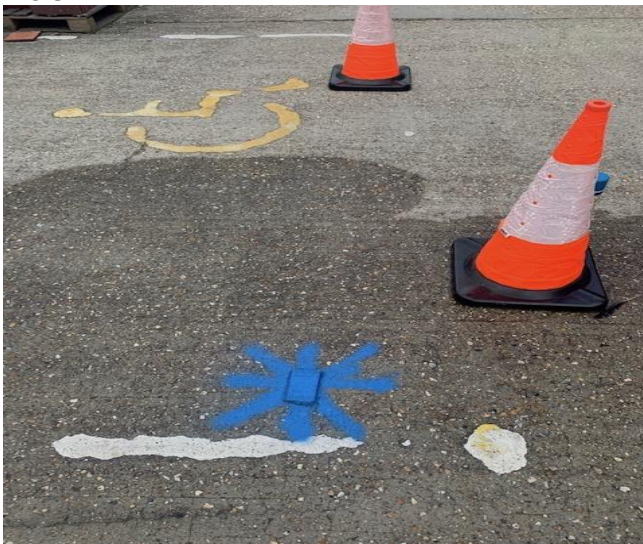
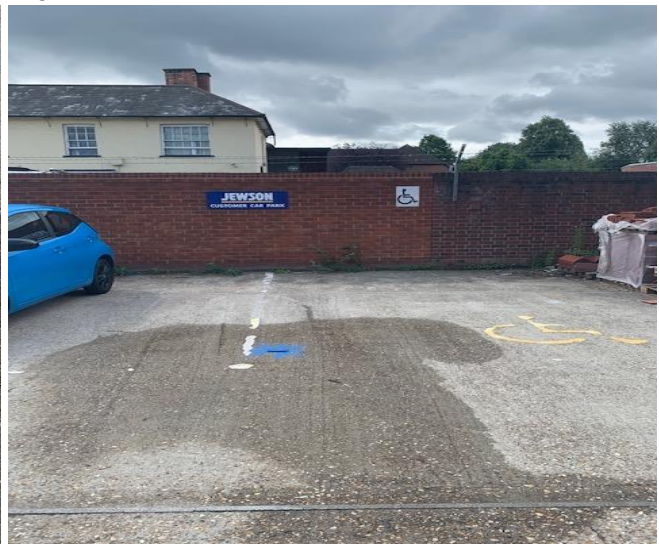
If the blue mark rubs off it will be easy to work out where the leak is based on the photos of the area (pic 3,4,5&6).

External leak located on supply and marked with blue paint

Excavate and repair
