Client: Plumbing and Timber Merchant, Poole, Dorset

Mains water meter information

Leakage Survey Activities

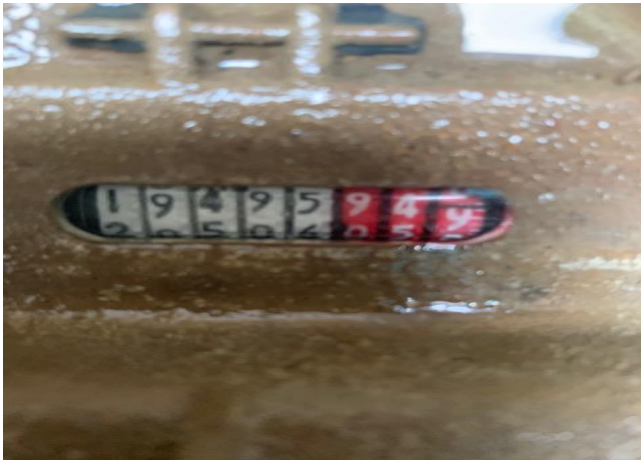
Pic 1

Site staff explained that there was an issue back in February with high water bills and that they had had the local WC and others on site investigating for possible leakage. I first checked the main meter (pic 1) and after pumping out the chamber, a meter reading was taken along with a flow rate confirmed at 6LPM. The meter was sounded and a substantial noise was evident on the pipe-work, the internal stop tap was placed in the closed position and the meter re-checked and again a flow rate confirmed at 6LPM, $0.36\text{m}^3/\text{hr}$, $8.64\text{m}^3/\text{day}$ = £9,460.80 per annum.

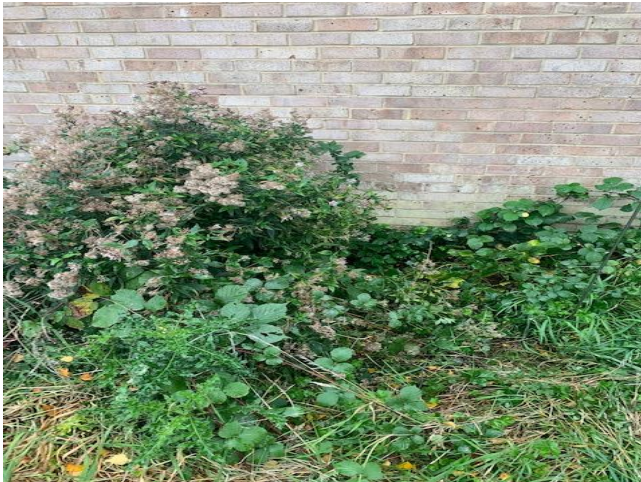
Pic 3

The area around the meter was checked and evidence of flooding under all the shrubbery (pic 3,4,5&6) was evident, on further investigation the leak was located and pinpointed. The leak was located approx. one metre in front of the main meter (pic 5), water could be seen bubbling up to the surface. The pipe-work from the main meter to the internal stop tap is of galvanised iron construction, the supply appears to be inside a 4" duct (pic7) it is therefore recommended that the supply pipe be renewed from the meter to the internal stop tap (pic 8) as the pipe is galvanised iron and will be no longer fit for purpose.

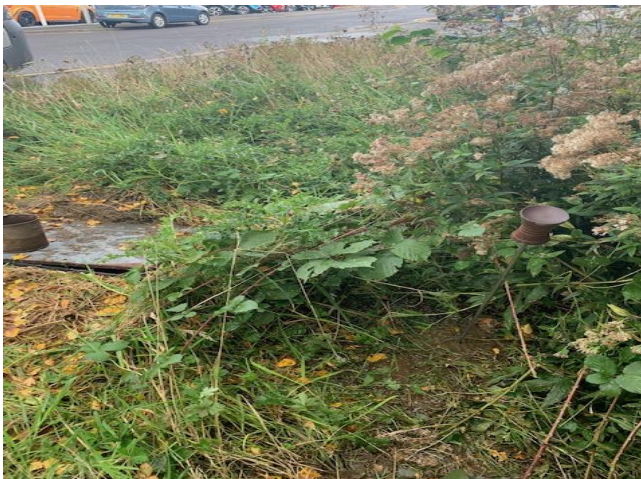
Pic 5

External leak located on supply and is flooding the area of the meter

Renew supply from meter to internal stop tap
