# Leakage Investigation Survey

**Client: Beverley, HU1**

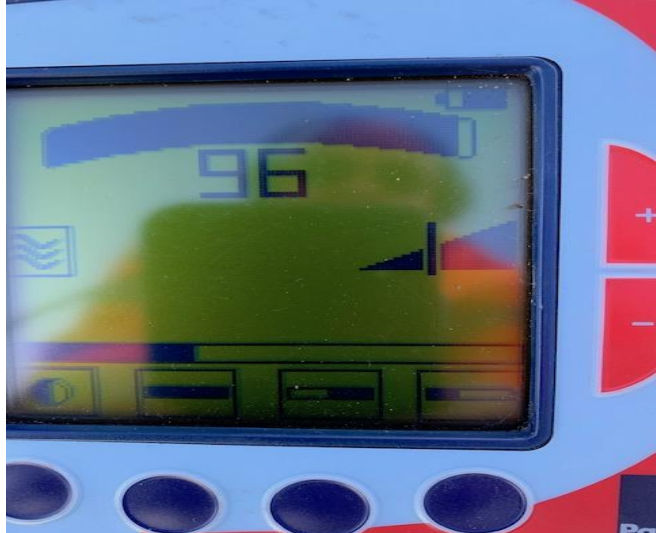
Pic 4

I shut the stop tap located inside the chamber, the meter had stopped recording at this point. I pump out the water once more and noted that the water was no longer rising in the chamber, I then opened the stop tap and in just a few seconds the chamber started to fill again confirming that there was a mains water leak not too far from the meter chamber. I set up the ground microphone soft ground probe and tested the area around the chamber, a very strong reading was recorded (pic 4) only half a meter from the outlet of the meter.

On checking this further with a longer probe water was being pulled up, based on the finding it confirmed that there is a mains water leak just half a metre from the outlet of the meter in the grass verge area. The leak has been marked in blue (pic 5).

The leak was measured at 31 litres per minute = **1.8m<sup>3</sup> per hour and 44m<sup>3</sup> per day at a cost of £136.40 per day x 365 days = £49,786 per annum.**

If consumption is still high after the repair it is recommended that a further survey be carried out as there maybe another leak as it was not possible to check any more of the supply during this survey as the leak found was making too much noise to allow this.

**Urgent repairs to supply**

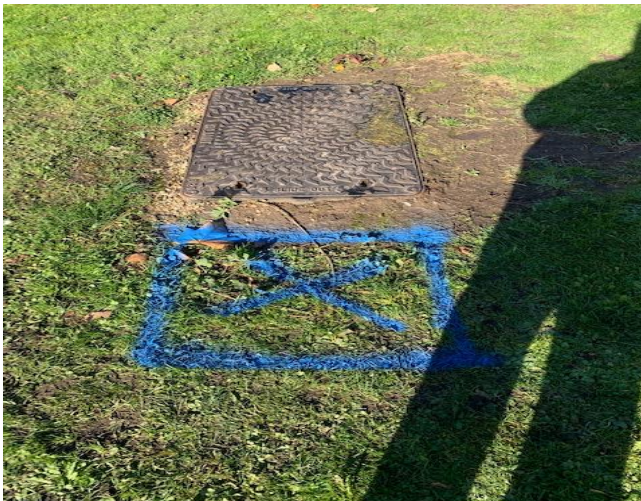
Pic 5

I continued with the leak survey and went to take a read from the meter (pic 5), on opening the chamber it was half full of clear water. Firstly I took a water sample from the chamber and tested it for chlorine, this proved positive so I then pumped out the water and noted that the water was rising quite quickly.

Underground leak located near main meter.

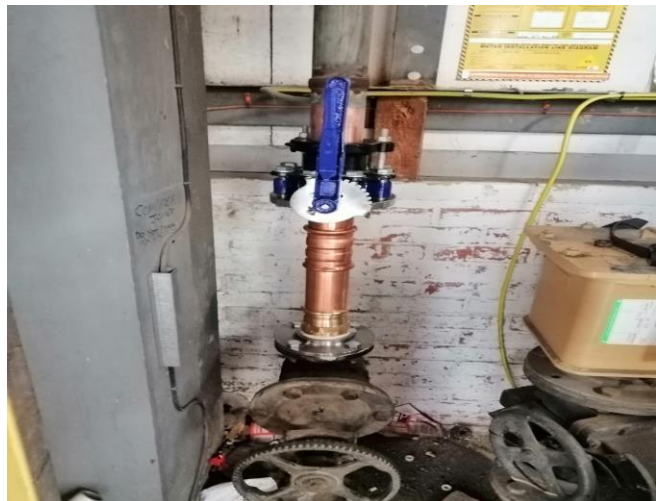
Pic 6

After signing in at site I met up with Nicki who showed me around the site, the internal riser (pic 6) was pointed out and the main meter (Pic 5) was also pointed out.

I began the survey by closing the internal riser and sounding it for leak noise, there was a very small noise but not related to the presumed leak I was looking for.
