# Leakage Investigation Survey

**Client: College, Oswestry**

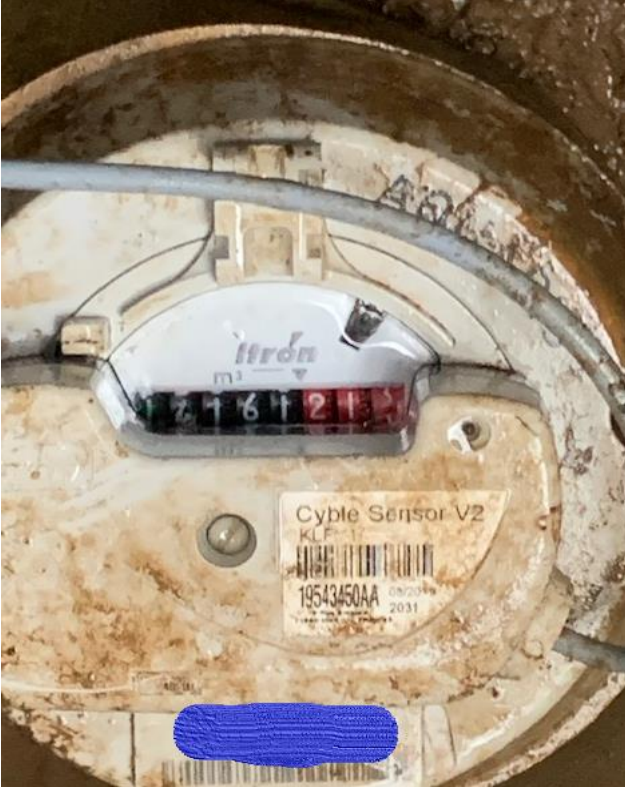
Pic 1

On checking both meters meter 19JE122211 (pic 1) was registering a flow rate of 90 litres per minute which equates to **5.4m<sup>3</sup>** per hour or **130m<sup>3</sup>** per day which equates to (if billed at the normal Water Plus STW rate) **£340 per day** which equates to **£124,319 per year**.

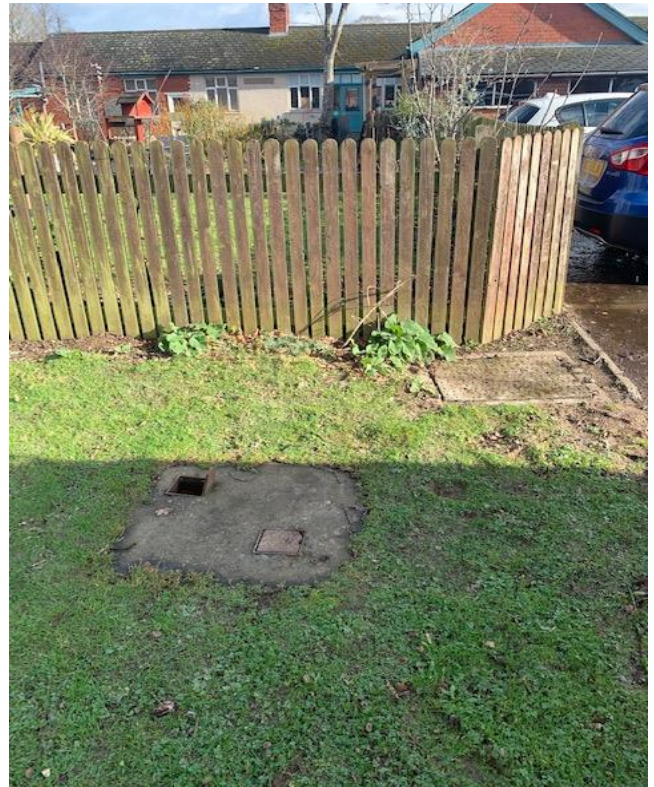
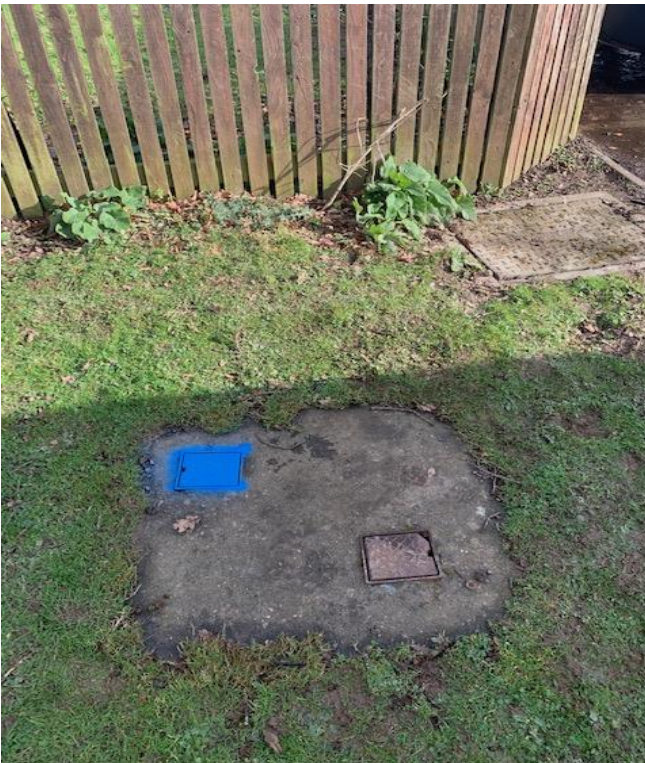
During our investigations we came across two stop tap boxes (Pic 2&3) one of the stop taps was leaking considerably at an estimated rate of 2 litres per minute, which equates to 2.8m<sup>3</sup> per day.

This was marked in blue for repair.

Excavate on stop tap and replace or repair leaking tap

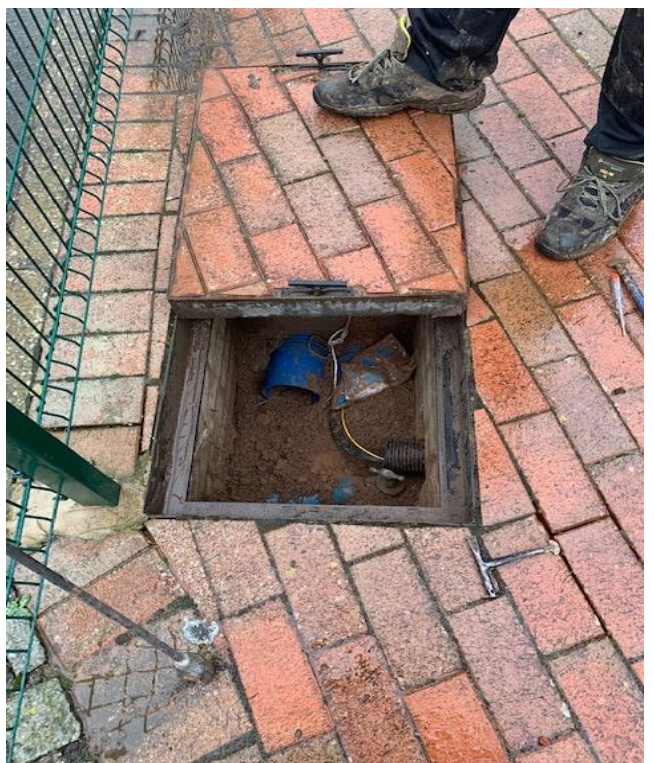
Pic 4

On further investigation we came across what was at first thought to be a sewer manhole but after removing the lid it was noted that there was a 50mm MDPE pipe complete with stop tap (pic 4).

This was sounded and had a very strong leak noise on it. After being escorted into the school grounds further investigations were carried out where a significant leak noise was detected along the kerb and in the plant room of Jackson House, further sounding was carried out along the route of the supply pipe and the leak pinpointed in the grass verge and marked with blue paint (Pic 5&6)
