Leakage Investigation Survey

Client: Lincoln,

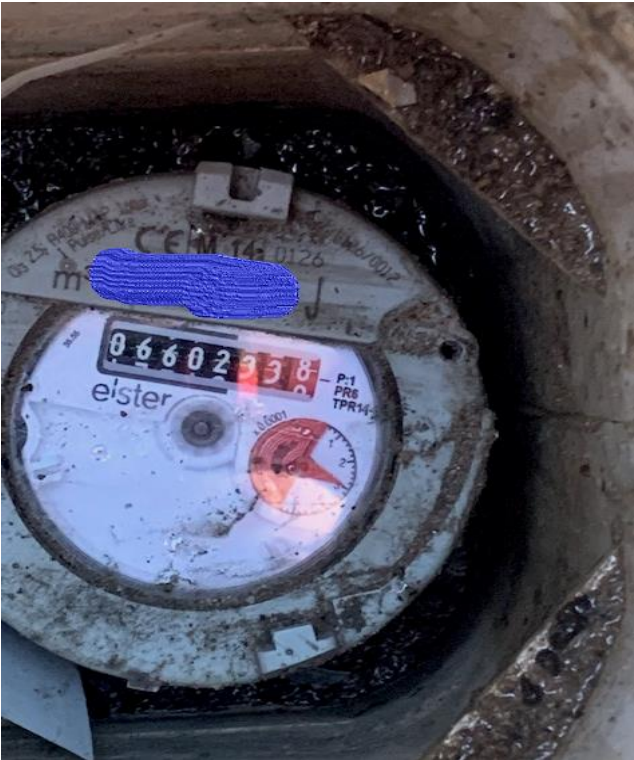
Pic 1

The the revenue meter was then checked (pic 1) where it had a constant flow rate of **11.5 litres per minute = = 0.6m³ per hour which equates to 16.56m³ per day = 6,044m³ per annum.**

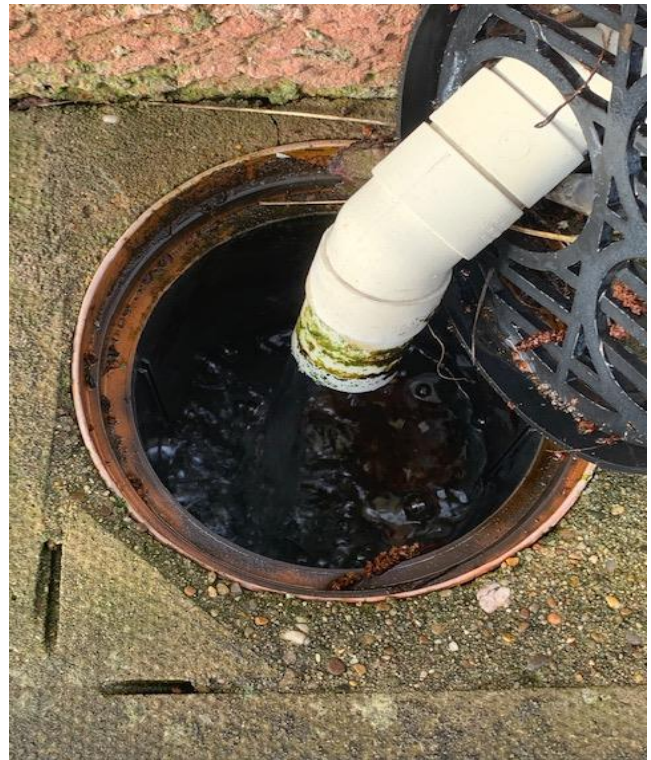
Pic 2

We checked outside and there was evidence of a substantial amount of water running to drain (pic 2)

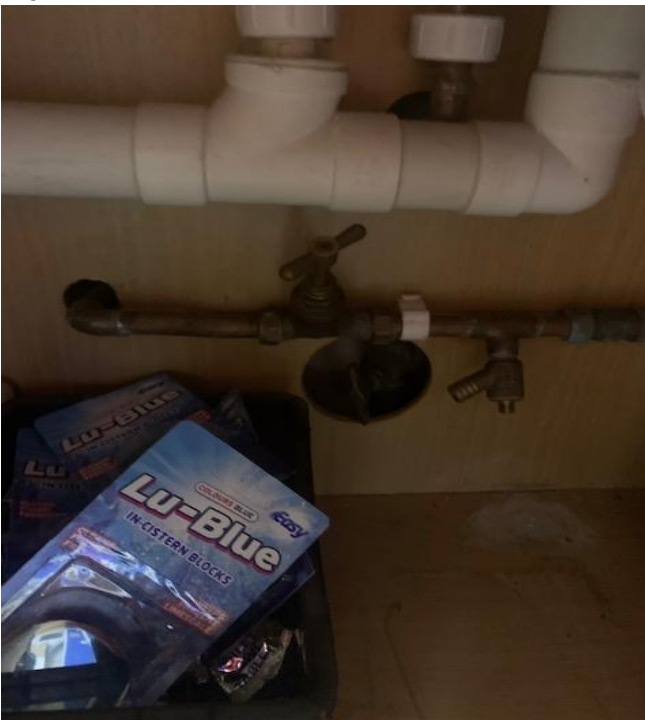
Pic 3

We went back inside and closed off the stop tap (pic 3).

The meter was re checked and the flow rate was now zero confirming that the water heater was the reason for the high consumption.

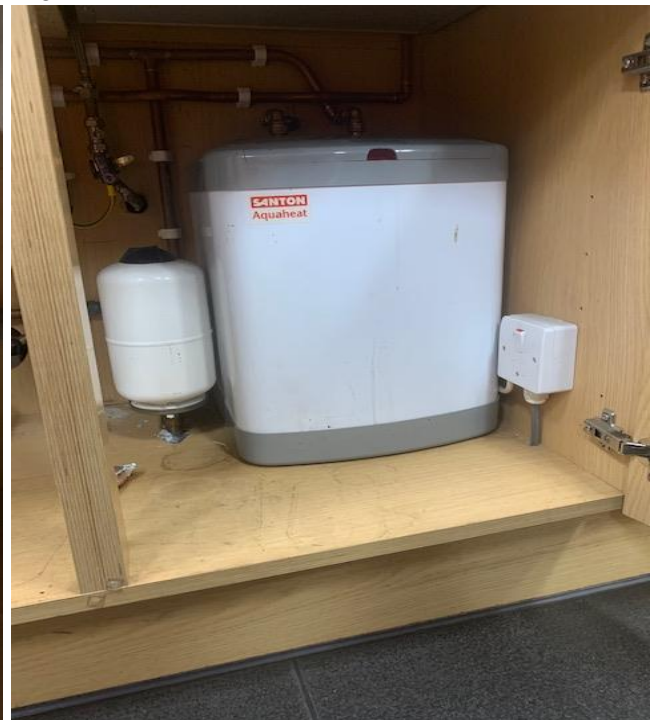
Pic 4

Upon further investigation the leak noise was found to be coming from a water heater located under the sink (pic 4).

Repair or renew water heater under sink in kitchen area.

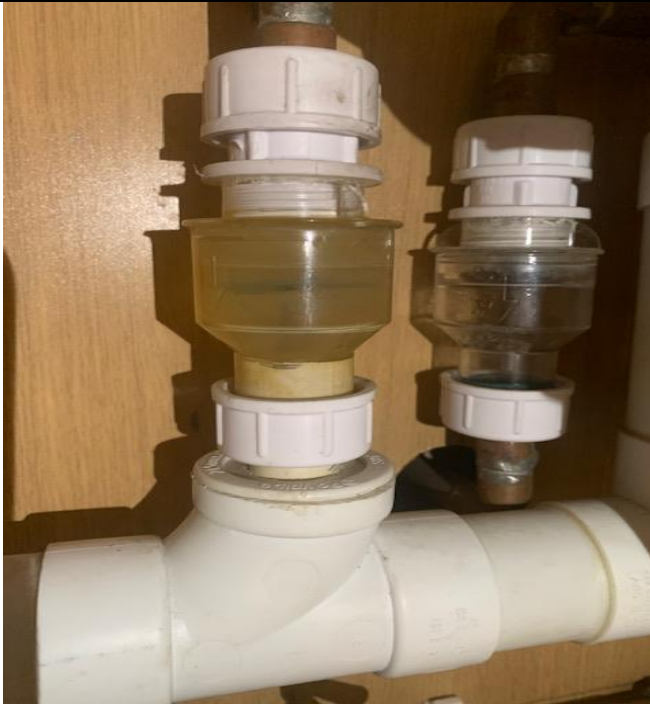
Pic 5

The water was running straight through the water heater and into drain (pic 5). We have also taken a video of this and have attached this with the report.
