# Leakage Investigation Survey

**Client: Chipping Norton, OX7**

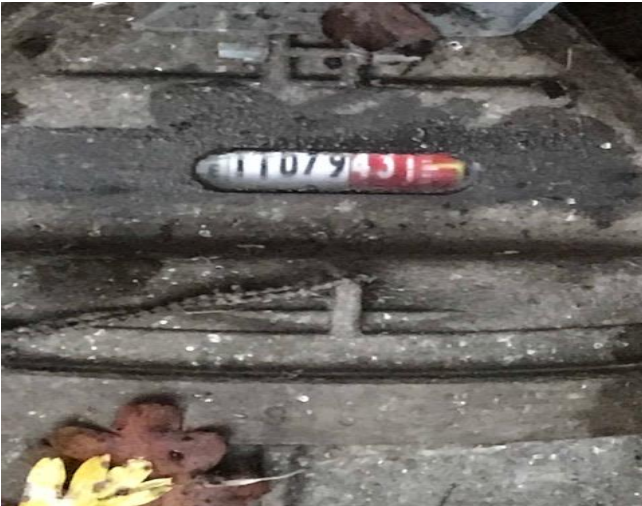
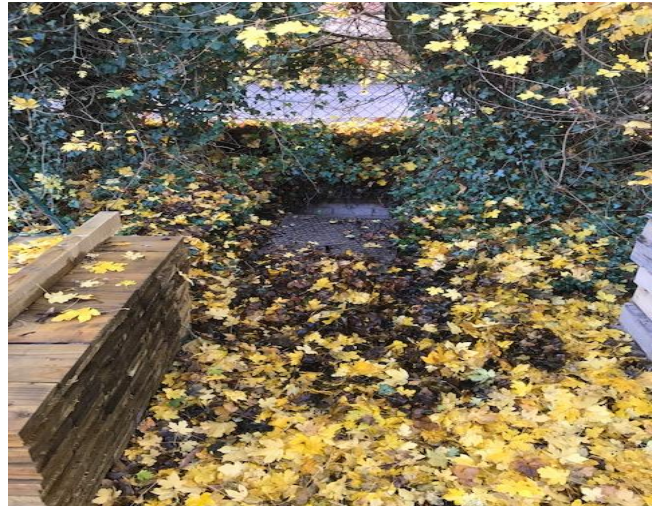
Pic 1

After first checking the meter (pic 1&2), a continuous flow rate of 4 litres per minute was being recorded. The main controlling stop tap was located in the plant room (pic 3) some 8 mtrs from the meter, the stop tap was then closed and the meter re checked. The flow rate was zero, confirming that the usage or leak was controlled by the main stop tap.

The water meter is located on LHS of delivery road in bushes opp plant room door

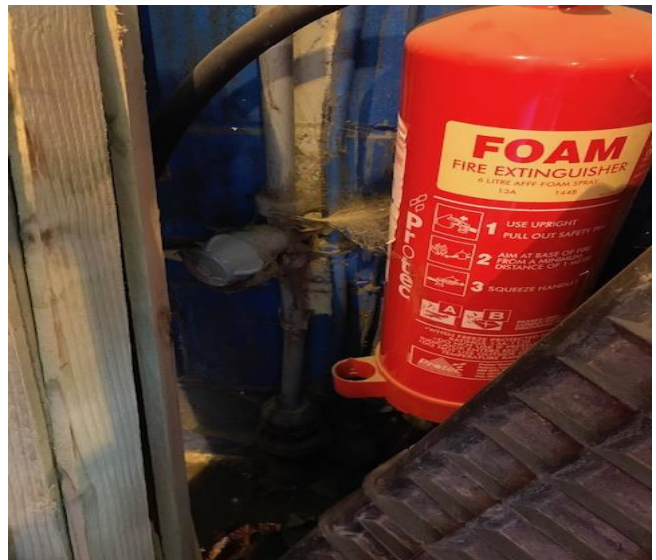
Pic 4

A grey pipe was located behind support beams, this was followed through the building and into the main timber warehouse where a controlling valve (pic 4) was found and the pipe continued after the tap and back below ground. On further investigations it was found that the new found stop tap controlled pipe-work supplying an outside tap and a jet at the bottom of the builders yard area, on entering the jet wash building it was noted that leak noise was evident.
