# Industrial Park, Newcastle

## Mains water meter information

### Leakage Activities

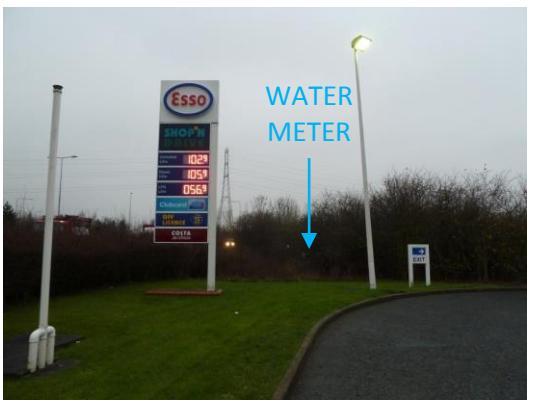
Main meter location off filling station forecourt

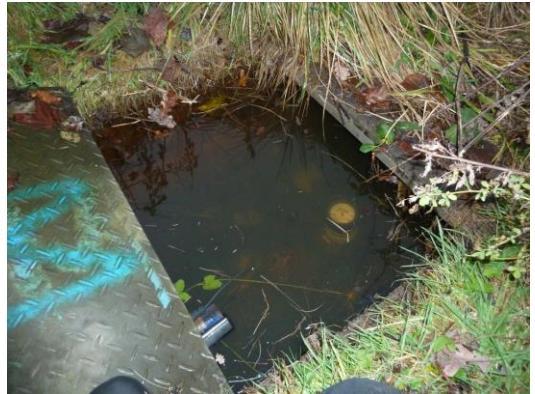
Main meter

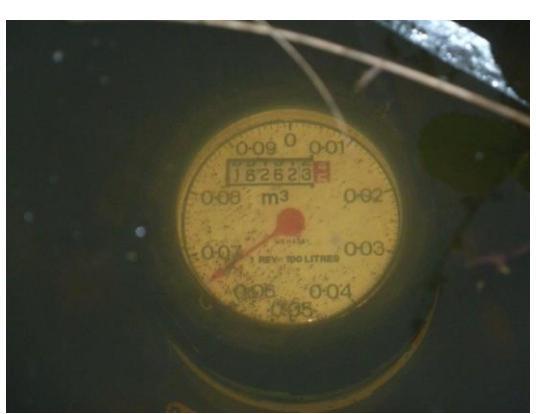
Main meter chamber (flooded)

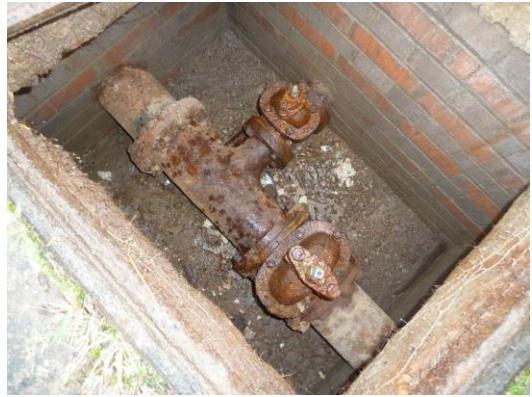
Pipework around the site is formed of a number of different materials. From the meter to the Transco compound the pipework is marked as 8" or 9" uPVC, then on the site itself it was visually confirmed to be mainly 6" and 3" cast iron, with some sections of MDPE (Medium Density PolyEthylene). Isolation valves are visible in chambers around the park but these were not operated due to their age and likelihood of being damaged due to lack of operation over the last few years.

View of site pipework in chamber

1. It is recommended in the first instance to try and identify the approximate area of leakage by operation of some of the old isolation valves on the site, but this must be carried out on the understanding that the packing glands may start leaking or the spindles could have rusted through. It is therefore advisable that a repair team is available on a standby basis in case of leaks caused by the operation of old valves. It is also likely that the valves will not close fully due to age and lack of operation, but it may just be possible to confirm a high volume of water flowing under the gate of the valve by acoustic sounding.

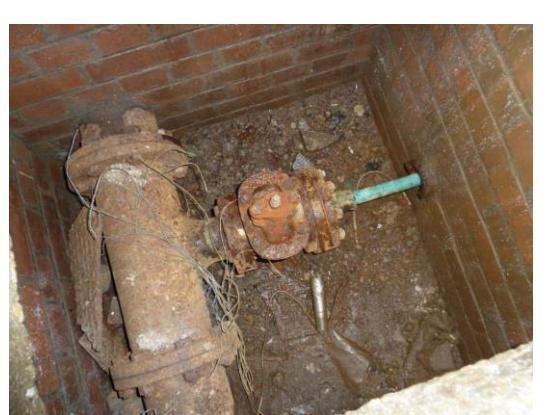
Section of sliplined pipework leading to workshops

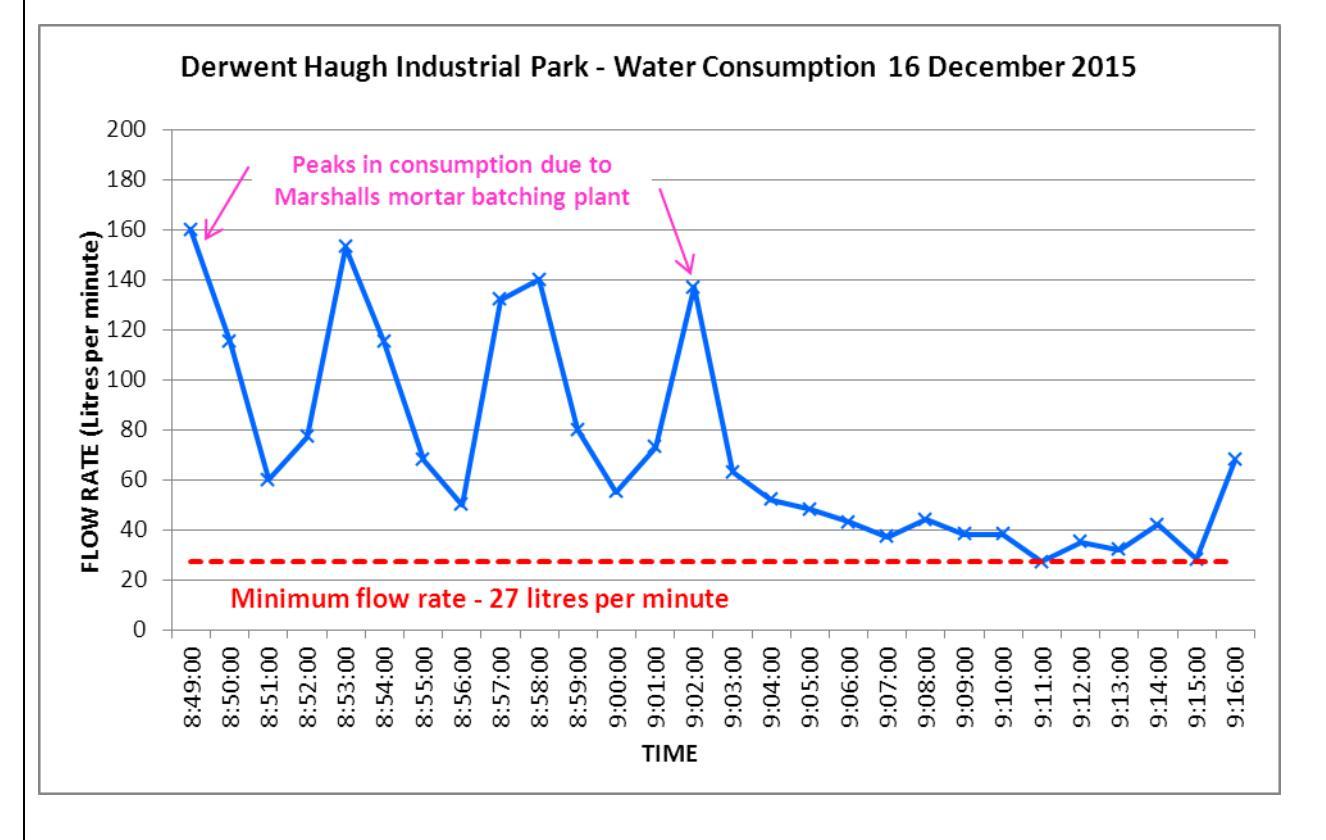
The water meter was monitored several times throughout the survey and on all occasions was found to be recording water consumption at a minimum rate of 27 litres per minute (38.8m<sup>3</sup> per day). With no other major water users on the site, it is expected that this flow rate represents the volume of leakage occurring on pipework to or around the industrial park.

When the cement batching plant is in operation a higher flow rate can be seen through the meter as shown in the chart below:

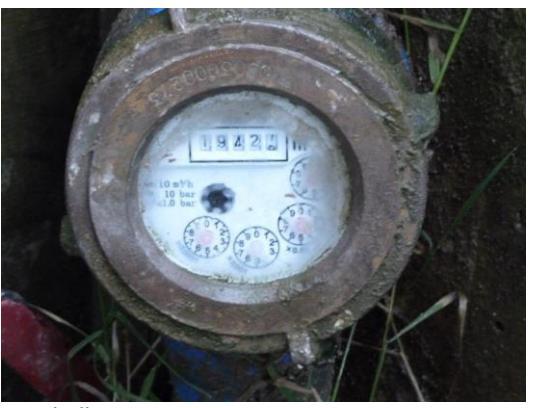
Marshalls meter

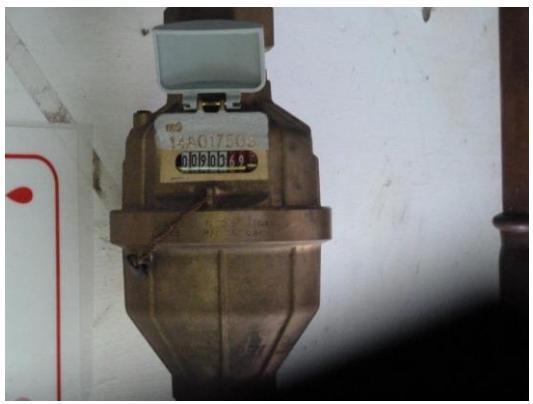
Dawson Rentals meter

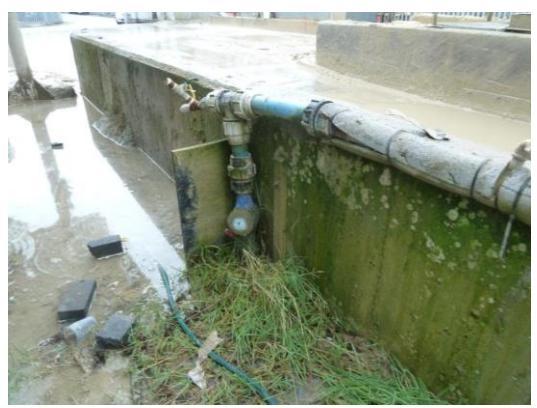
Meter location under mortar batching plant

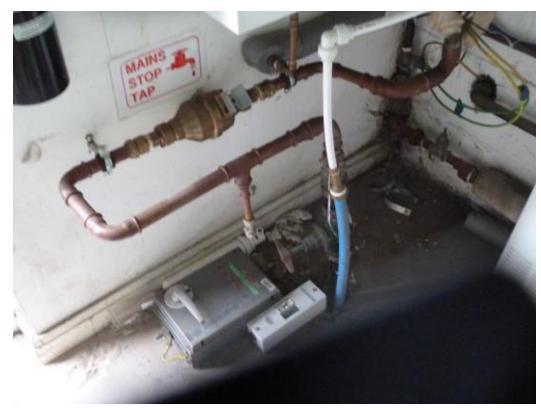
Meter location in plant room

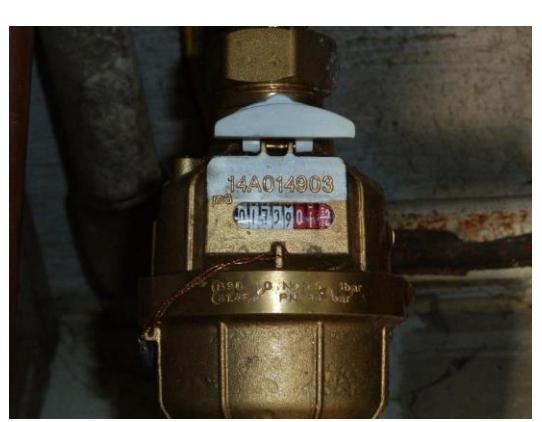
Unit A - Colas offices meter in gas meter cupboard

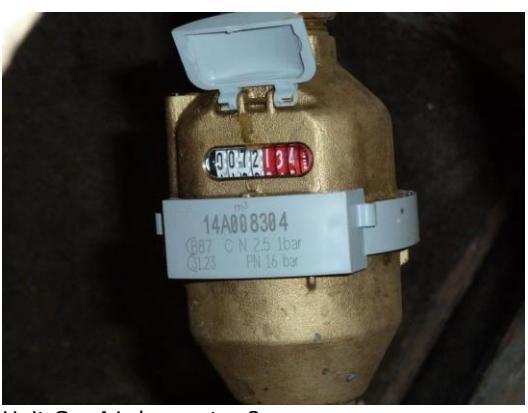
Unit C – A1plus meter 2

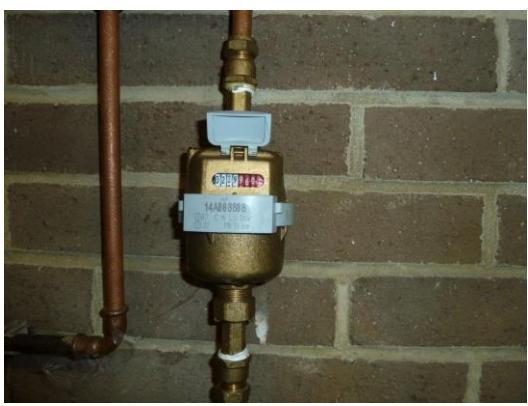
Unit H/N meter

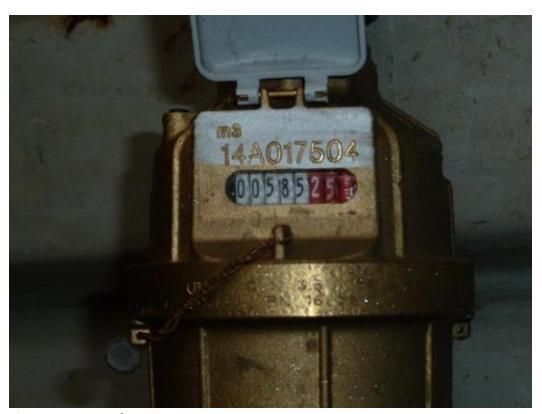
Compound X9 meter

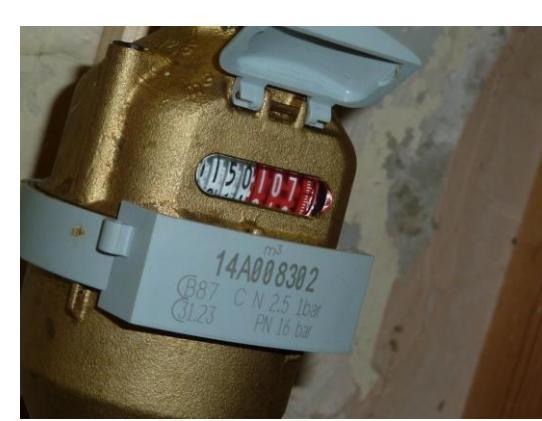
Unit C – A1plus meter 1

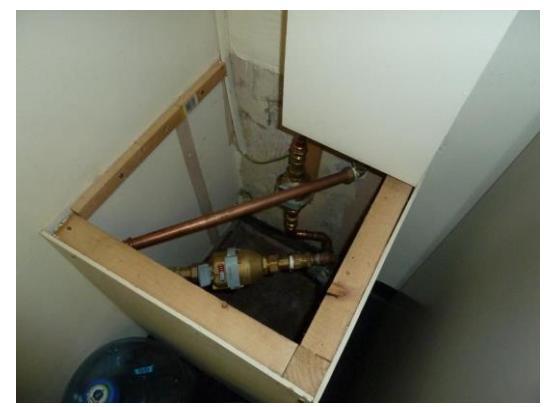
Unit C meter location

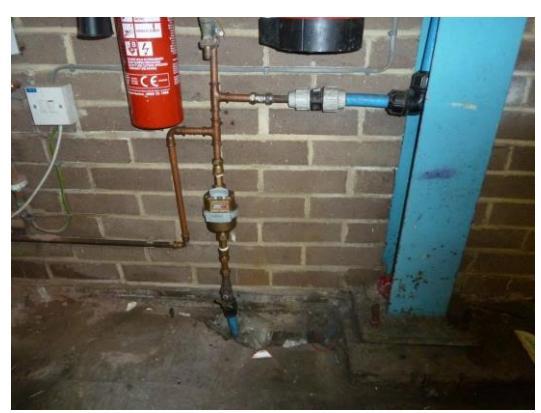
Unit H/N meter location

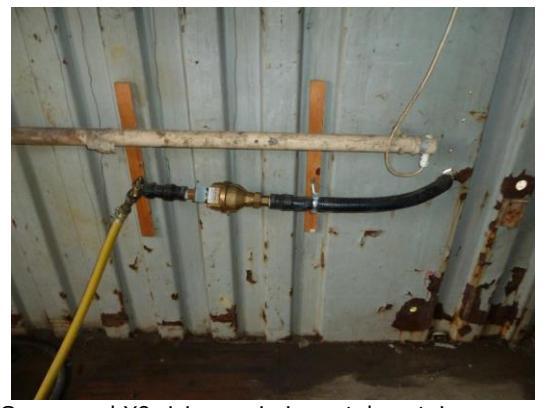
Compound X9 rising main in metal container
