Leakage Investigation Survey

20 January 2015

Vue Cinema, Star City, 100 Watson Road, Birmingham B7 5SA

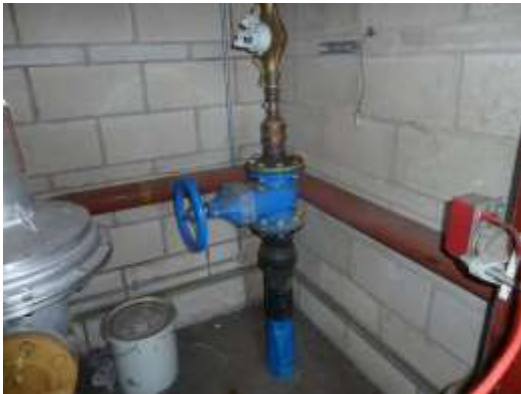
The water meter is located in a small plant room at the rear of the building. The rising main is 100mm Ductile Iron. After the meter, the pipework rises with no intermediate offtakes up to the tank room on the top floor (projection level). The water tank is fitted with an Aylesbury K type float valve. This type of float valve has a delayed action when the water level drops and operates either fully open or fully closed (the volume of water required to replenish the tank was measured at an average 184 litres per fill). This prevents water hammer when compared to a typical standard float valve which allows a range of flows through it to maintain a tanks water level. A set of 3 fixed speed pumps then pressurise the water supply from the tank outlet before a pressure reducing valve regulates the delivered pressure to the entire water network. Copper pipework branches off in three directions to supply all points of water use on the premises.

Meter location and rising main in plant room

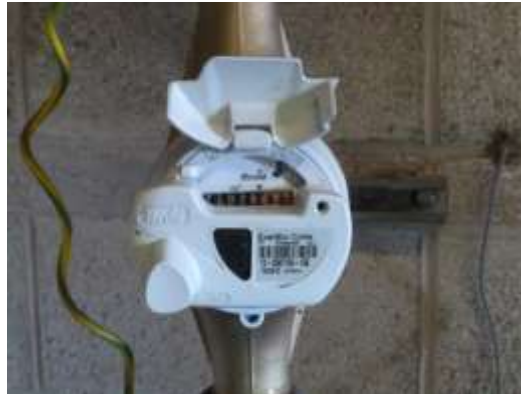
Size (mm)	15-28		32-50	✓	75-100		125-200		Above 200mm
Serial number	12KD124019								
Readings (1)	14027.400				Time:	08:50 20 January 2015			
Readings (2)	14028.690				Time:	14:05 20 January 2015			
Location	Meter located in plant room at rear of premises.

Meter

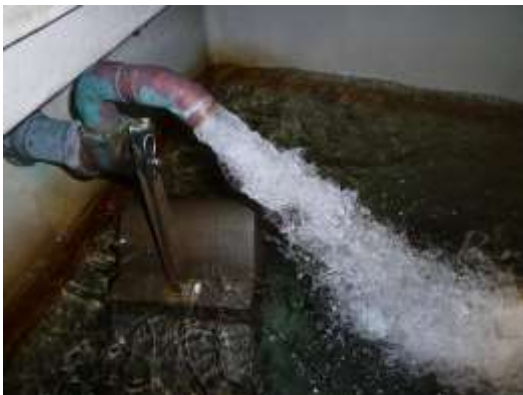
Aylesbury K type delayed action float valve

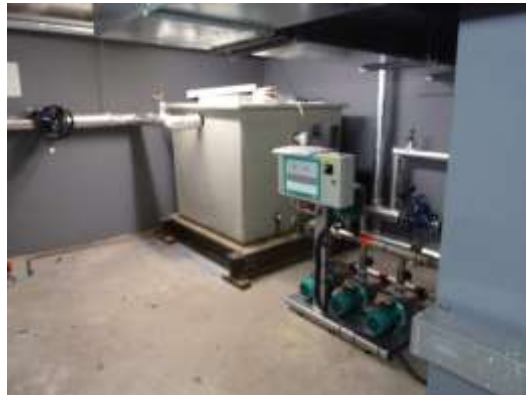
Water tank and pumps

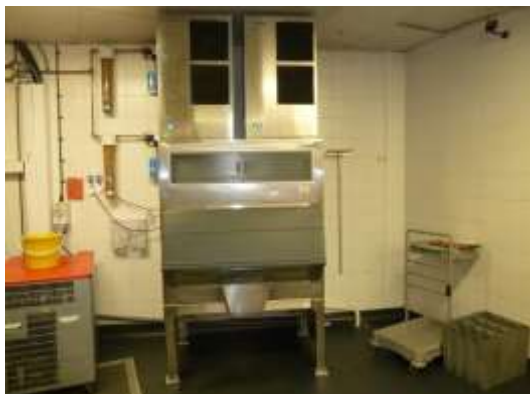
One of the two ice machines in the catering area

Enquiries with a supplier of Follett ice machines in the UK (Folletts are based in the United States and Poland) confirmed that this brand of ice machine was particularly thirsty for water, and that it was normal operating procedure for the unit to discharge significant quantities of water during the production of ice.

From water consumption calculations carried out, the ice machines may prove to be the cause of the unexplained water consumption recorded during the night, and the continued high water usage in general. As an average, the calculated water volume (in the table below) used by both ice machines is **160 litres per hour**. This equates to an **unaccounted water loss of 3.84m³ per day**, an **unaccounted cost of £9.48 per day** and an **unaccounted annual loss of £3,461.95** as a result of the ice machines.

1. Install water meter on 15mm copper supply pipework supplying one of the ice machines to quantify volumes of water used. Alternatively, isolate water and electricity supplies to both ice machines overnight and monitor water usage through main water meter. If found to be cause of high water consumption, consider replacement to more water efficient model;
2. Repair 3 no. float valves on WC cisterns in washrooms:
 - a) WC in ladies near prop shop
 - b) WC in staff female washroom area
 - c) WC in staff male washroom area

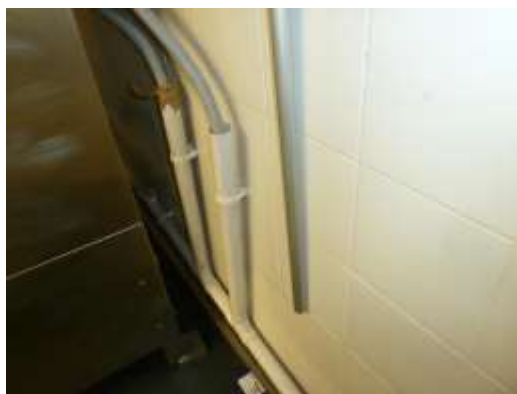
Although the wastewater and overflow pipework at the back of the ice machines had previously been checked and found not to be running, it was noticed on this occasion that the waste pipework was discharging water. A significant volume of clear water was found running from the waste pipework into the drain while a batch of fresh ice was dropping into the holding hopper. Each half of the machine was found to produce a batch of ice approximately every 30 minutes, and when the ice drops, approximately 20 litres of clear water is discharged to waste (measured in a bucket). With 2 ice machines producing ice to maintain a level in the holding hopper, each with 2 ice production channels, it was calculated that around 20 litres of water was flowing to waste every 7 or 8 minutes or so between all machines. The ice holding hopper is metallic and was very cold to the touch, suggesting that it is not particularly well insulated. The ice within the hopper was also noted to be melting, suggesting that the machine may have to work through the night to replace ice that melts in addition to that used during the peak evening time.

Waste pipework to rear of ice machine

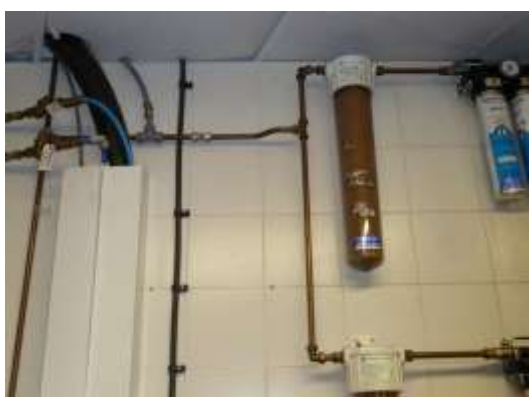
Cold water inlet pipework to ice machine
