Cheltenham Repair Report

7th May 2015

We attended the site in Cheltenham to excavate, expose and repair the leakage point previously marked up in our leak detection visit.

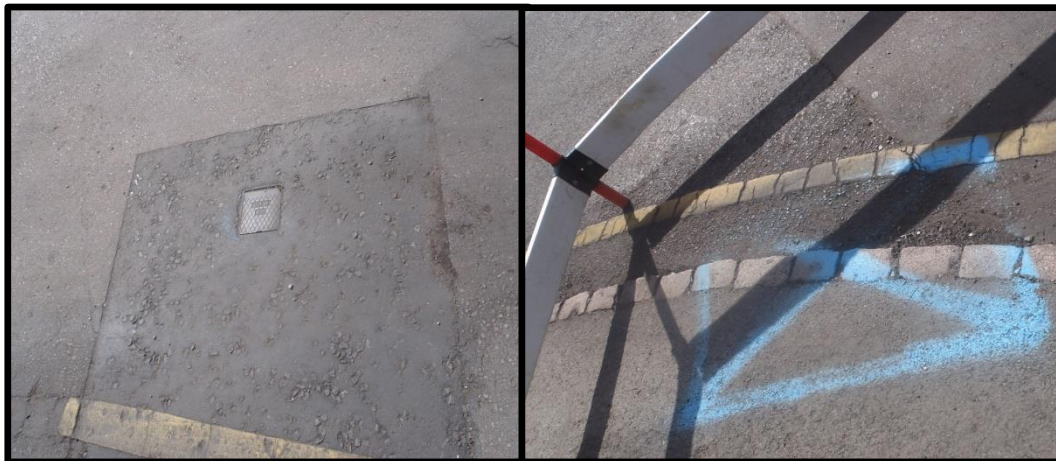
Picture 1 – Water Meter Location

Picture 2 – Excavation Point

After reading the water meter, we began by excavating in tarmac on the pavement, over the point sprayed up in blue paint from our previous visit. We dug down and exposed a leak on the 20mm black polyethylene pipe which was spraying out from a hole in the pipework.

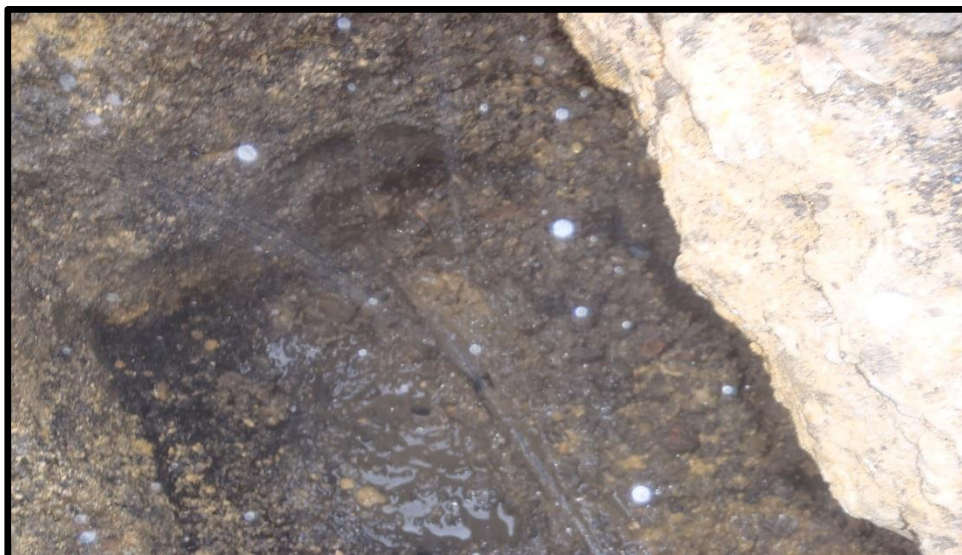
Picture 3 – The leak on the 20mm supply pipe

We temporarily isolated the supply whilst we cut out the leaking section of pipework. We placed the leaking section of supply with a brand new piece of blue MDPE pipework. This was connected back up to match the existing pipework and the water supply reinstated.

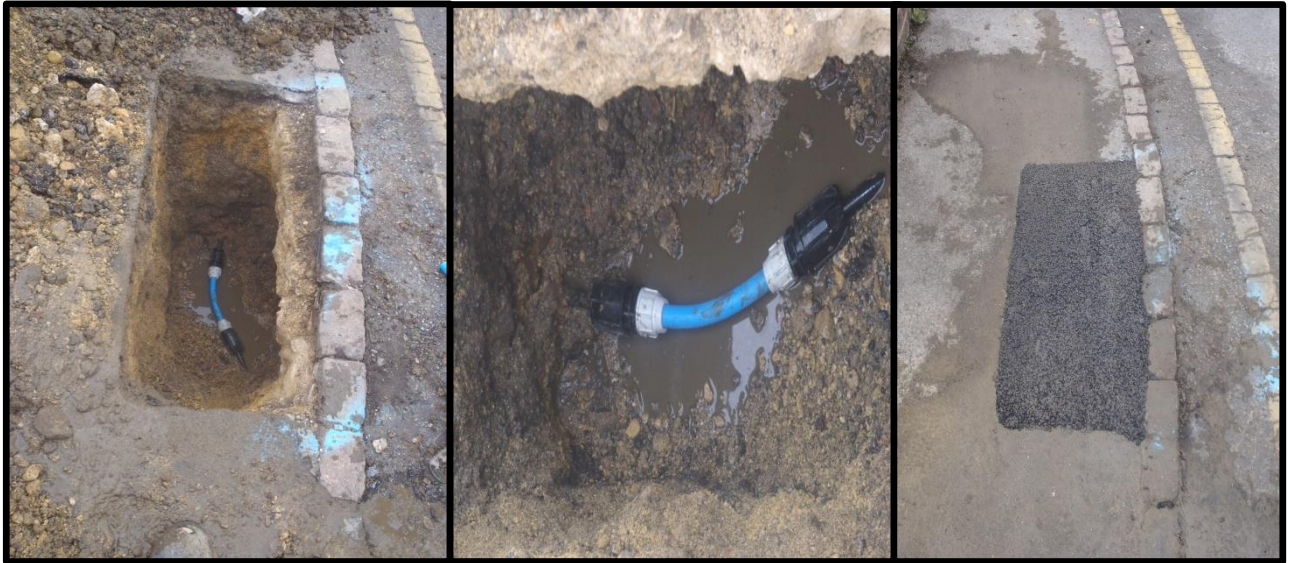
Picture 4 – The excavation in tarmac

Picture 5 – The repaired section of pipework

Picture 6 – The reinstatement

We backfilled the excavation and reinstated in tarmac to match the existing surface.
