Water Leak Detection Site Survey Report

29th April 2015

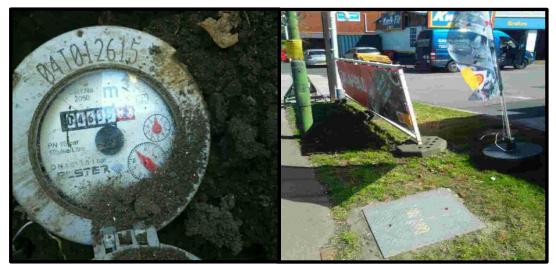
We confirmed the meter feeding the property to be 4T012345 and the meter read 4640m³ on 22nd April 2015.

The Water Meter: 04T012345

The Water Meter Location

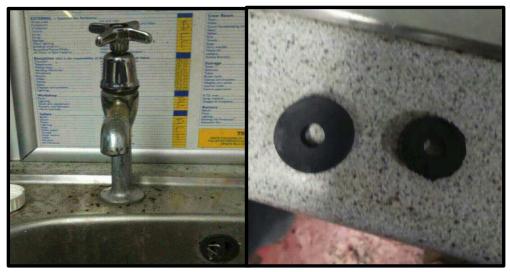
We continued to investigate all areas of the site and came across a tap in the kitchen which was constantly dripping. We unscrewed the tap and exchanged the rubber washer inside the tap as it appeared this had worn away, hence why the tap was leaking. With a new rubber washer fitted, the tap was repaired.

The leaking tap found in the Kitchen

The washer on the right can be seen to have worn away. The one on the left is the replacement we installed.

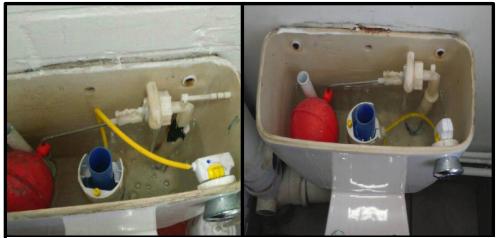
From here we found ourselves in the upstairs toilets. Both toilets were found to be constantly filling up. We attempted to adjust the ball valve in the toilets tanks but both ball valves are completely worn and need replacing to repair the toilets. We found no other leakage issues whilst on site.

Both of the toilets upstairs were found to be constantly running due to broken ball valves within the toilet tanks

We recommend retuning to site to fit x2 brand new ball valves to the toilets. As all the water has run straight down the drain to sewer.
