# Lyons Holiday Parks

## Pendyffryn Hall Leak Detection Site Survey

21<sup>st</sup> December 2015

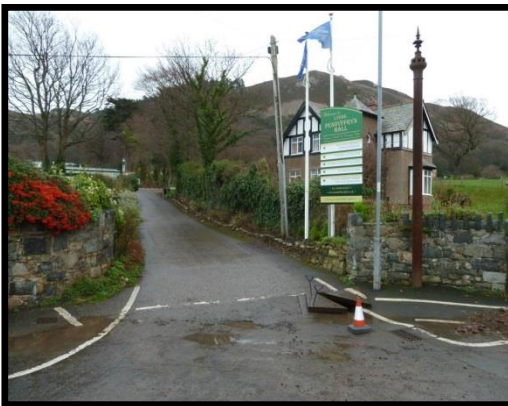
Picture 1 – Water Meter Location

Upon arrival at site, we identified x2 water meters located in large split lid chamber at the entrance to the park. This can be accessed with pair of large lifting keys.

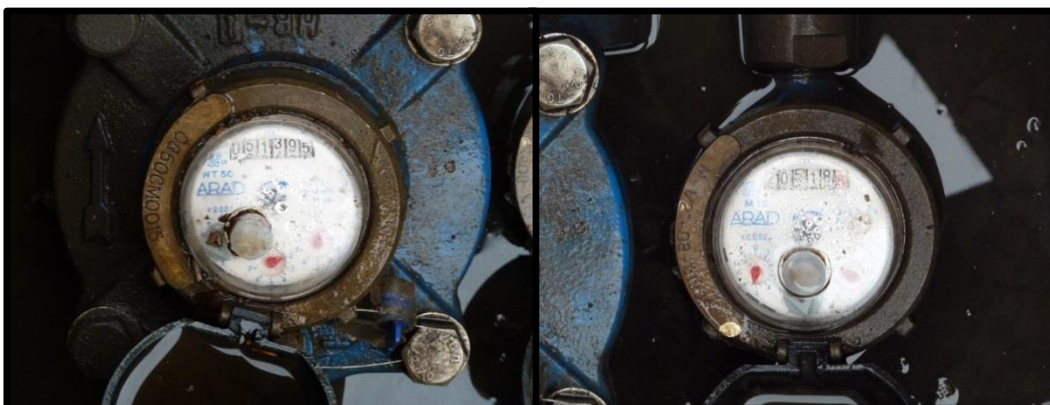
Picture 3 – Main Water Meter 0850Cm0015

The main water meter was 0850Cm0015 reading 51394m<sup>3</sup> at 10am on 14<sup>th</sup> December. We read this meter again at 4pm on 14<sup>th</sup> December and the meter showed 51395m<sup>3</sup>. Therefore, in approx. 6 hours the site had used 1m<sup>3</sup> of water (0.16m<sup>3</sup> per hour).

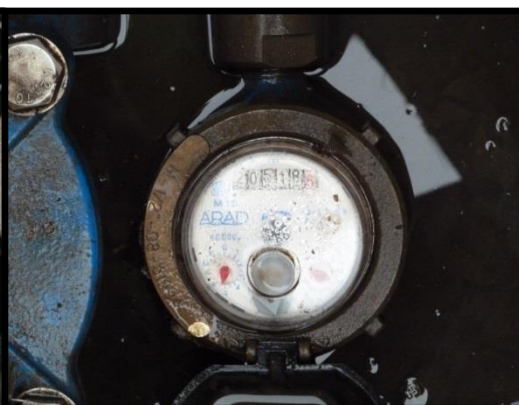
Picture 4 – Bypass Meter 08-519945

We read the bypass meter, 08-519945, which at 10am read 20516m<sup>3</sup> and at 16.01pm, read 20519m<sup>3</sup>. The bypass recorded consumption of 3m<sup>3</sup> in 6 hours (0.5m<sup>3</sup> per hour).

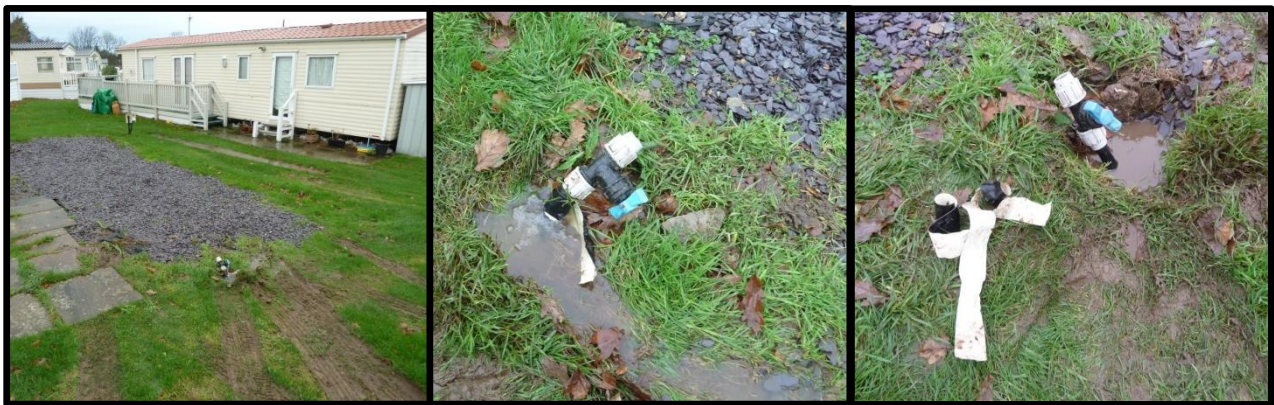
During the survey a visible leak was identified on a connection to one of the empty plots – T11. **This leak was repaired at the time of the survey by H2O.**

Picture 5 – Location of leak – Plot T11

Picture 6 – Split on Pipework causing leak

Picture 7 – Repaired leak  
(cut back pipe to remove split section)

Prior to repairing the leak, the meter was monitored for a short period of time and found to be recording water consumption at a minimum rate of 8 litres per minute. This equates to 0.48 cubic metres per hour or 11.5 cubic metres per day.

Following the repair, the meter was monitored and found to be recording an average minimum flow rate of 4 litres per minute (0.24m<sup>3</sup>/hour or 5.7m<sup>3</sup>/day). This is an instant saving for Lyons due to repair of **0.24m<sup>3</sup> per hour (240 litres per hour )** and an **instant financial save of £17.12 per day & over one year, £6,244.13.**

1. Repair 2x minor leaks identified;
2. Provide protection for the repaired leak to prevent it being driven over again;
3. Provide easier access to the rising main or isolating valve underneath each mobile home to enable a full survey to be carried out;
4. In the absence of a data logger, it is also recommended that the meter is read on a monthly or weekly basis to monitor water consumption. Note: both meters must be read within the chamber to obtain an accurate figure.
