Leakage Investigation Survey

A leak has been identified by site staff, area of flooding left of front of entrance doors in car park

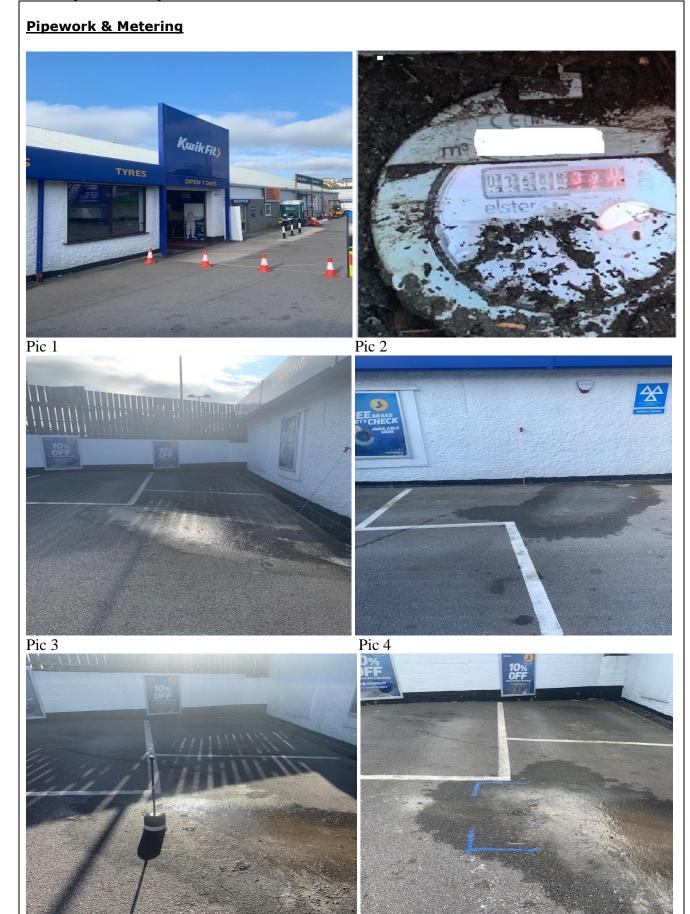
Pic 5 Pic 6

On arriving at site it was evident where the area of possible leakage was as there was a large wet patch (pic 3&4) in the car park and was pointed out by site staff.

The ground microphone (pic 5) was then used and a faint sound was obtained.

The leak noise was now much louder and could be pinpointed ready for excavation, the area was marked up with plue paint s(pic 6) o that it could be identified by the excavation team.

Summary & Recommendations
Summary:
External leak located on supply and marked with blue paint
Recommendations:
Excavate and repair
