Leakage Investigation Survey

17 November 2016

Leisure Park, County Durham

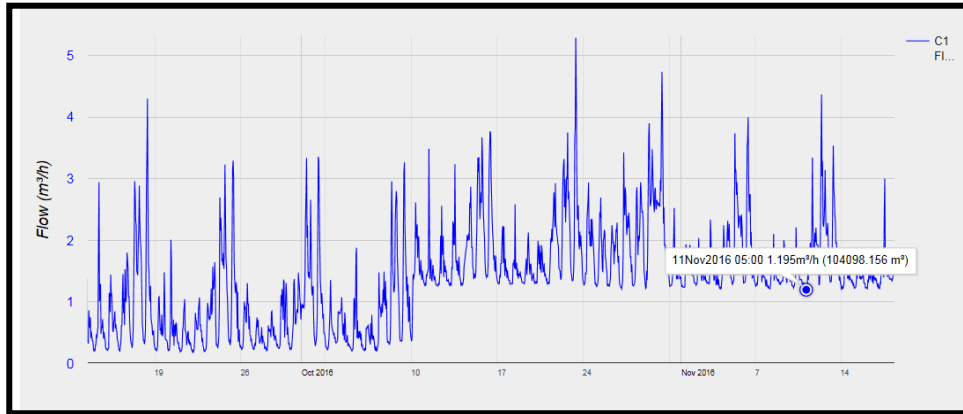
When checked, there was a high level of leak noise on the pipework in the meter chamber. With the valve behind the meter closed for a short period, the water level in the chamber was found to drop quite quickly. A chlorine residual test confirmed mains water immediately. The chamber was completely dewatered before opening the valve again. Water started filling the chamber within a few seconds.

Water in chamber (level drops when gate valve closed)

1. Leakage on the section of off-site pipework between the water meter and the main valve into the park confirmed to be 16.2 litres per minute or over 23m³/day equating to an excess cost of approx. £52.95 per day.

1. H2O to arrange with Water Company to attend site, identify, inspect and repair this leak.
2. Confirm reduced leakage volume (if any) once leak has been repaired.
