Client: Plumbing and Timber Merchant, Poole, Dorset

Mains water meter information

Leakage Survey Activities

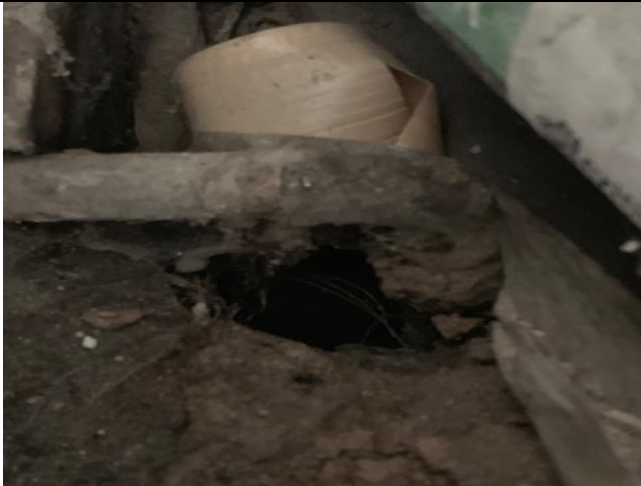
Pic 7

The area around the meter was checked and evidence of flooding under all the shrubbery (pic 3,4,5&6) was evident, on further investigation the leak was located and pinpointed. The leak was located approx. one metre in front of the main meter (pic 5), water could be seen bubbling up to the surface. The pipe-work from the main meter to the internal stop tap is of galvanised iron construction, the supply appears to be inside a 4" duct (pic7) it is therefore recommended that the supply pipe be renewed from the meter to the internal stop tap (pic 8) as the pipe is galvanised iron and will be no longer fit for purpose.
