# Leakage Investigation Survey

**Client: Chipping Norton, OX7**

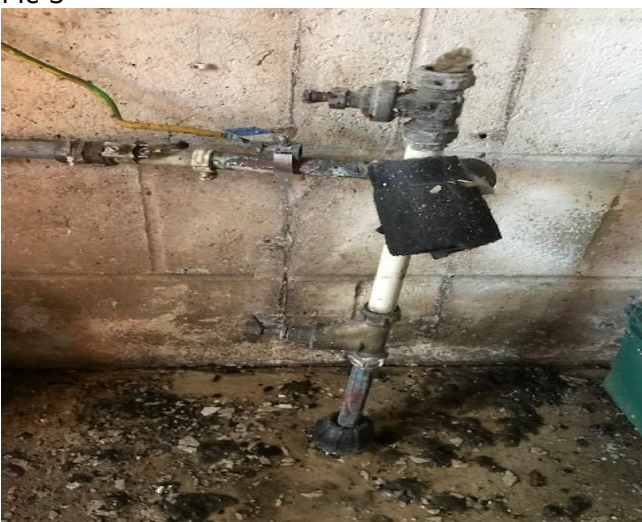
Pic 5

The tap was then closed and the area of leak noise re-checked, the leak noise had stopped confirming the tap controlled the leak. On restoring the supply to the jet wash compound, leak detection was then carried out to locate and pinpoint the leak. The leak was located somewhere below ground on the feed to the jet wash. An excavation will have to be taken out inside the jet-wash storeroom and possibly externally as well, it has been confirmed that the pipe-work below ground at this location is of iron construction. Site materials (pic 6) will have to be moved from both inside the small building and outside to make the areas safe to work in.

External leak located on supply below concrete flooring in jet-wash store room

Excavate and repair, pressure test for further water leaks £1,545 + VAT
