Leakage Investigation Survey

Activity Summary

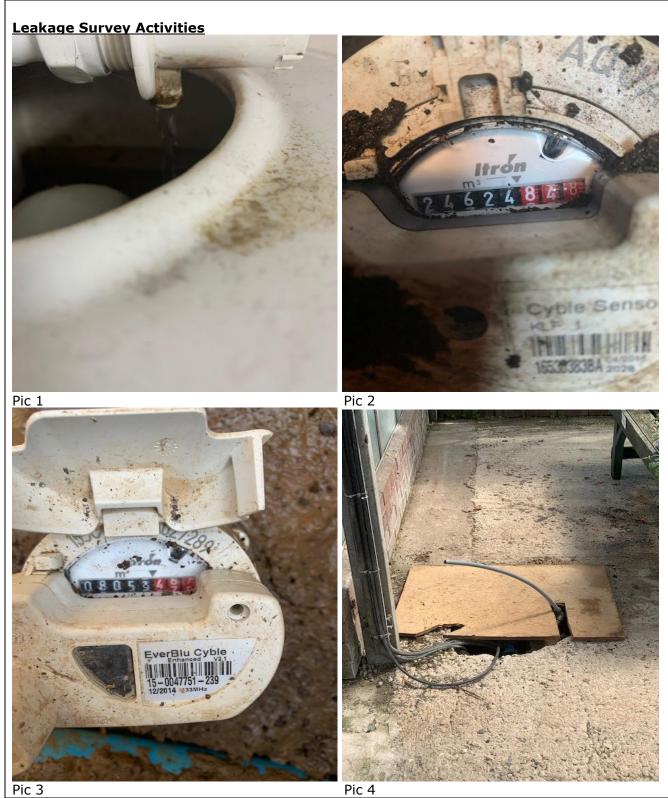
Pic 5

On entering the first greenhouse there was a board laid on the floor (pic 4), on lifting the board you could clearly see a leak (pic 5) with a very good flow rate.

It was not possible to shut this off as the leak was the live side of the stop tap, on reporting this back to office we were instructed to isolate it and get a team on ASAP to carry out repairs.

Carry out repairs on failed supply in greenhouse
